Recall Bulletin

F/CMVSS NONCOMPLIANCE RECALL

SUBJECT: Front Safety Belt Anchor Pretensioner Installation

MODELS: 2009-2010 Chevrolet Impala

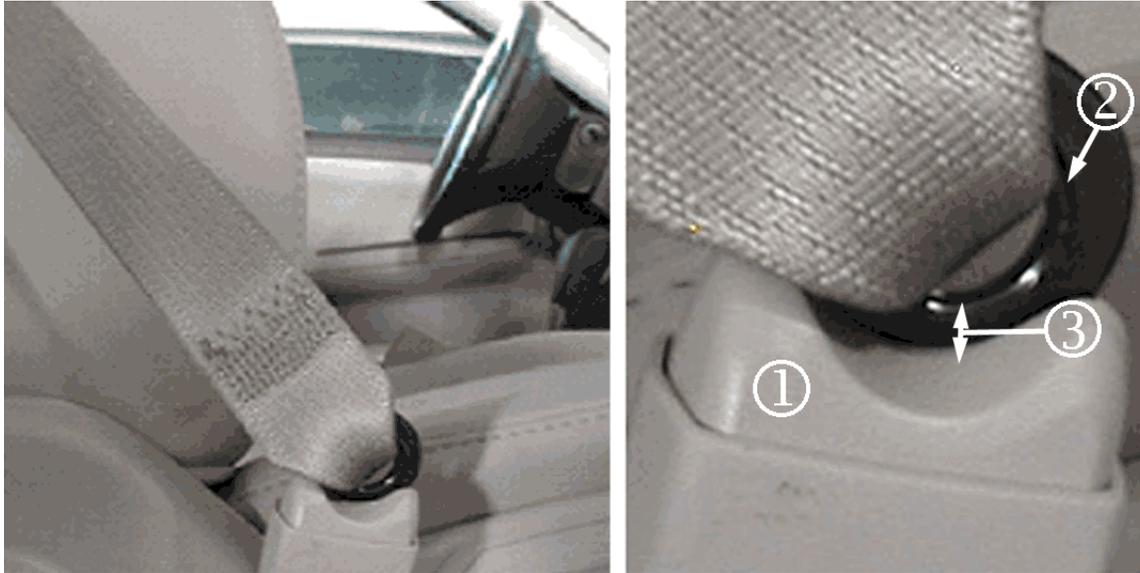
2536195

Seat Belt and Anchor Pretensioner Correctly Installed

There is a small gap (3) between the anchor linkage plate ring (2) and plastic cover (1). You should only see the anchor linkage plate ring and a small portion of black metal between the bottom of the anchor linkage plate ring and plastic cover.

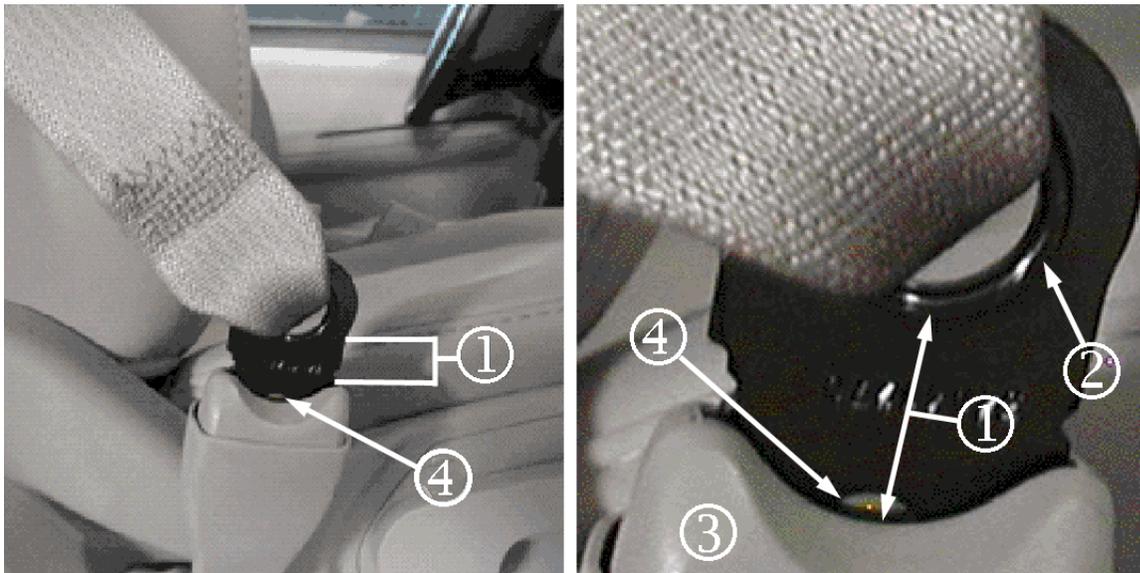
2536196

Seat Belt and Anchor Pretensioner Incorrectly Installed

There is a large gap (1) between the anchor linkage plate ring and plastic cover. A portion of the anchor plate hole (4) may be visible. There will be approximately 19 mm ($\frac{3}{4}$ in) of black metal visible between the bottom of the anchor linkage plate ring (2) and plastic cover (3).

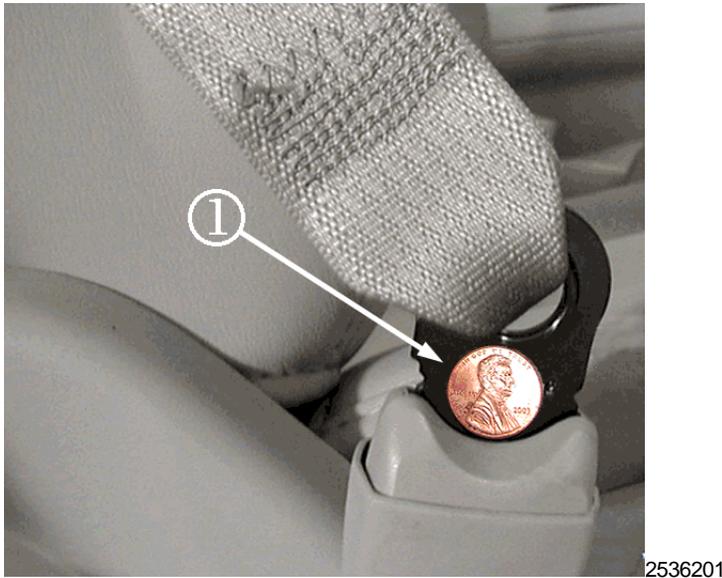
If you can stick a penny (1) between the anchor linkage ring and plastic cover, the seat belt and anchor pretensioner are incorrectly installed.

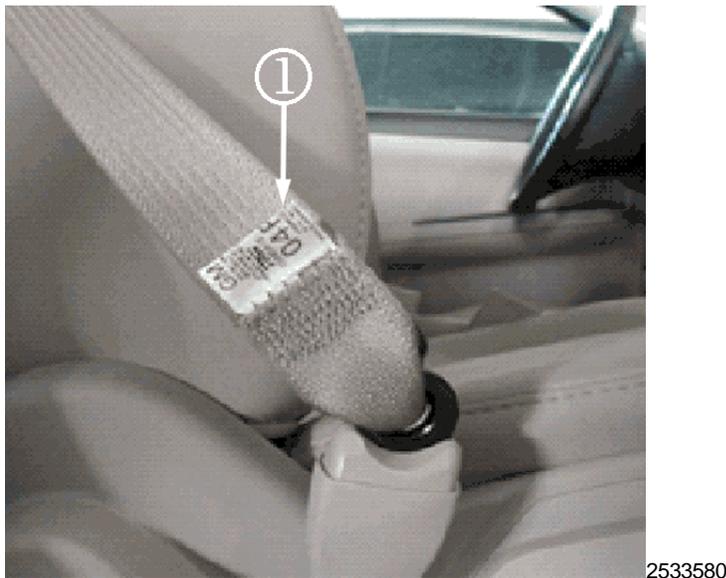
Label Facing Door

Seat Belt and Anchor Pretensioner Incorrectly Installed

If the seat belt label (1) is facing the front door of the vehicle, the seat belt and anchor pretensioner are incorrectly installed. The seat belt label must face the seat back.

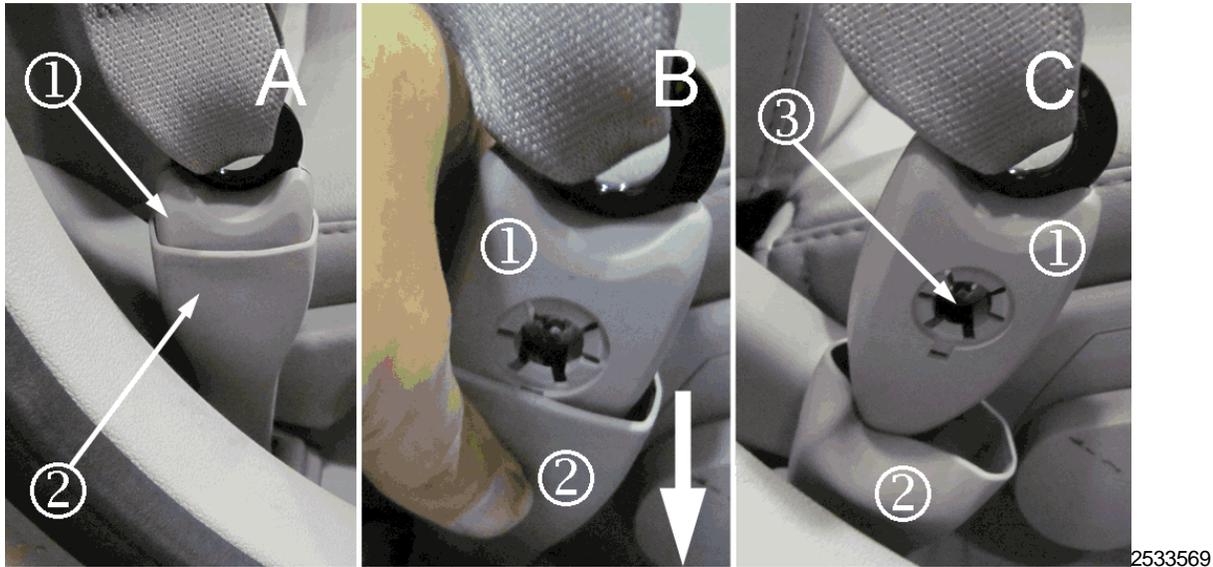
(A) Anchor Linkage Cover (1) and Cover Sleeve (2) (B) Sleeve Pulled Down Below Anchor Linkage Cover (C) Location of Anchor Linkage Cover Screw (3). Illustration shown with the Seat Belt and Anchor Pretensioner Correctly Installed.

2. Pull the sleeve (2) down below the anchor linkage cover (1).
3. Remove the anchor linkage cover screw (3) by loosening the screw. Push the screw through the hole using the small access hole on the opposite side of the anchor linkage cover (1).
