Re: Toyota Safety Recall 10V-499

Subject: Safety Recall A0M – Rubber Seal (Brake Master Cylinder Cup)  
Certain 2005 through 2006 Model Year Toyota Avalon Vehicles &  
Certain 2004 through 2006 Model Year Highlander (Non Hybrid) Vehicles

**TECHNICAL INSTRUCTIONS**  
**FOR**  
**SAFETY RECALL A0M**  
**RUBBER SEAL (BRAKE MASTER CYLINDER CUP) REPLACEMENT**  
**2004 – 2006 MODEL YEAR HIGHLANDER**  
**2005 – 2006 MODEL YEAR AVALON**

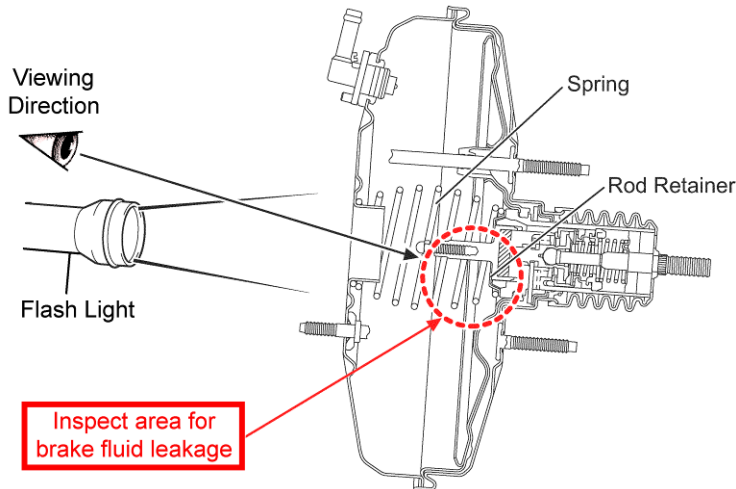
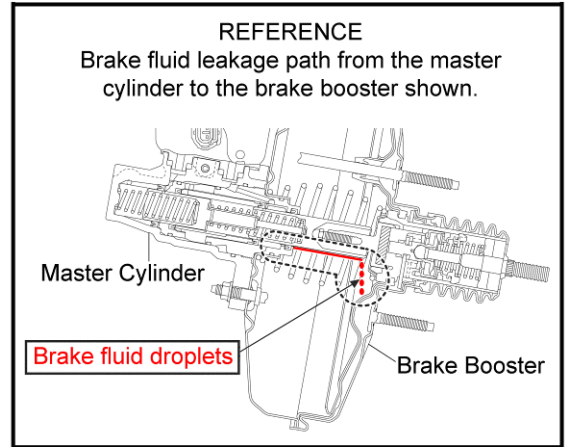
- As shown below, visually inspect the booster for signs of brake fluid leakage from the master cylinder.

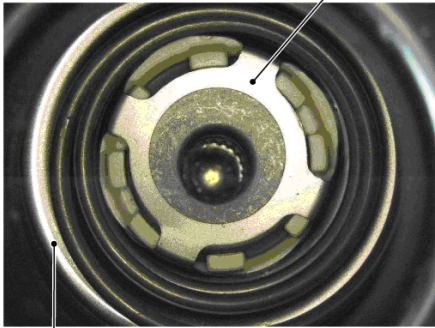
| Brake Booster Judgment Criteria | Result |
|---|---|
| <p>No fluid found.</p> <p>Rod Retainer</p> <p>Spring</p> | <p><b>Booster is OK</b></p> <p>Replace the cylinder cup as outlined in section F.</p> |

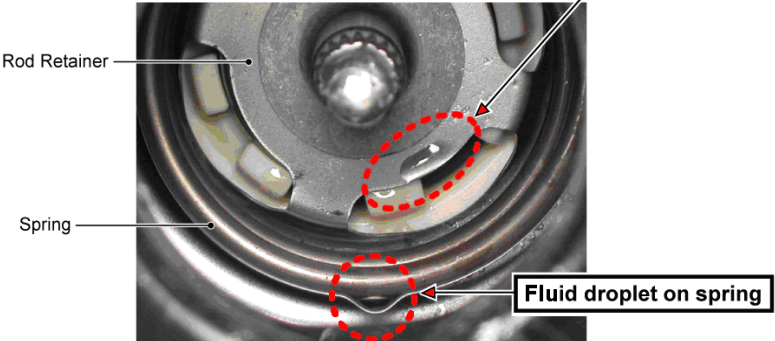
| Brake Booster Judgment Criteria | Result |
|---|---|
| <p>Fluid droplet(s) are visible on the rod retainer and/or spring.</p> <p>Rod Retainer</p> <p>Spring</p> <p>Fluid droplet on rod retainer</p> <p>Fluid droplet on spring</p> | <p><b>Booster requires additional inspection</b></p> <p>Proceed to section D "SECONDARY INSPECTION FOR BRAKE FLUID LEAKAGE"</p> |

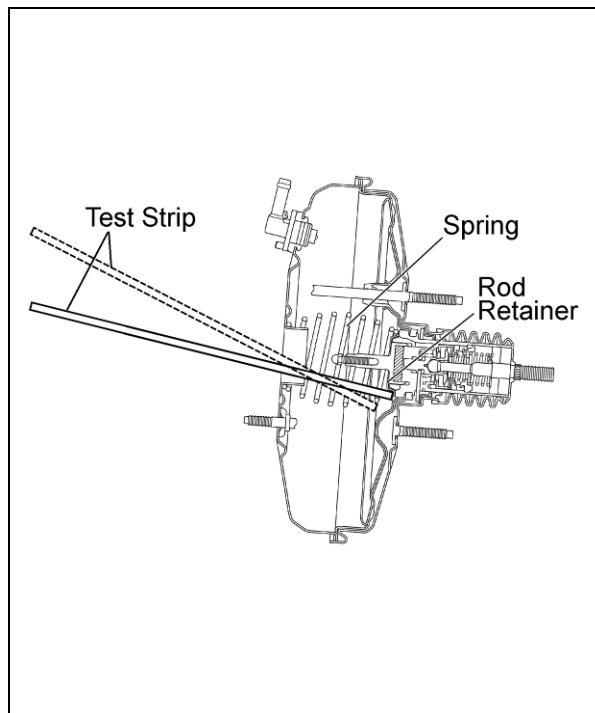
| Judgement | Result |
|---|---|
| | Assembly oil detected.<br><b>Booster requires additional inspection</b><br>Proceed to step 3 "BRAKE FLUID LEAK CHECK PART 2". |
| | Brake fluid detected.<br><b>Booster is NG</b><br>Replace the brake booster as outlined in section E.<br>&<br>Replace the cylinder cup as outlined in section F. |

- Insert a new test strip in the locations shown or where the fluid was found.
- Remove the test strip and let it sit for 1 minute, then determine the judgement using the table below.

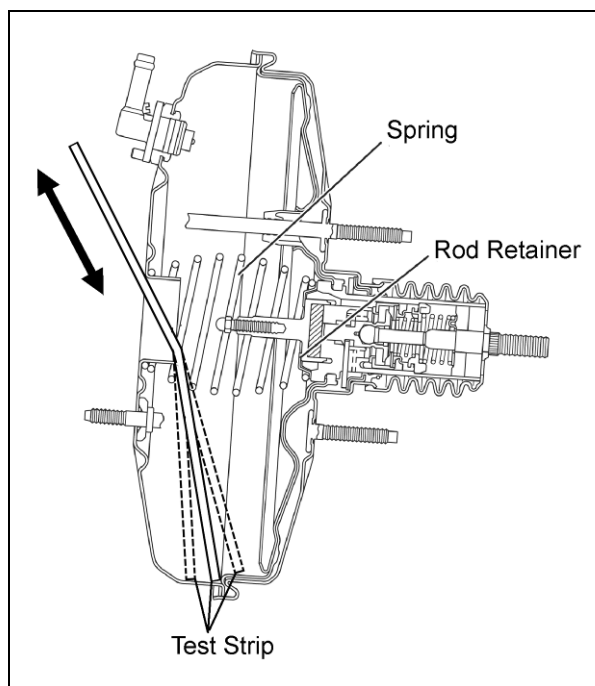
| Judgement | Result |
|---|---|
| | Assembly oil detected.<br><b>Booster is OK</b><br>Replace the cylinder cup as outlined in section F. |
| | Brake fluid detected.<br><b>Booster is NG</b><br>Replace the brake booster as outlined in section E.<br>&<br>Replace the cylinder cup as outlined in section F. |

- Insert a new test strip inside the bottom of the booster in the locations shown.
- Remove the test strip and let it sit for 1 minute, then determine the judgement using the table below.
