Re: Toyota Safety Recall 10V-499

Subject: Safety Recall ALG - Remedy Available
Certain 2004 - 2006 RX 330, 2006 GS 300, 2006 IS 250 and 2006 IS 350 Vehicles
Rubber Seal (Brake Master Cylinder Cup)

RUBBER SEAL (BRAKE MASTER CYLINDER CUP) REPLACEMENT

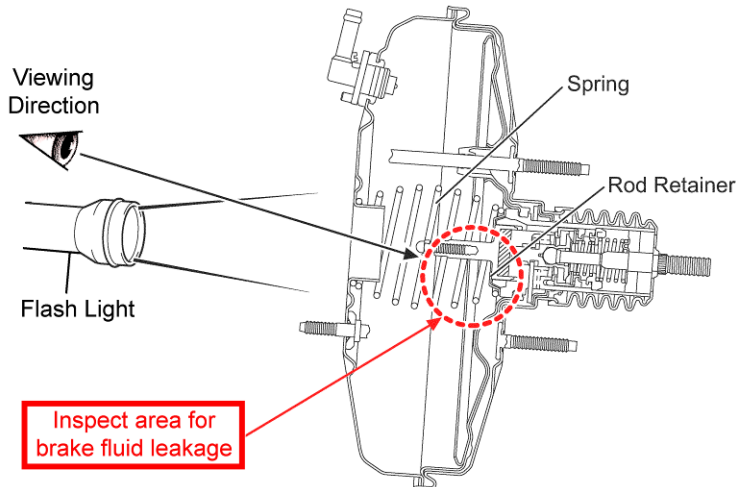
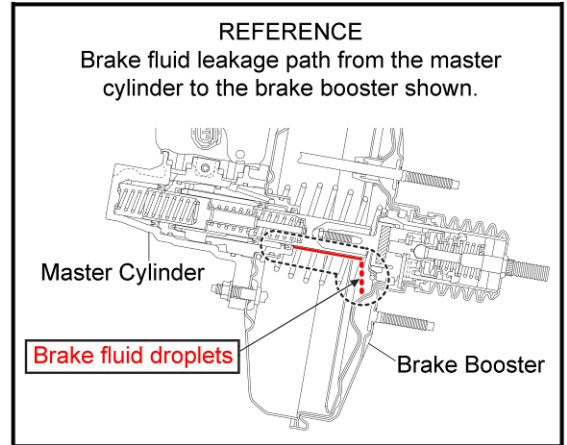
2. INSPECT FOR BRAKE FLUID LEAKAGE

- As shown below, visually inspect the booster for signs of brake fluid leakage from the master cylinder.
