June 27, 2018

Version 3

Safety Recall: Master Cylinder May Be Leaking

Supersedes 10-047, dated February 25, 2011, to revise the information highlighted in **yellow**

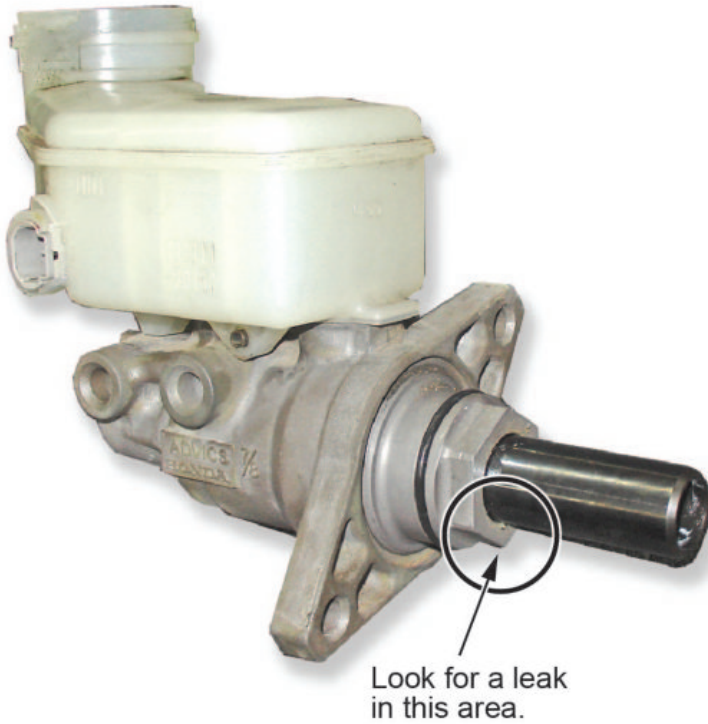
7. Check for brake fluid leaking from the installed end of the master cylinder:

- If there is a leak, go to step 8.
- If there is no leak, go to step 9.

8. Replace the brake booster. Replacement includes checking the adjustment of the brake pedal height and the brake pedal position switch. Torque the brake booster mounting nuts to **13 N·m (9.4 lb-ft)**.
