Daimler Buses Recall Bulletin

Orion VI Models

NHTSA 10V538000/TC 2010379

1.0 WHEELCHAIR RAMP HYDRAULIC FITTING RECALL NOTICE

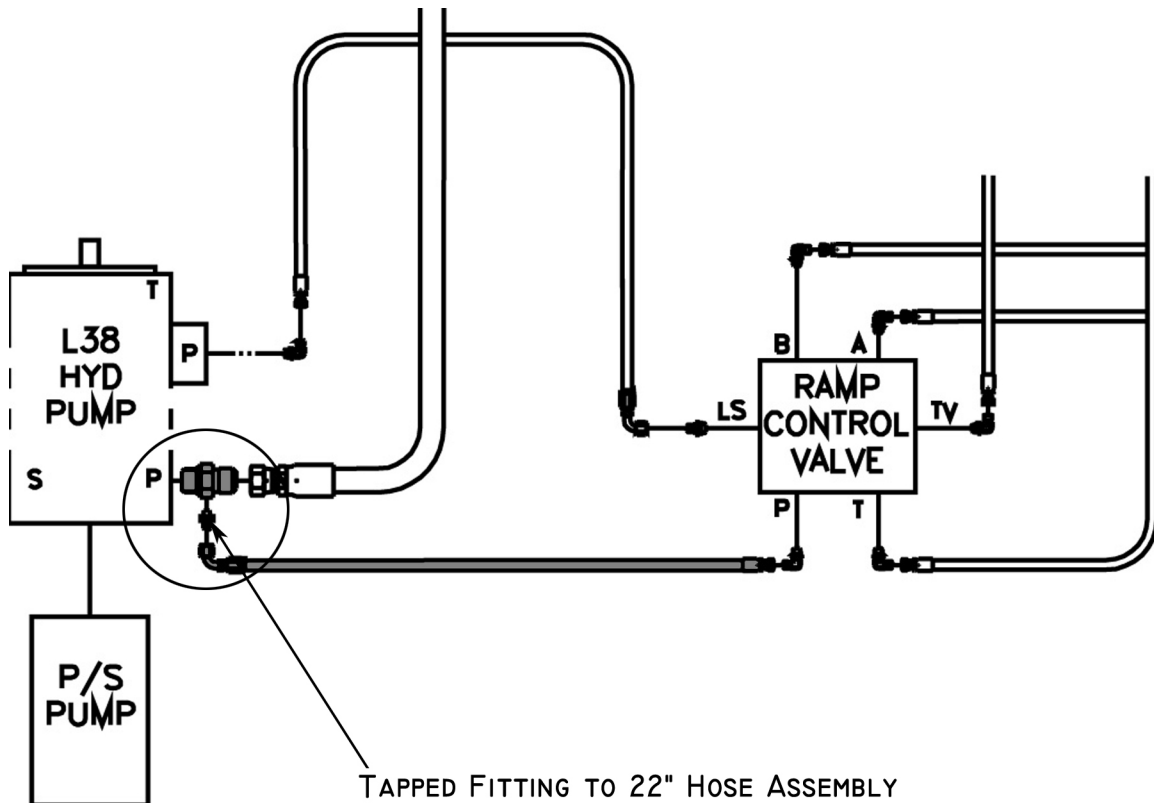
FIGURE 1-1 OLD HYDRAULIC FITTING CONFIGURATION

On certain Orion VI transit buses configured with a Detroit Diesel Series 50 engine, a tapped reducer fitting on the 22" hydraulic line to the wheelchair ramp control valve can crack and cause hydraulic fluid to leak into the engine compartment.

Hydraulic fluids leaking into the engine compartment can be ignited by the hot turbocharger and cause an engine fire.

- a. If the hydraulic fitting and hose assembly resembles the configuration in [Figure 1-1](#), continue with **“Component Replacement”** on page 4.
- b. If the hydraulic fitting and hose assembly resembles the configuration in [Figure 1-2](#), no further action needs to be taken. Close the rear engine compartment and return the bus to revenue service.

1. Ensure control of the engine ignition is from the rear of the vehicle and the engine is shut down. Wait for the system to cool if necessary.
2. Place a clean container under the L38 hydraulic pump assembly and remove the existing straight connector from the pump. (See [Figure 1-1](#))
3. Place another clean container under the ramp control valve and disconnect the hose assembly from the ramp control valve. (See [Figure 1-1](#))
