SERVICE BULLETIN NO. SB-08-131

**SUBJECT: ArvinMeritor – Technical Bulletin – Safety Recall:
Lower Axle Seat Weld Inspection and Repair for Meritor RideSentry™**

Lower Axle Seat Weld Inspection and Repair for Meritor RideSentry™ MPA Series Sliding Tandem Trailer Air Suspension Systems

TP-10172
Issued 09-10
(16579)

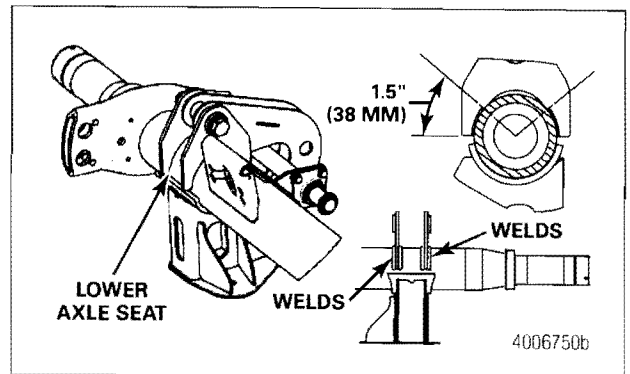
Figure 2

1. Wear safe eye protection. Park the vehicle on a level surface. Block the wheels to prevent the vehicle from moving.
2. From underneath the trailer, inspect the lower axle seat welds as follows.
 - A. Check that there are a total of four welds per axle seat side (two lower axle seats welded on each side). Figure 1.
 - B. Verify the welds are nominally 1.5-inches (38 mm) long and 0.25-inch (6.35 mm) wide on each side of the lower axle seat onto the axle. The welds should not be more than 1.5-inches (38 mm) long. Figure 2.

Do not weld over the end of the lower seats. Weld repairs to the axle seat must not extend more than 1.5-inches (38 mm). Welds longer than this specification may result in premature fatigue fractures to the axle tube. Serious personal injury and damage to components can result.

1. Wear appropriate clothing and eye protection when using welding equipment. Refer to Maintenance Manual 8 for complete welding instructions.
2. Use 0.035 E70 wire and 75/25 gas to weld the missing or incomplete areas. Make each weld 1.5-inches (38 mm) long and 0.25-inch (6.35 mm) wide. Welds should not be longer than 1.5-inches (38 mm). Do not weld over the end of the lower seats. Figure 2.
3. When you have finished, verify there is a total of eight complete welds, (two lower axle seats welded on each side). Continue repairs on the other end of the axle, if necessary.
