Recall Bulletin

PRODUCT SAFETY RECALL

SUBJECT: Power Steering Line Contact

MODELS: 2010-2011 Buick Lucerne Equipped with V8 Engine
2010-2011 Cadillac DTS

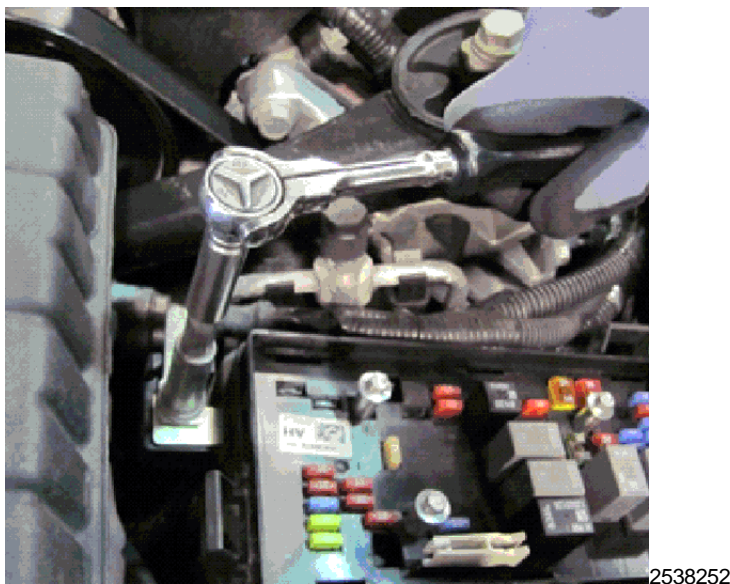
5. Examine the starter/alternator cables (2) and engine wire harness (3) at the power steering line and power steering bracket (1) location.
- If the cables are twisted or touching the power steering line or power steering line bracket, proceed to Step 6.
 - If the starter/alternator cables and engine wire harness are NOT twisted or touching the power steering line or power steering line bracket, proceed to Step 13.

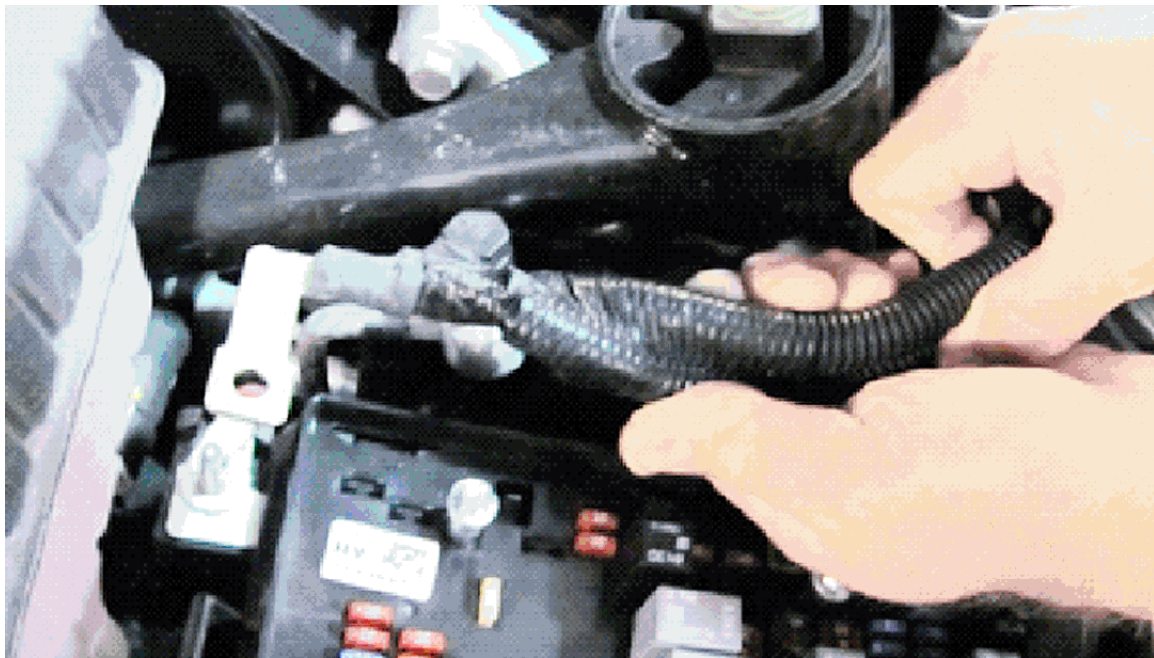
2538266

Note: The (A) portion of the illustration shows the line touching the power steering line. The (B) portion of the illustration shows the engine wire harness tucked below and away from the power steering line and power steering line bracket.

8. Push the engine wire harness (1) below and away from the power steering line and power steering line bracket (2).

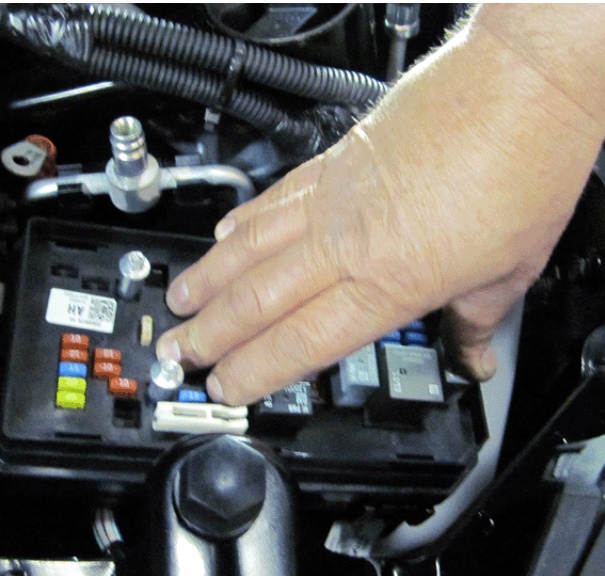
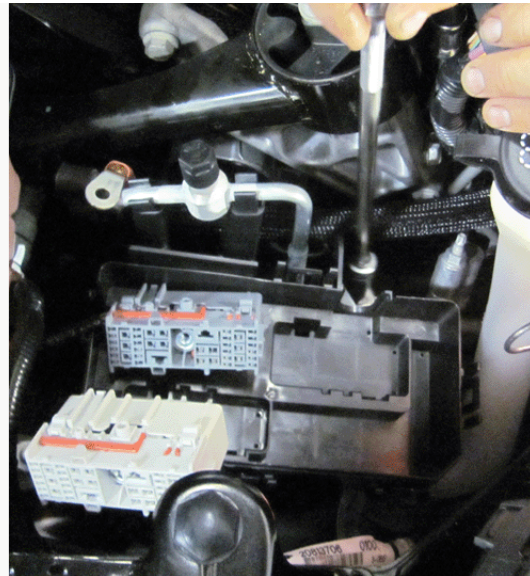
2540513

8. Determine if the engine wire harness (1) has been routed between the starter and alternator cables (2).
 - If the engine wire harness (1) is routed between the starter and alternator cables (2), proceed to Step 9.
 - If the engine wire harness (1) is NOT routed between the starter and alternator cables (2), proceed to Step 10.
