Recall Bulletin

F/CMVSS NONCOMPLIANCE RECALL

SUBJECT: Child Restraint Top Tether Anchor Not Accessible for Front Center Seating Position

**MODELS: 2004-2011 Chevrolet Colorado
2004-2011 GMC Canyon
Regular Cab, Extended Cab without Rear Seats
Equipped with a Front 60/40 Split Bench Seat**

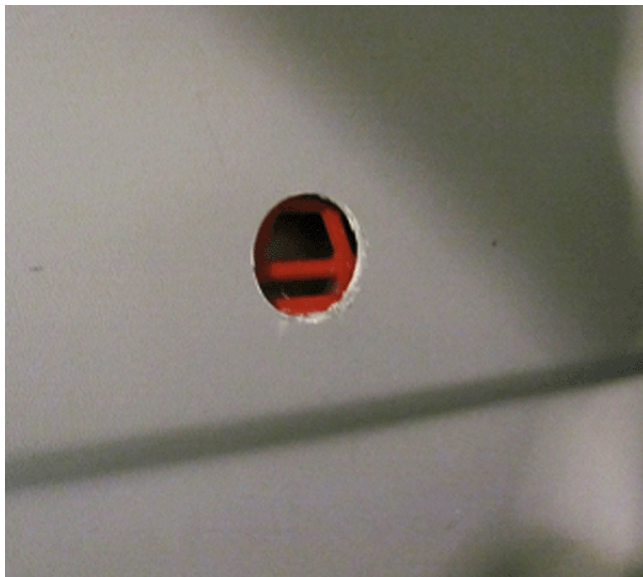
2545042

Note: To avoid damaging the sheet metal behind the trim panel, the drill bit must **NOT** extend more than 12 mm (3/16 in) from the outside edge of the hole saw.

7. Using a 63.5 mm (2.5 in) hole saw, cut a hole in the panel to gain access to the center tether access anchor point. Use the marks made in Steps 5 and 6 as your center point for the cut.
