RECALL BULLETIN:
101105FRV

Terra, built 6/24/2010 through 10/4/2010

MODEL(S) AFFECTED:
31TS, 34DS

SUBJECT:
Inspection/Correction of high-beam and low-beam headlights

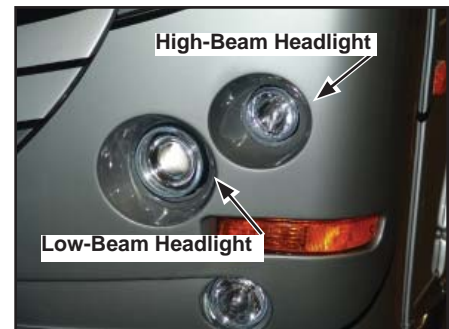
The 2011 Terra motor homes affected by this recall were built with the high-beam and low-beam headlights in the incorrect locations, as specified by the standards of FMVSS108.

According to the pertinent language of FMVSS108, the lower beam should be provided by the “outboard light source (or the uppermost if arranged vertically)”, and the upper beam should be provided by “the inboard light source (or the lower one if arranged vertically)”. An example of incorrect headlights is shown in Figure 1 and an example of correct headlights is shown in Figure 2.

Figure 1 - INCORRECT Headlights

If the headlights are not located in the positions described above, proceed to the CORRECTION, Step 2.

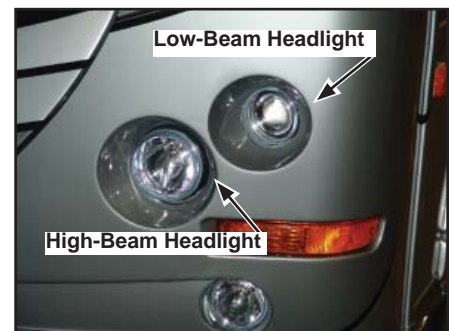
1. Park the motor home and examine the headlights. The low-beam headlight should be located in the higher, outboard position (as shown in Figure 2). The high-beam headlight should be located in the lower position, nearer the center of the cap. An example of a low-beam headlight is shown in Figure 3, and an example of a high-beam headlight is shown in Figure 4.

Figure 2 - Correct Headlights

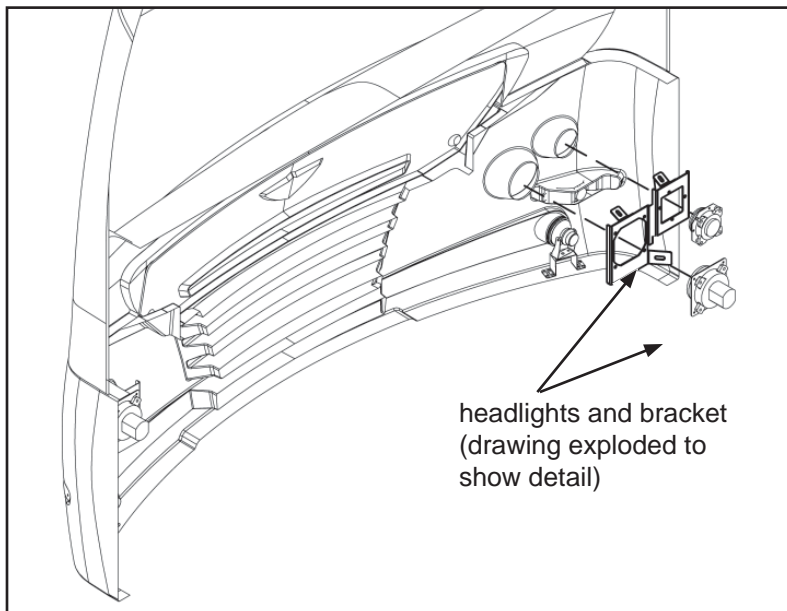
Figure 5 - View shown from inside of lower front cap

- Label and then remove the battery cables from the Main chassis battery, located on the front of the bulkhead, and the Auxiliary batteries, located under the entry step. Remove the battery negative cable first, and then remove the positive cable.
- Open the engine compartment door to access the headlights. **VERIFY** there is no power to the headlights. Cut the wires for each headlight where the chassis wire harness connects to the headlight wire harness. Label the chassis wire harness connections (e.g., "HI" and "LO") if no labels are present.
- Locate the two brackets securing the headlights to the studs inside of the lower front cap. (See Figures 5 and 6.) Use an inspection mirror if necessary to locate and remove the fastening hardware for the brackets, then remove the brackets using a driver with socket bit, or a ratchet. Retain brackets and fastening hardware for reassembly.

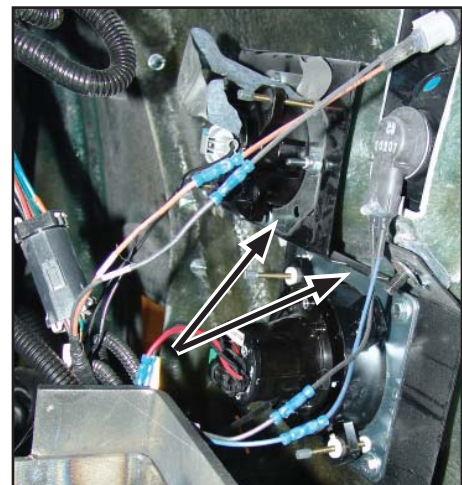
Figure 6 - Headlights and bracket assembled inside of front cap

8. Plug the headlight wire harnesses (included with each new headlight) into the back of the new lights.
9. Position the headlight assembly inside the lower front cap and reinstall the bracket onto the studs in the cap using original fastening hardware. Torque nuts to 40-45 inch-lbs.

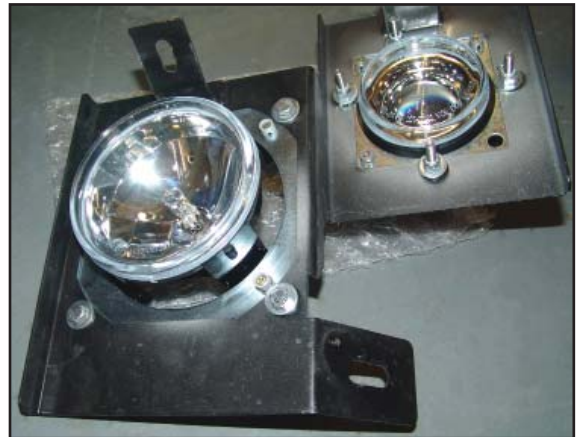
<u>Headlight Harness</u>	to	<u>CHASSIS HARNESS</u>
Low-beam connection:	Black	to	BLACK
	Black	to	TAN
High-beam connection:	Red	to	GREEN
	Black	to	BLACK

10. Strip approx. 3/16" of the jacket insulation from the ends of the new headlight harness wires and from ends of the headlight wires on the chassis wire harness. Slide a piece of heat-shrink tubing over each of the headlight harness wires. Use insulated butt connectors to connect the new headlight wire harness to the chassis wire harness. Center the heat shrink tubing over each new connection. Use a heat gun to seal the tubing into place. Wrap each new connection at least four times with electrical tape. Verify all connections are secure and water-proof. Cover the connections with wire loom.
