RECALL BULLETIN:
101105FRV

Terra, built 6/24/2010 through 10/4/2010

MODEL(S) AFFECTED:
31TS, 34DS

SUBJECT:
Inspection/Correction of high-beam and low-beam headlights

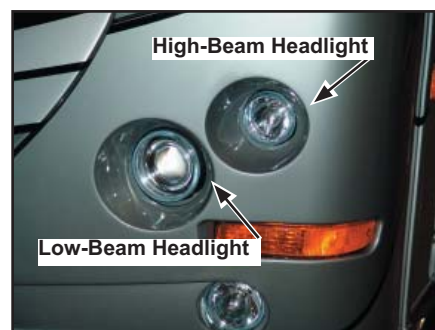
Figure 1 - INCORRECT Headlights

The 2011 Terra motor homes affected by this recall were built with the high-beam and low-beam headlights in the incorrect locations, as specified by the standards of FMVSS108.

According to the pertinent language of FMVSS108, the lower beam should be provided by the “outboard light source (or the uppermost if arranged vertically)”, and the upper beam should be provided by “the inboard light source (or the lower one if arranged vertically)”. An example of incorrect headlights is shown in Figure 1 and an example of correct headlights is shown in Figure 2.

If the headlights are not located in the positions described above, proceed to the CORRECTION, Step 2.

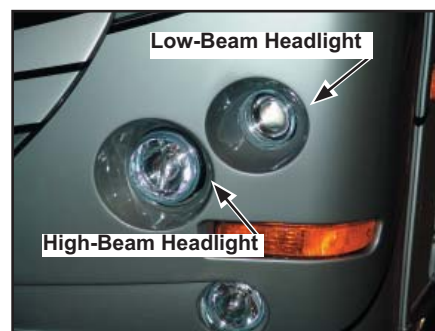
Figure 2 - Correct Headlights

1. Park the motor home and examine the headlights. The low-beam headlight should be located in the higher, outboard position (as shown in Figure 2). The high-beam headlight should be located in the lower position, nearer the center of the cap. An example of a low-beam headlight is shown in Figure 3, and an example of a high-beam headlight is shown in Figure 4.
