# TECHNICAL BULLETIN

No: J019  
Issue: 1  
Date: 17 NOV 2010

## Safety Recall: Wiper Arm Securing Nut Check

XJ (X351)

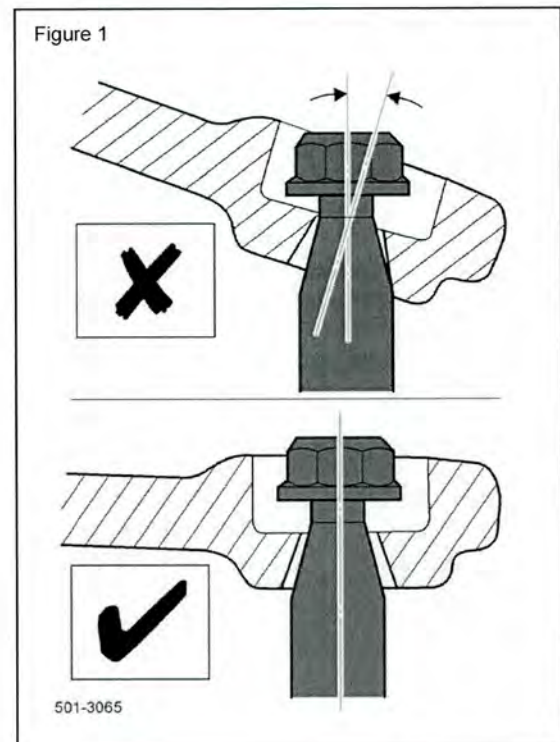
**Situation:** A concern has been identified with certain 2010 - 2011 model year Jaguar XJ vehicles whereby the wiper arm securing nuts may suffer torque relaxation as a result of an insufficiently controlled vehicle manufacturing assembly process.

Torque relaxation of the securing nut could potentially result in loss of wiper arm synchronization which can cause a clash of the wiper arms. If the wiper arms lose synchronization and clash, they could detach from the vehicle and, in certain circumstances, the driver's forward vision could be impaired.

3. Remove and retain the left-hand (LH) wiper arm spindle nut cover.
4. Loosen the wiper arm securing nut sufficiently to allow the wiper arm knuckle to realign with the wiper spindle.
5. Apply hand pressure on the wiper arm to ensure correct arm alignment to the spindle. (Figure 1)
6. Tighten the wiper arm spindle nut to **25Nm (18.5lbf ft)**.
7. Install the wiper arm spindle nut cover.
8. Repeat steps 3 -7 to the right-hand (RH) wiper arm.
9. Close the hood.
