Technical Bulletin

Lower Axle Seat Weld Inspection and Repair for Meritor RideSentry™ MPA Series Sliding Tandem Trailer Air Suspension Systems

TP-10172
Issued 09-10
(16579)

NOTICE: Defect Information Notice – Certain ArvinMeritor MPA trailer suspension systems manufactured and shipped by ArvinMeritor Inc.

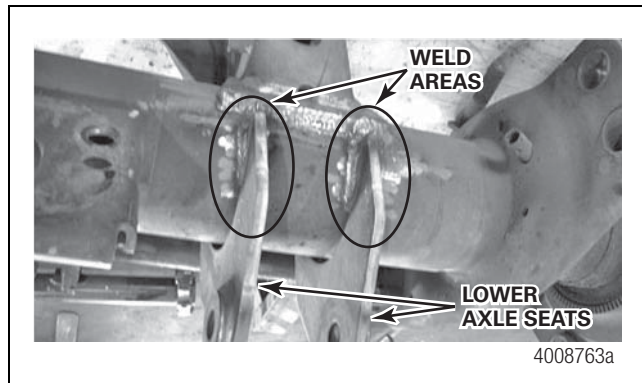
Figure 1

1. Wear safe eye protection. Park the vehicle on a level surface. Block the wheels to prevent the vehicle from moving.
2. From underneath the trailer, inspect the lower axle seat welds as follows.
 - A. Check that there are a total of four welds per axle seat side (two lower axle seats welded on each side). Figure 1.
 - B. Verify the welds are nominally 1.5-inches (38 mm) long and 0.25-inch (6.35 mm) wide on each side of the lower axle seat onto the axle. The welds should not be more than 1.5-inches (38 mm) long. Figure 2.

- **If any welds are missing or incomplete:** Call ArvinMeritor's OnTrac Customer Service Center at 866-OnTrac1 (668-7221) for repair authorization. Refer to Contact the ArvinMeritor OnTrac Customer Service Center at the end of this bulletin. Once you receive authorization, perform the Weld Repair Procedure in this bulletin.
