Technical Bulletin

Lower Axle Seat Weld Inspection and Repair for Meritor RideSentry™ MPA Series Sliding Tandem Trailer Air Suspension Systems

TP-10172
Issued 09-10
(16579)

NOTICE: Defect Information Notice – Certain ArvinMeritor MPA trailer suspension systems manufactured and shipped by ArvinMeritor Inc.

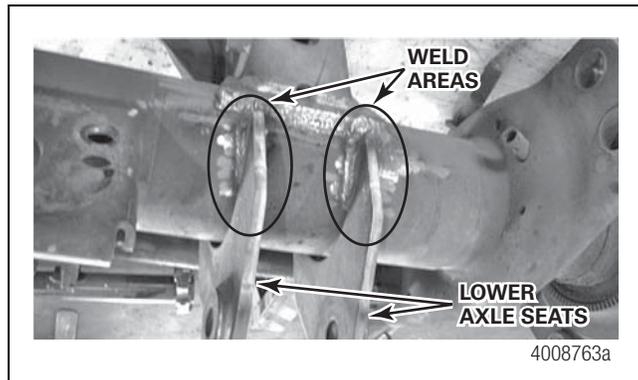
Figure 1

1. Wear safe eye protection. Park the vehicle on a level surface. Block the wheels to prevent the vehicle from moving.
2. From underneath the trailer, inspect the lower axle seat welds as follows.
 - A. Check that there are a total of four welds per axle seat side (two lower axle seats welded on each side). Figure 1.
 - B. Verify the welds are nominally 1.5-inches (38 mm) long and 0.25-inch (6.35 mm) wide on each side of the lower axle seat onto the axle. The welds should not be more than 1.5-inches (38 mm) long. Figure 2.

- **If any welds are missing or incomplete:** Call ArvinMeritor's OnTrac Customer Service Center at 866-OnTrac1 (668-7221) for repair authorization. Refer to Contact the ArvinMeritor OnTrac Customer Service Center at the end of this bulletin. Once you receive authorization, perform the Weld Repair Procedure in this bulletin.

1. Wear appropriate clothing and eye protection when using welding equipment. Refer to Maintenance Manual 8 for complete welding instructions.
2. Use 0.035 E70 wire and 75/25 gas to weld the missing or incomplete areas. Make each weld 1.5-inches (38 mm) long and 0.25-inch (6.35 mm) wide. Welds should not be longer than 1.5-inches (38 mm). Do not weld over the end of the lower seats. Figure 2.
3. When you have finished, verify there is a total of eight complete welds, (two lower axle seats welded on each side). Continue repairs on the other end of the axle, if necessary.

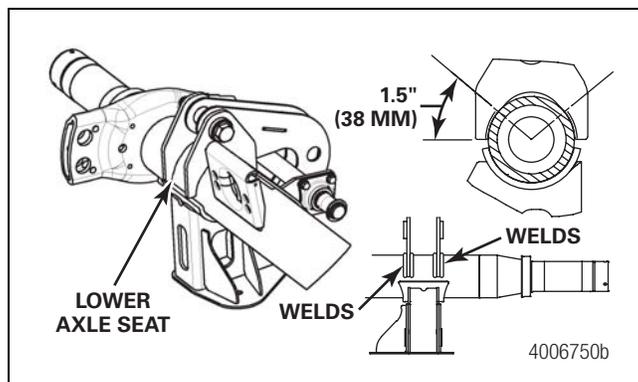
Figure 2

Do not weld over the end of the lower seats. Weld repairs to the axle seat must not extend more than 1.5-inches (38 mm). Welds longer than this specification may result in premature fatigue fractures to the axle tube. Serious personal injury and damage to components can result.
