Safety Recall Circular

Code: **2014**

**Subject: 2006-2010 Jetta, New Beetle & New Beetle Convertible,
2007-2009 Rabbit and 2009 - 2010 Jetta SportWagen
Vehicles Equipped with a 2.5L Engine
Under Hood Fuel Supply Line**

January 2011

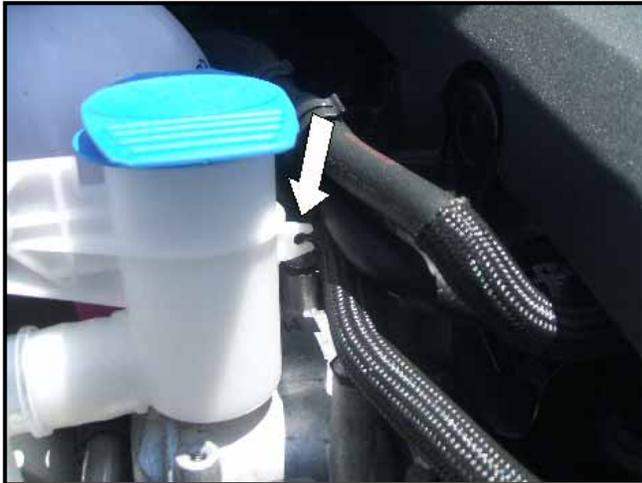
Section A - Washer Bottle Inspection

- Open hood
- ⇐ Inspect washer bottle for tab <arrow>
 - If tab is present, **continue to Section B**
 - If tab is **not** present, **continue to Section C**

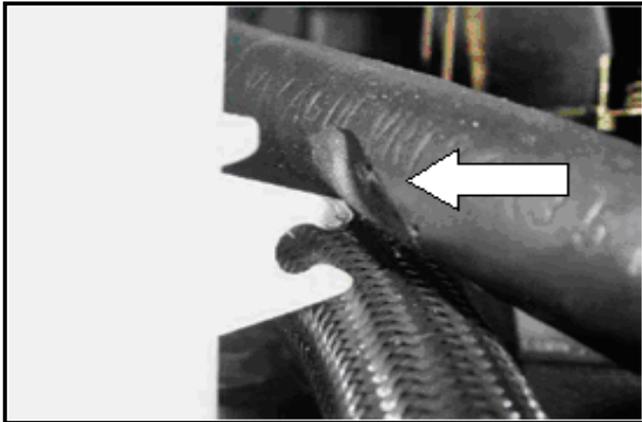
Section C – Inspect Fuel Line

- ⇐ Inspect fuel line for any damage <arrow>
 - If fuel line shows any signs of wear or chafing, **continue to Section D**
 - If fuel line DOES NOT show any signs of wear or chafing, **continue to Section E**

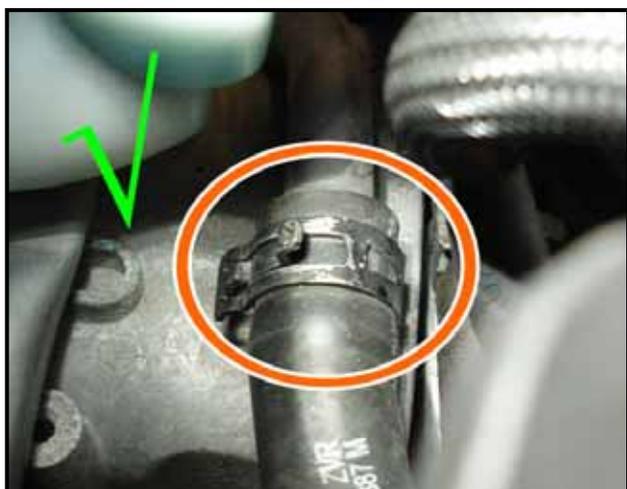
- ⇐ Inspect position of clamp for power steering <circle>
- If clamp is positioned correctly <circle>, and a potential for interference of clamp with the fuel line is **NOT** present, **continue to Section I to inspect fuel supply line**

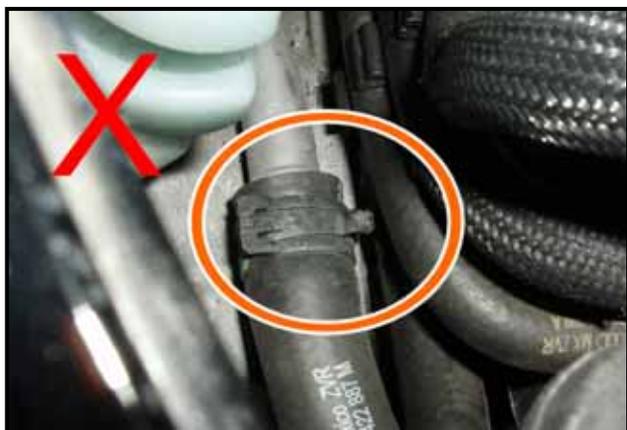
- If clamp is **NOT** positioned correctly <circle>, **continue to Section H to correctly position clamp**

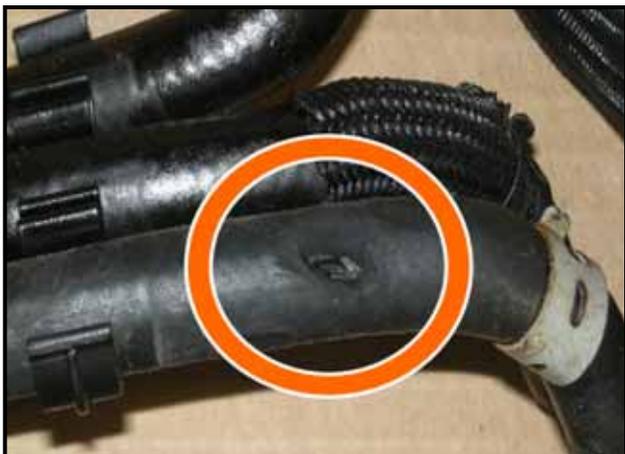
Section I – Inspect Fuel Supply Line

⇐ Inspect fuel supply line for any damage to the fuel supply line <circle>

- If fuel supply line shows any damage, **continue to Section J**
- If fuel supply line DOES NOT show any damage, **continue to Section K**
