SERVICE BULLETIN

TITLE: Improve joint strength under the driver side window

PRODUCT: G5 School vehicles, 2008-2009, 158"/159" Wheelbase

Reference : recall 10-039-JSU

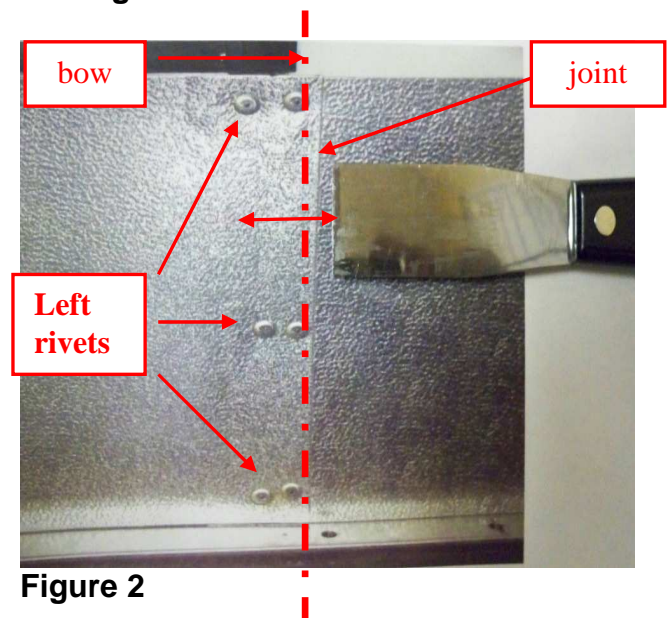
Figure 2

The aluminium panel joint affected by this recall is located on the left side (driver side) under the first window.

Easily identifiable by six (6) rivets;
 (3) Rivets located in the bow.
 (3) Additional rivets join both panels together. (Figure 2).

If the spatula can be inserted beyond the left rivets, there is no adhesive. Follow the steps below to correct the situation.

2- Locate the joint and check to see if adhesive was applied between the panels using a small spatula (Figure 2)
