## SERVICE BULLETIN

**TITLE:** Improve joint strength under the driver side window

**PRODUCT:** G5 School vehicles, 2008-2009, 158"/159" Wheelbase

Reference : recall 10-039-JSC

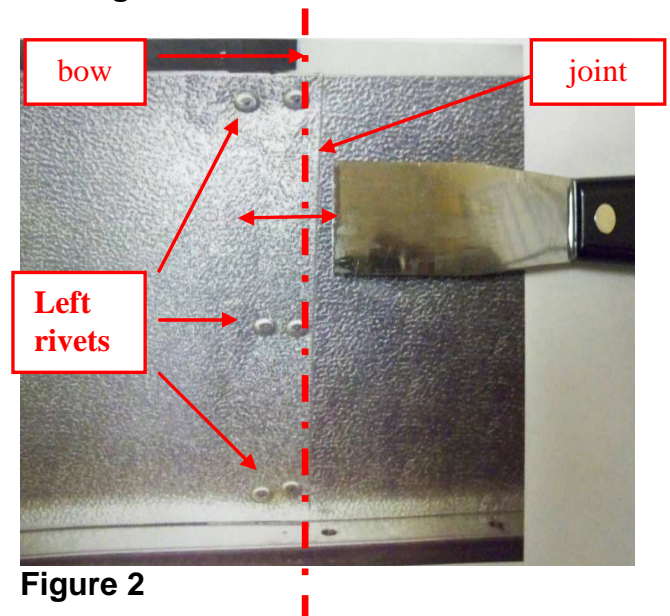
Figure 2

The aluminium panel joint affected by this recall is located on the left side (driver side) under the first window.

Easily identifiable by six (6) rivets;  
 (3) Rivets located in the bow.  
 (3) Additional rivets join both panels together. (Figure 2).

If the spatula can be inserted beyond the left rivets, there is no adhesive. Follow the steps below to correct the situation.

2- Locate the joint and check to see if adhesive was applied between the panels using a small spatula (Figure 2)

\*\* If there is adhesive, fill in and return the reply sheet indicating that the repair is not required.
