Campaign No. 2011010002, February 2011

SUBJECT: **Model 906, Model Year 2010 - 2011**  
**Replace Emergency Exit Window**

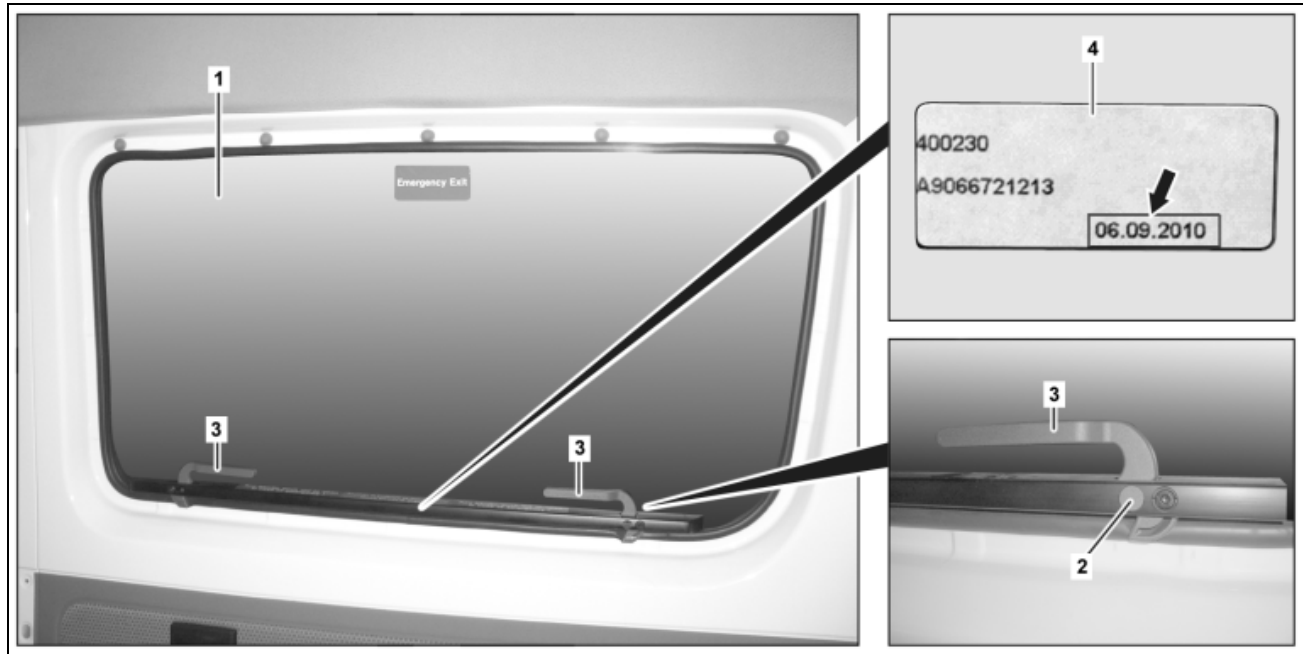
**Figure 1**

Daimler AG (DAG), the manufacturer of Mercedes-Benz and Freightliner Sprinter vehicles, has determined that on certain vehicles equipped with an emergency exit window the adhesive bond between the glass and the hinge on the top of the window may loosen. As a result the emergency exit window may separate from the body. Dealers will check a production date on the window and replace the emergency exit window if necessary.

Window (1) may be loose at the top hinge and fall down when opened.

Lead seals (2) will be destroyed when handles are pulled up.

1. Open emergency exit window (1, Figure 1):

- Secure window (1) from falling down then pull handles (3) to upright (unlock) position.

- Remove any lead seal (2) pieces from holes in sealing frame.
  - Open window (1, Figure 1) slightly.
2. Check if window (1, Figure 1) is loose at top hinge:
    - If window (1) **is** loose at top hinge when opened, proceed to step 5 (replace emergency window).
    - If window (1) is **not** loose at top hinge when opened, proceed to step 3 (check manufacturer's date).
  3. Check manufacturer date (arrow, Figure 1) on sticker (4) affixed to bottom edge of emergency exit window (1):
    - If manufacturer date is **not**: 15.07.2010 or 21.07.2010; proceed to step 4 (close and lock window).
    - If manufacturer date **is**: 15.07.2010 or 21.07.2010, proceed to step 5 (**replace** window).

4. Close and lock window (1, Figure 1) in reverse order:

- Press new lead seals (2, Figure 1) into sealing frame.

5. Replace window; refer to WIS: AR67.30-D-2305B.
