# Recall Bulletin

## PRODUCT SAFETY RECALL

**SUBJECT:** Rear Axle Cross Pin Fracture

**MODELS:** 2011 Cadillac Escalade EXT  
2011 Chevrolet Avalanche, Silverado  
2011 GMC Sierra

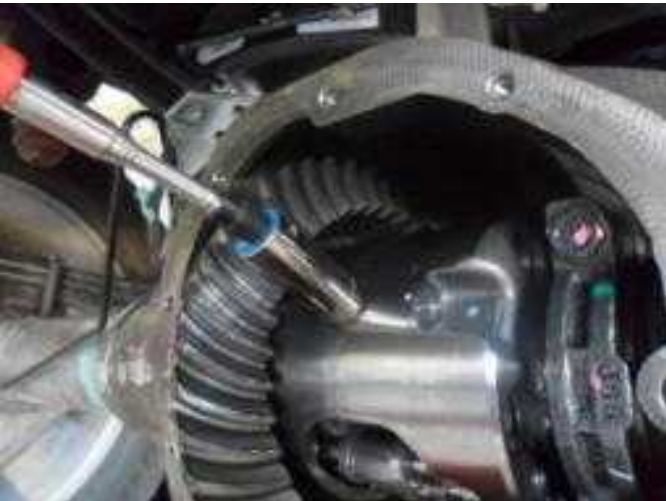
General Motors has decided that a defect, which relates to motor vehicle safety, exists in **certain** 2011 model year Cadillac Escalade EXT; Chevrolet Avalanche, Silverado; and GMC Sierra vehicles. Some of these vehicles have a condition in which the rear axle cross pin was not manufactured to specification. The pin was improperly heat treated and could fracture and become displaced within the rear axle. If this were to occur, the driver may hear a banging noise coming from the axle. If the pin shifts out of position, it could create an interference condition and cause the rear axle to lock. The driver may not be able to maintain directional control of the vehicle and a crash could occur without prior warning.

- 10. Remove the cross pin by pulling it with the magnet. Discard the cross pin.
