Safety Recall K28

Left Tie Rod End

2008 – 2010 (DM) Ram Truck (4500/5500 series cab chassis)

2011 (DP) Ram Truck (4500/5500 series cab chassis)

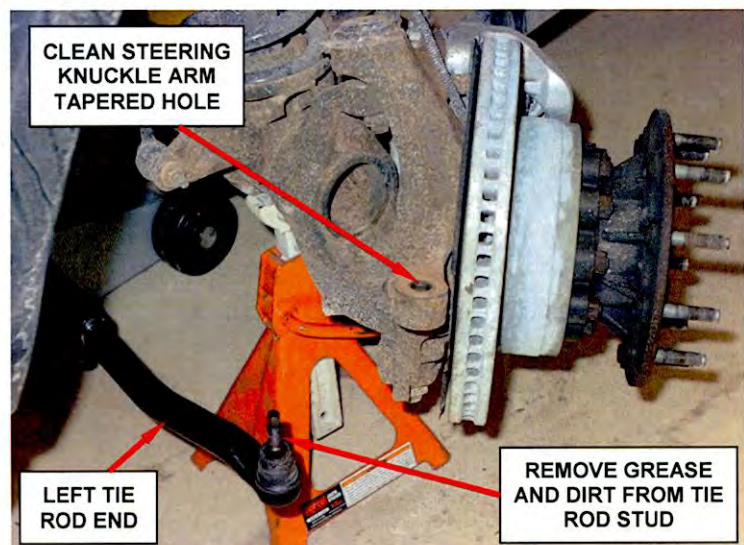
Figure 4 – Clean Steering Knuckle Arm Tapered Hole and Tie Rod End Stud

CAUTION: Failure to clean the steering knuckle arm tapered hole may cause the tie rod end connection to the steering knuckle to not seat properly. The steering knuckle arm tapered hole must be clean and dry.

12. Remove any grease or dirt from the tie rod end stud before installing the stud into the steering knuckle arm tapered hole (Figure 4).
13. Place the tie rod end stud into the steering knuckle arm and install the tie rod retaining nut. Tighten the nut to 75 ft. lbs. (102 N·m).

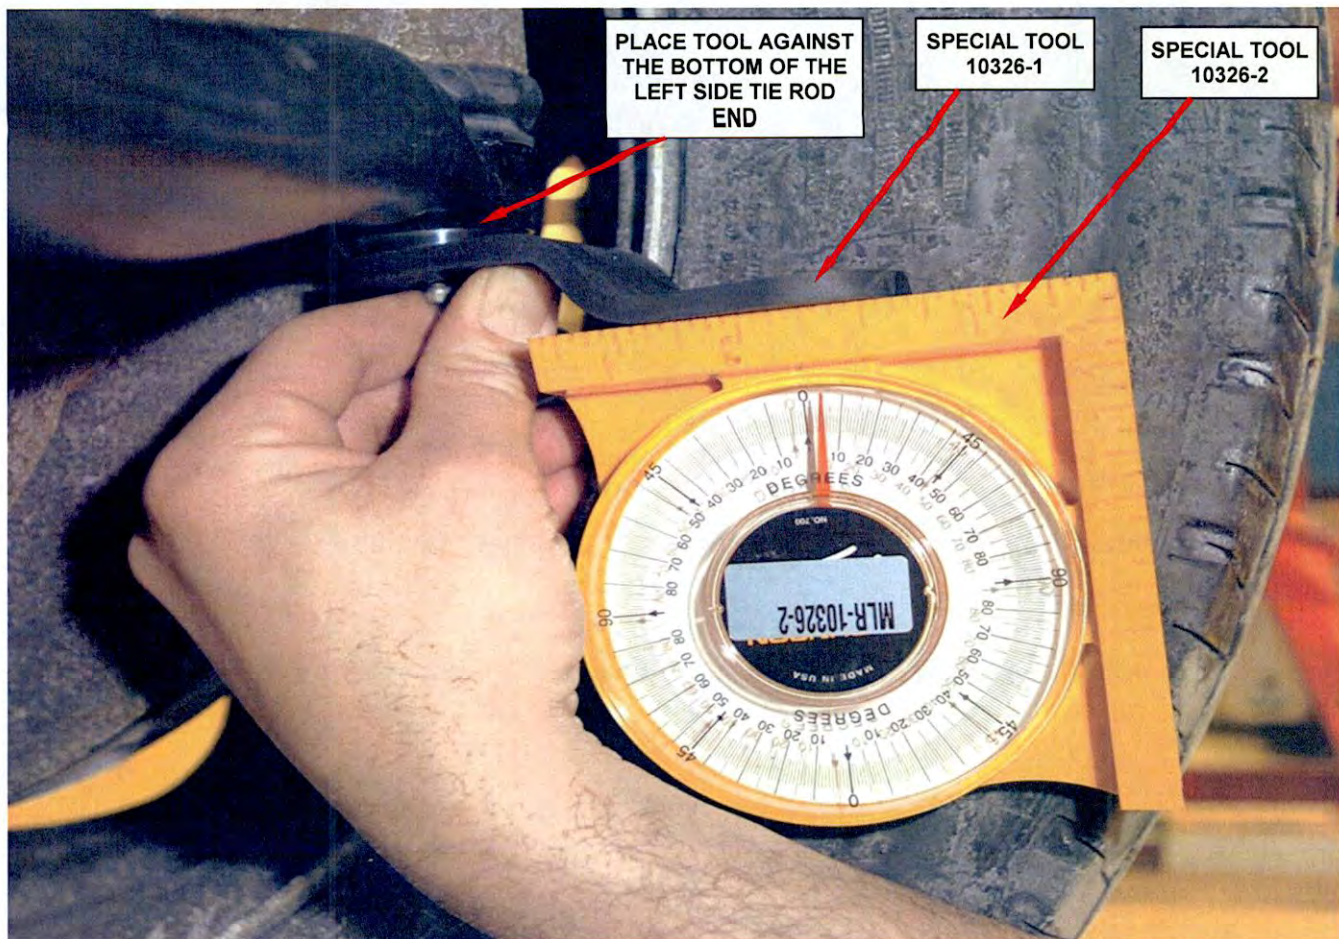
Figure 7 – Adjust the Left Tie Rod End Angle to Match Right Tie Rod End Angle

WARNING: Failure to have the same right and left tie rod end angles will cause the condition this recall is addressing to still be present.

23. Install Special Tool 10326-1 and 10326-2 onto the bottom surface of the left side tie rod end as shown in Figure 7.
24. Adjust the left tie rod end so that the same angle appears on the inclinometer gauge as was measured on the right tie rod end.

25. Tighten tie rod adjuster clamps to 40 ft. lbs. (54 N·m).
26. Recheck both right and left tie rod end angles. The right and left tie rod end angles must be the same. If the tie rod end angles are different, loosen the left tie rod adjuster clamp and readjust left tie rod as required.
