SUBJECT: RECALL R10RW POWER CABLE LUG ORIENTATION

R10RW

Incorrect Power Cable Lug Orientation

Models Affected: 2004 through 2009 Vision

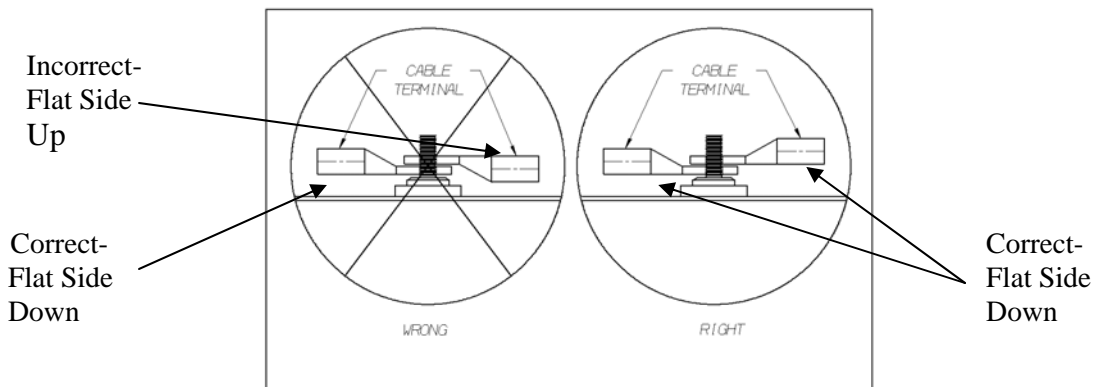
4. Inspect the electrical cable connections at the Power Stud and Aux Power Stud, if installed. See the diagram below to determine if the cables were installed correctly. ALL terminal lugs on each power stud should be oriented such that the barrel of the lug is further away from the mounting surface of the isolated stud. The flat side of terminal end (lug) must be down.

5. If the cables were installed incorrectly, remove the nut securing the cables. Then remove the cables and reinstall correctly per the diagram above. Make sure the terminal lugs are fanned out on the stud as opposed to directly on top of each other. Vice-grip pliers are recommended when turning incorrectly installed cable terminal lug to the correct orientation of flat side down.
