**SUBJECT: SAFETY RECALL OF ARVINMERITOR ADAPTER PLATE BOLT
UNDER-TORQUE**

Ref.: **ARVINMERITOR NHTSA # 10E-014
MCI NHTSA # 10V-199
TRANSPORT CANADA #TC 2010-153
MCI Service Bulletins 345 & 346**

Service Bulletin No. 345

MODEL D Series Coaches	TYPE Field Change Program	SECTION/GROUP 15 – Wheel	DATE May 28, 2010
SUBJECT ARVINMERITOR WHEEL ADAPTER CAPSCREWS ON UWE AXLES			
CONDITIONS

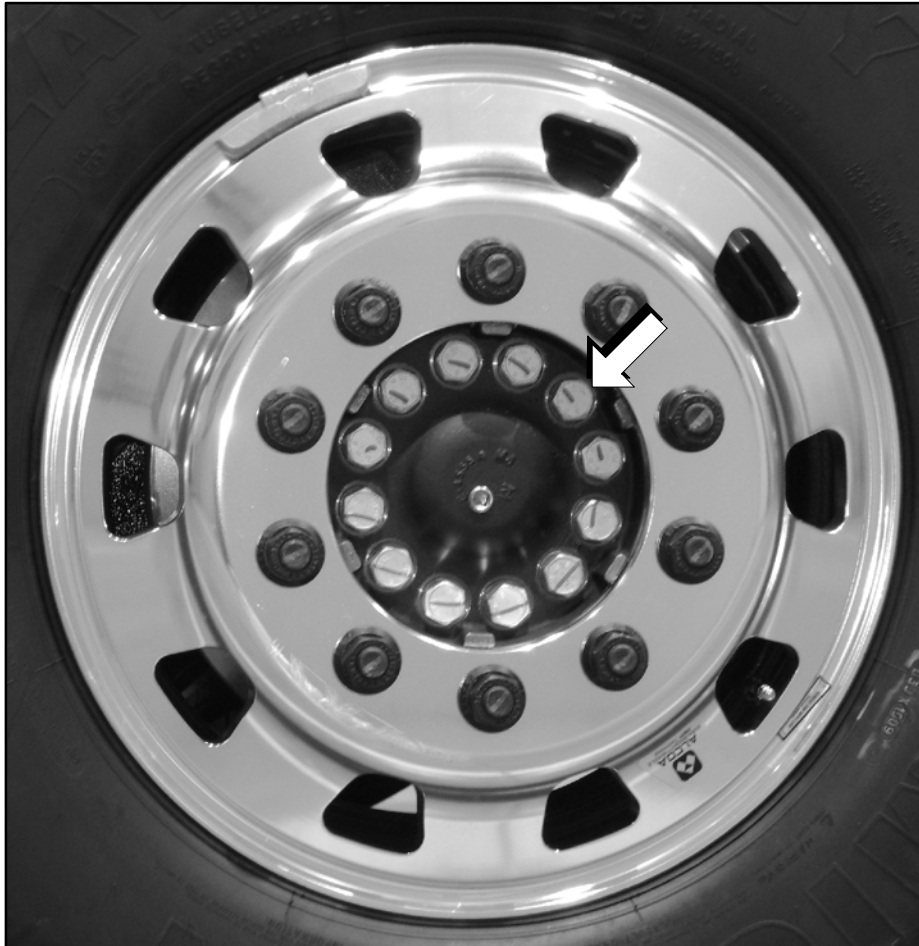
Figure 1.

1. Open the engine doors. Position the ENGINE RUN and ENGINE START switches on the engine compartment remote control box to the OFF position. Chock both sides of the tires.
2. Locate the twelve (12) wheel adapter capscrews on the front axle (refer to Figure 1).

3. Using a torque wrench with a dial indicator, check and record the torque value of all twelve (12) wheel adapter capscrews on the MCI Coach–UWE Bolt Torque–Inspection Chart.

Upon inspection, if one (1) capscrew is found at a torque less than 150 ft-lbs, the capscrew needs to be replaced with p/n 15-02-1047, and properly torqued. Discard existing capscrew.

Upon inspection, if two (2) or more capscrews are found at a torque less than 150 ft-lbs, all twelve (12) capscrews need to be replaced with Kit p/n 15-02-1060, and properly torqued.

4. Using a torque wrench, tighten all twelve (12) capscrews to 250 to 300 ft–lbs, in a star pattern. Apply torque seal from the face of the capscrew to the face of the wheel adapter.
5. Proceed to the opposite side of the front axle. Repeat Steps 2. to 4. in their entirety.
6. Proceed to the tag axle. Repeat Steps 2. to 4. in their entirety to both sides of the tag axle.
7. Position the ENGINE RUN and ENGINE START switches on the engine compartment remote control box to the ON position. Close the engine doors.

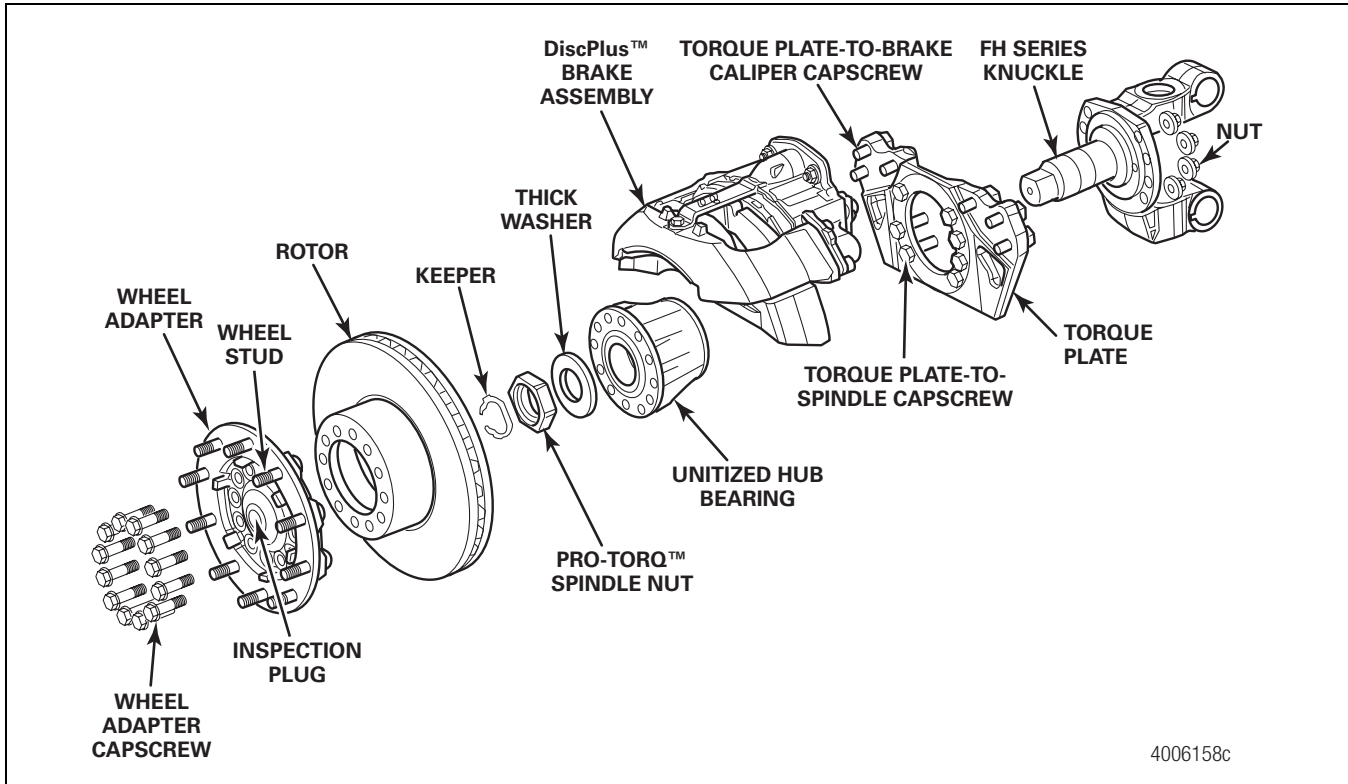
3. Use a torque wrench with a dial indicator to check hub/rotor/adapter plate bolt torque on all 12 bolts on each unitized wheel end. The bolt torque must not be less than 150 lb-ft (203 N•m). Record the torque on the Inspection Sheet included in this bulletin.

- If hub/rotor/adapter plate bolt torque on any one of the 12 bolts on each unitized wheel end is less than 150 lb-ft (203 N•m): Replace the bolt using ArvinMeritor part number 10X1711. Discard the bolts that were removed. Do not reuse old bolts. Record the bolt replacement on the Inspection Sheet included in this bulletin.

- If any two or more bolts in the same bolt circle on a wheel end are less than 150 lb-ft (203 N•m): Replace all 12 bolts on the untized wheel end using ArvinMeritor part number 10X1711. Remove, replace and tighten each bolt one at a time to maintain the correct clamp load on the wheel end. Discard the bolts that were removed. Do not reuse old bolts. Record the bolt replacement and torque in the Inspection Sheet included in this bulletin.

4. Use a click torque wrench to tighten all remaining bolts and any replacement bolts in a star pattern to 275 ± 25 lb-ft (373 ± 34 N•m). Record the torque on the Inspection Sheet included in this bulletin. When you have tightened all of the bolts, recheck the torque of all 12 bolts in a star pattern.

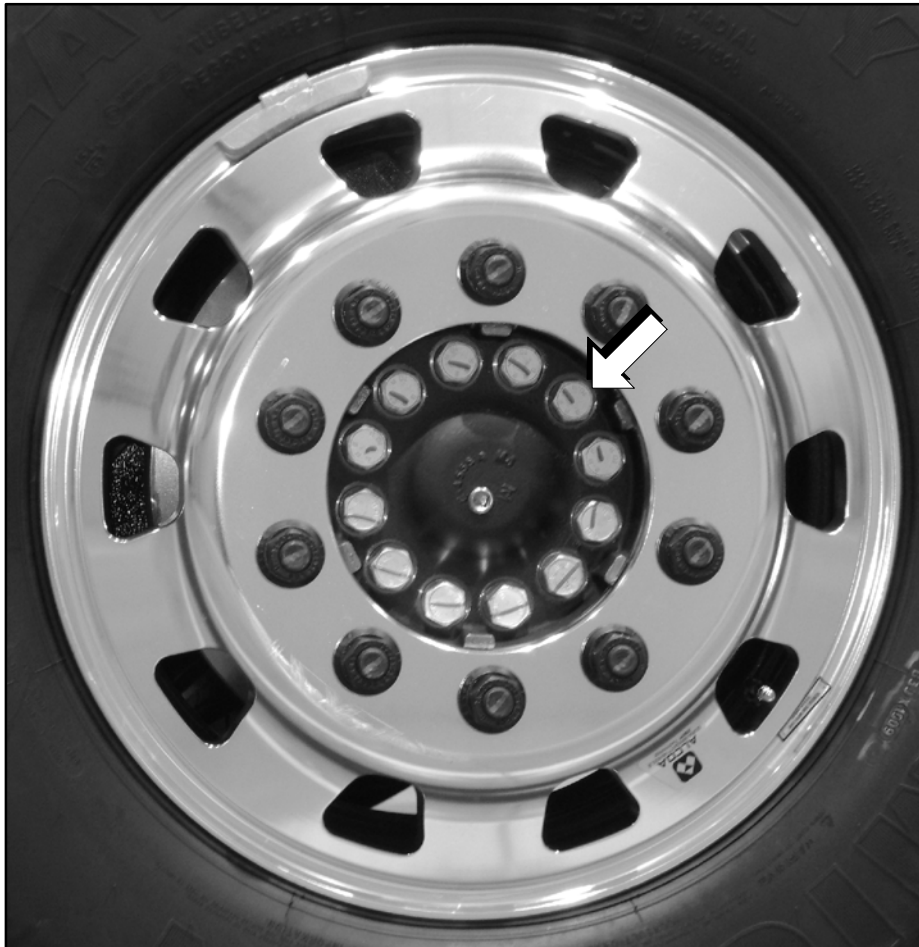
Figure 3.

4. Locate the twelve (12) wheel adapter capscrews on the front axle (refer to Figure 3).

5. Using a torque wrench with a dial indicator, check and record the torque value of all twelve (12) wheel adapter capscrews on the MCI Coach–UWE Bolt Torque–Inspection Chart.

Upon inspection, if one (1) capscrew is found at a torque less than 150 ft-lbs, the capscrew needs to be replaced with p/n 15-02-1047, and properly torqued. Discard existing capscrew.

Upon inspection, if two (2) or more capscrews are found at a torque less than 150 ft-lbs, all twelve (12) capscrews need to be replaced with Kit p/n 15-02-1060, and properly torqued.

6. Using a torque wrench, tighten all twelve (12) capscrews to 250 to 300 ft–lbs, in a star pattern. Apply torque seal from the face of the capscrew to the face of the wheel adapter.
7. Proceed to the opposite side of the front axle. Repeat Steps 4. to 6. in their entirety.
8. Proceed to the tag axle. Repeat Steps 4. to 6. in their entirety to both sides of the tag axle.
9. If coach is so equipped, use a short handle rubber mallet and controlled force on the lug nut feature in a counter–clockwise patter to re-install the hub covers. When hub cover is fully installed, there is no gap between the hub cover and the wheel face.
10. Position the ENGINE RUN and ENGINE START switches on the engine compartment remote control box to the ON position. Close the engine door.
