**SUBJECT:   RECALL R10SB TRW INTERMEDIATE STEERING SHAFT WELD**

### Service Procedure # COL-201

#### IGEN 3 Intermediate Shaft Weld Location Inspection Procedure

## TRW IGEN3 Intermediate Steering Shaft Assembly

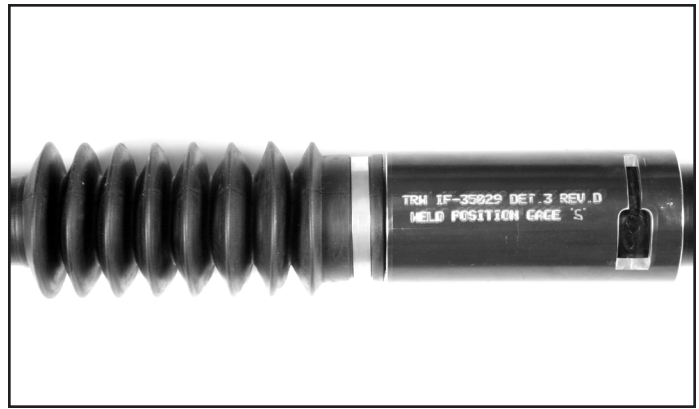
Figure 3

1. Check the weld position using the TRW gauge (SEE Tools Required Page 1). Place the template end of the gauge against the base of the boot seal as shown in **Figure 3** with the gauge placed over the top of the part number stamp location.

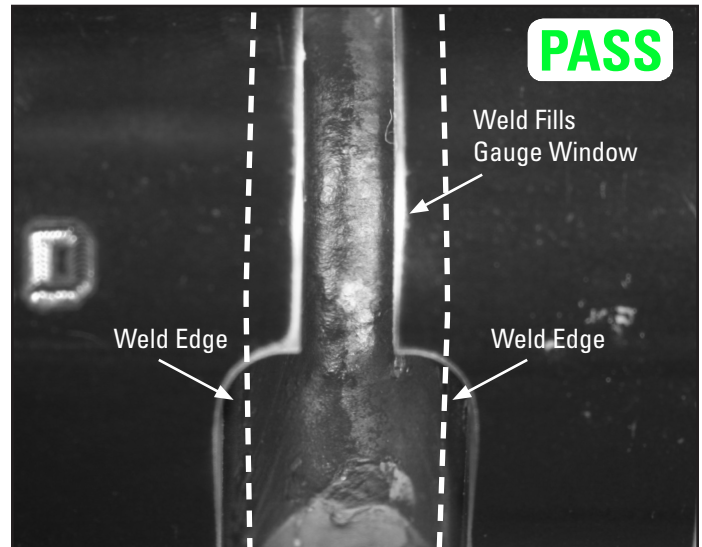
Figure 4

2. Visually inspect the position of the weld bead in reference to the small gauge window (3/16" width). The full circumference of weld seam must be inspected in the gauge window. **Figure 4**

- The weld bead must completely fill the gauge window.
- No joint line between the 2 tubes should be visible, the edges where the tubes join should be covered by the weld.
- The parent tube should not be visible in the narrow section of the gauge window.

- 2a. **Part Passes** if the weld bead completely fills the narrow gauge window **Figure 4**. Mark the parts that pass inspection with yellow or white paint mark adjacent to the part number stamp.

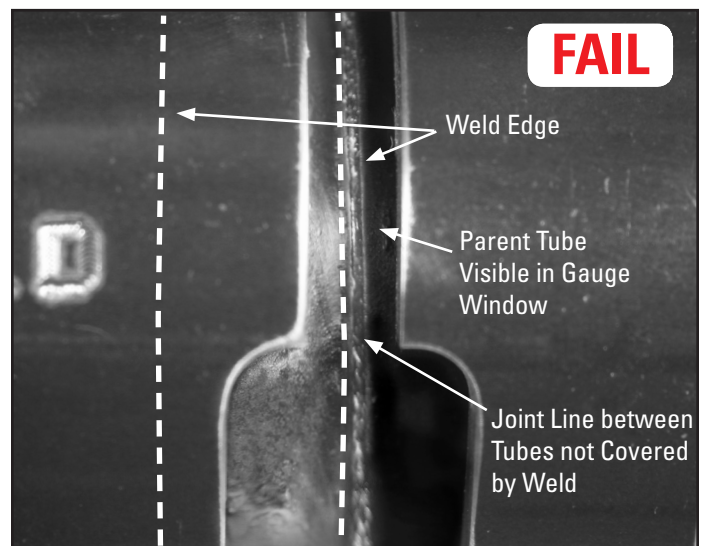
Figure 5

- 2b. **Part Fails** if any of the following are seen in the inspection.

- The weld bead does not completely fill the narrow gauge window.
- The parent tube is partially visible in narrow gauge window.
- The joint line between the 2 tubes is visible at any point around the circumference of the shaft. **Figure 5**

Remove intermediate shaft and replace.

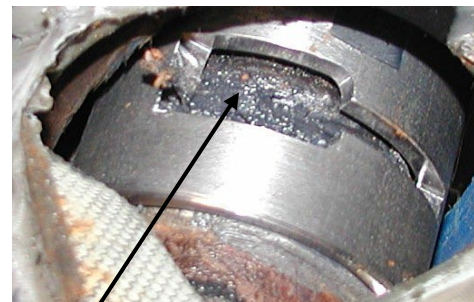
10. The window for the inspection will be visible from underneath driver's floor. Rotate the shaft by turning the steering wheel to inspect weld per TRW Service Procedure # COL-201. If the part passes, follow TRW Service Procedure # COL-201 and then mark the Blue Bird Sheet. If the part fails, mark the sheet and return to the Blue Bird Recall Administrator. **NOTE:** If the weld cannot be seen in the installed position, remove the shaft for inspection. New fasteners **MUST** be use to reinstall the shaft.

Weld shown through TRW inspection tool from underneath driver's floor

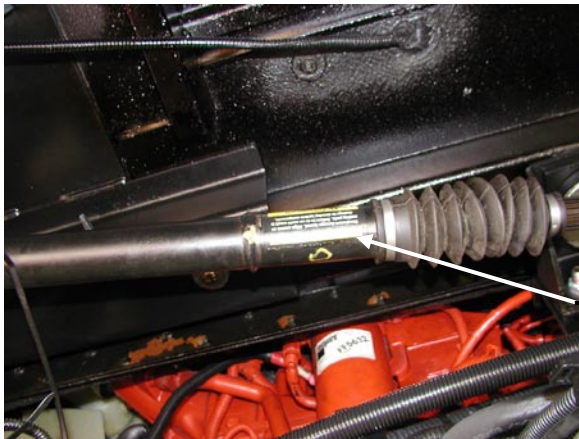
Date Code Location

5. The lower shaft TRW date code identification stamped on the shaft is located on steering gear end of the shaft. Turn the steering wheel to rotate shaft for stamped number to be visible.

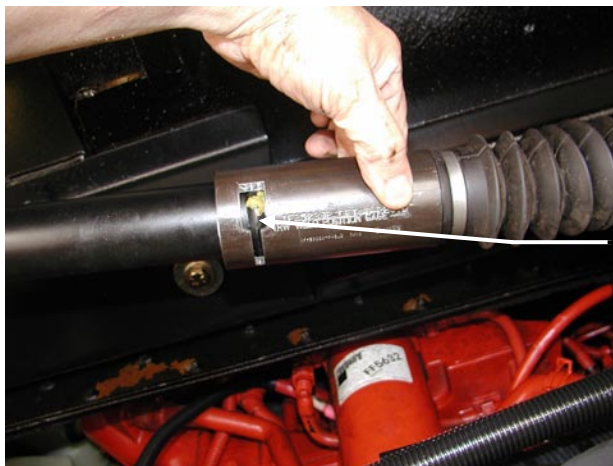
Weld shown through TRW Inspection tool

9. Rotate the shaft by turning the steering wheel to inspect weld per TRW Service Procedure # COL-201. If the part passes, follow TRW Service Procedure # COL-201 and then mark the Blue Bird Sheet. If the part fails, mark the sheet and contact Blue Bird Recall Administrator.
10. After the inspection process has been completed for both upper and lower shaft, remove jack stands, and reconnect batteries by connecting the negative last.
11. Place bus back in service.

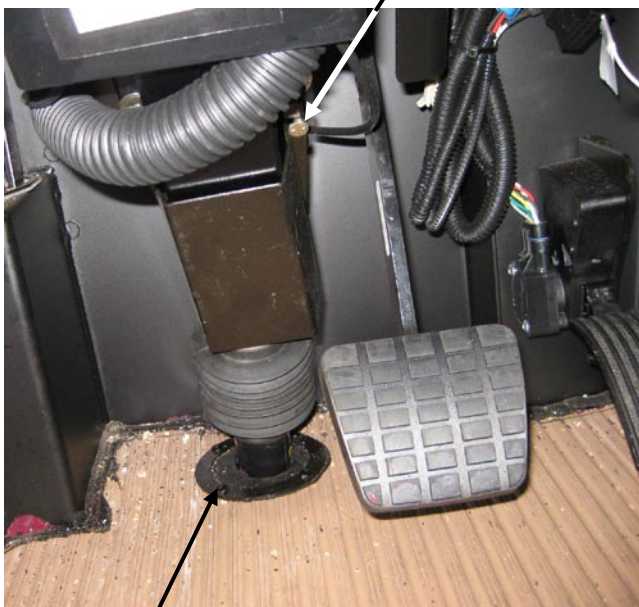
Remove two capscrews and  
shaft cover to access pinch bolt

Remove four screws from  
ring, lift ring and remove  
shaft seal.

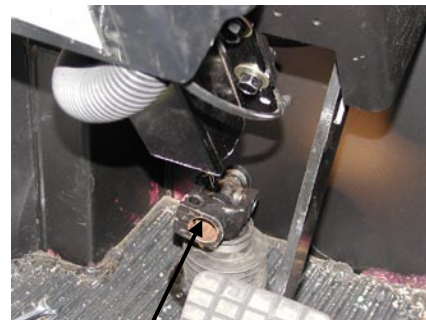
Shown with pinch  
bolt removed
