BLUE BIRD

SUBJECT: RECALL R10SB TRW INTERMEDIATE STEERING SHAFT WELD

Recall R10SB TRW Intermediate Steering Shaft Assembly Inspection Reply Sheet

IGEN 3 Intermediate Shaft Weld Location Inspection Procedure

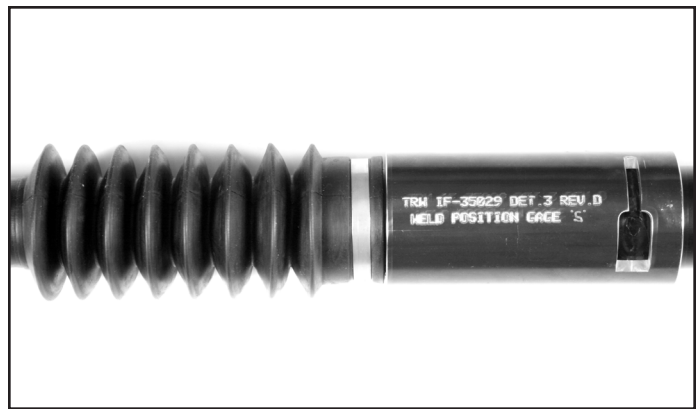
Figure 3

1. Check the weld position using the TRW gauge (SEE Tools Required Page 1). Place the template end of the gauge against the base of the boot seal as shown in **Figure 3** with the gauge placed over the top of the part number stamp location.

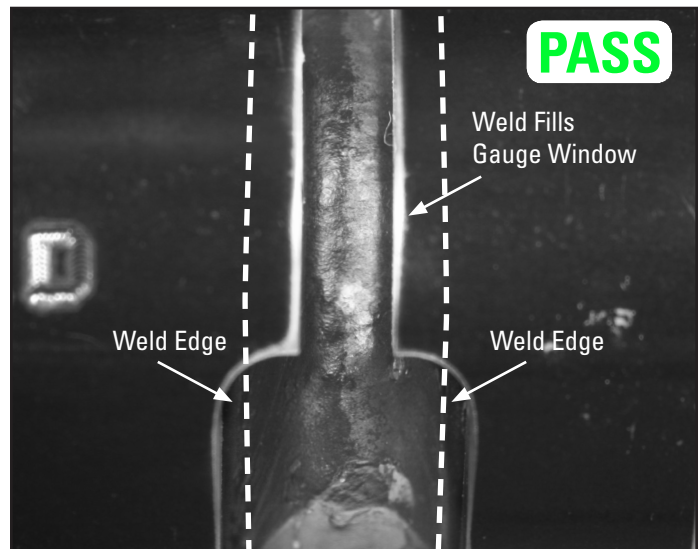
Figure 4

2. Visually inspect the position of the weld bead in reference to the small gauge window (3/16" width). The full circumference of weld seam must be inspected in the gauge window. **Figure 4**
Look for the following criteria:

- The weld bead must completely fill the gauge window.
- No joint line between the 2 tubes should be visible, the edges where the tubes join should be covered by the weld.
- The parent tube should not be visible in the narrow section of the gauge window.

- 2a. **Part Passes** if the weld bead completely fills the narrow gauge window **Figure 4**. Mark the parts that pass inspection with yellow or white paint mark adjacent to the part number stamp. **Figure 1**

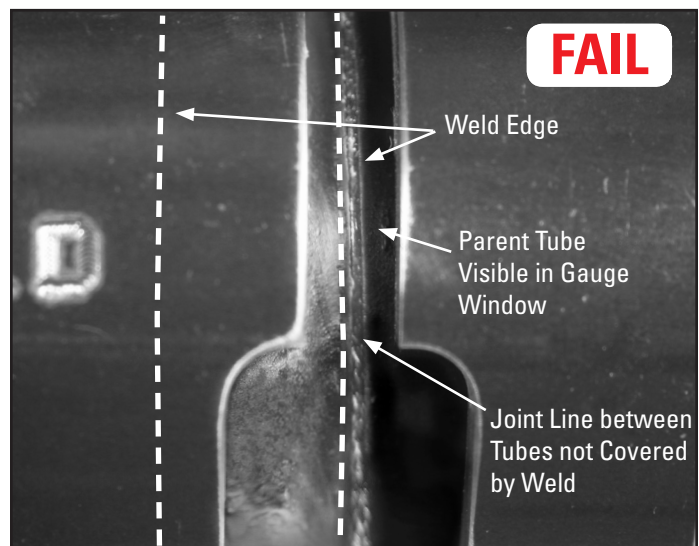
Figure 5

- 2b. **Part Fails** if any of the following are seen in the inspection. **Figure 5**
 - The weld bead does not completely fill the narrow gauge window.
 - The parent tube is partially visible in narrow gauge window.
 - The joint line between the 2 tubes is visible at any point around the circumference of the shaft. **Figure 5**

Remove intermediate shaft and replace.

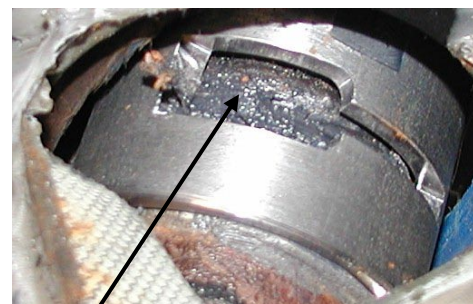
Weld shown through TRW inspection tool from underneath driver's floor

10. The window for the inspection will be visible from underneath driver's floor. Rotate the shaft by turning the steering wheel to inspect weld per TRW Service Procedure # COL-201. If the part passes, follow TRW Service Procedure # COL-201 and then mark the Blue Bird Sheet. If the part fails, mark the sheet and return to the Blue Bird Recall Administrator. **NOTE:** If the weld cannot be seen in the installed position, remove the shaft for inspection. New fasteners **MUST** be use to reinstall the shaft.

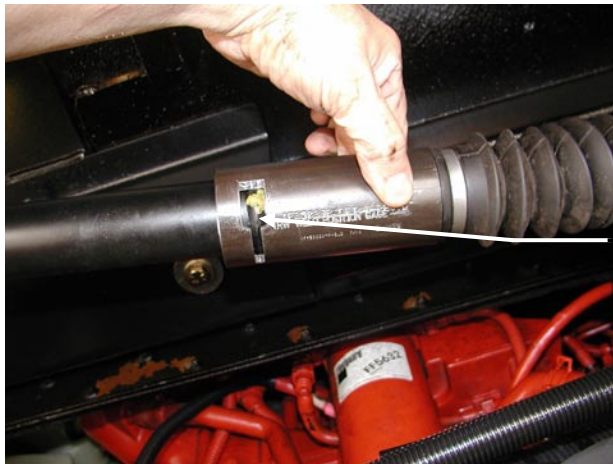
Weld shown through TRW Inspection tool

9. Rotate the shaft by turning the steering wheel to inspect weld per TRW Service Procedure # COL-201. If the part passes, follow TRW Service Procedure # COL-201 and then mark the Blue Bird Sheet. If the part fails, mark the sheet and contact Blue Bird Recall Administrator.
10. After the inspection process has been completed for both upper and lower shaft, remove jack stands, and reconnect batteries by connecting the negative last.
11. Place bus back in service.
