SUBJECT: SAFETY RECALL OF SE-GI WINDOWS

Ref.: **NHTSA # 10V-373**
TRANSPORT CANADA #TC 2010-270
MCI Service Bulletin 348

Service Bulletin No. 348

MODEL E4500 / J4500 Series Coaches	TYPE Field Change Program	SECTION/GROUP 3-Body	DATE Aug. 16, 2010
SUBJECT SE-GI WINDOW GLASS ASSEMBLY ADHESIVE DEBONDING			
CONDITIONS

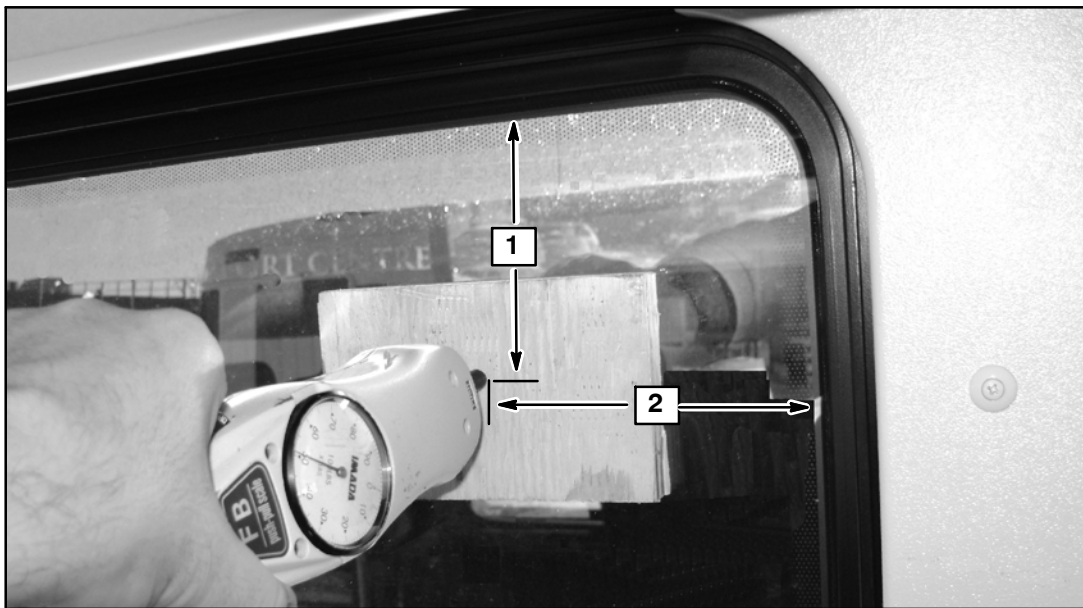
Figure 1.

3. Ensure window is in locked position.
4. From inside the coach, carefully position a 4.0 x 4.0 x 0.5 inch flat wood block flat against the glass surface, the center of which should be six (6) inches from both edges (as shown in Figure 1). Position a push / pull gauge at the center of the wood block and apply 50 lbs. push force against the glass, perpendicular to the glass surface, to accentuate any partial de–bonding that may exist.
5. Look for any evidence of de-bonding from the frame, as force is applied.
