**BLUE BIRD**

**SUBJECT: RECALL R10SL STARTER CABLE AND ENGINE WIRING  
HARNES MAY CONTACT FAN HUB**

# Starter Cable and Wiring Harness May Contact Engine Fan Hub

**Models Affected:** 2007 – 2011 All American (A3FE) and Commercial Series (C3FE), and 2010-2011 All American (D3FE) equipped with Cummins ISB Engines

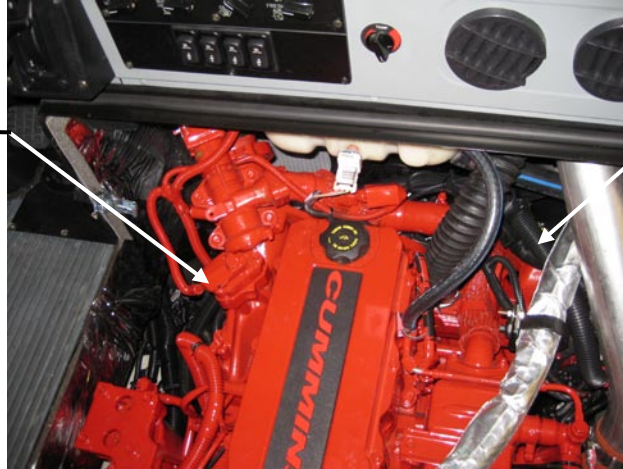
- 5 Inspect the starter cable and wiring harness from the right side of the engine, across front of engine to left side of engine for any chaffing, rubbing or damage. If starter cable and wiring harness shows any evidence of damage, contact Blue Bird Recall Administration.

Area of Left side support Bracket, See photos in step 8

Area of Right side support Bracket, See photo in Step 7

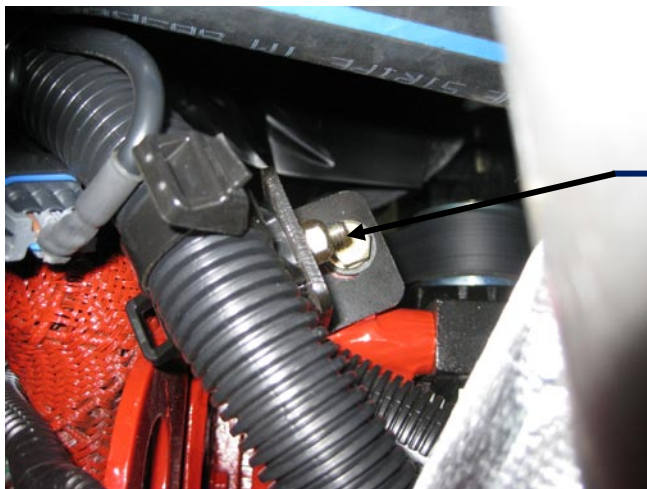
- 6 One starter cable and wiring harness support is located on the right side of the engine between the alternator and engine fan.
- 7 Remove and discard the ¼" serrated nut (and flat washer if installed). Install the new ¼" locknut (0145847) and flat washer (01247709) provided. Torque nut to 60-85 in. lbs. Note: two complete threads must extend completely through the nut.

Replace with new locknut and flat washer (Note: new locknut shown)

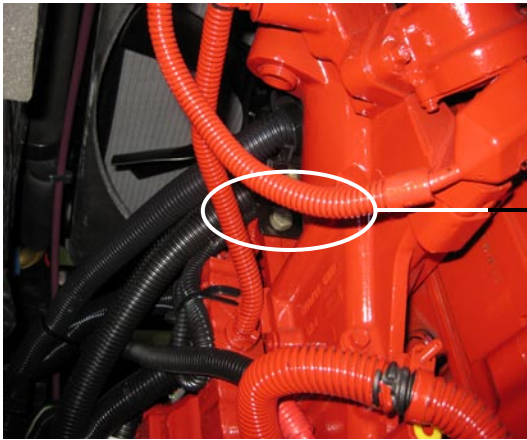
Left Side support

8. The second starter cable and wiring harness support is located on the front left side of the engine block.
9. Remove and discard the  $\frac{1}{4}$ " serrated nut (and flat washer if installed). Install the new  $\frac{1}{4}$ " locknut (0145847) and flat washer (01247709) provided. Torque nut to 60-85 in. lbs. Note: two complete threads must extend completely through the nut.

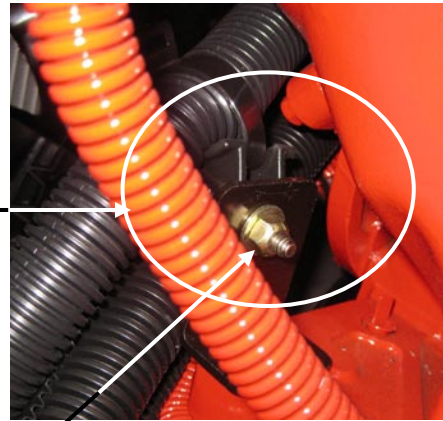
Replace with new locknut and flat washer (Note: New locknut shown)

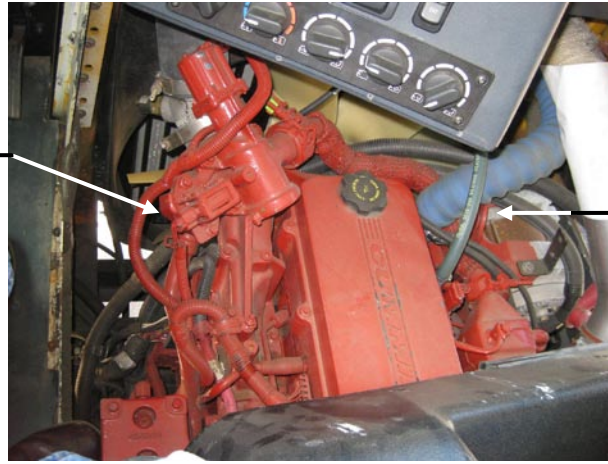
Area of Left Side Support Bracket, see photos in step 6

Area of Right Side Support Bracket, see photo in step 5

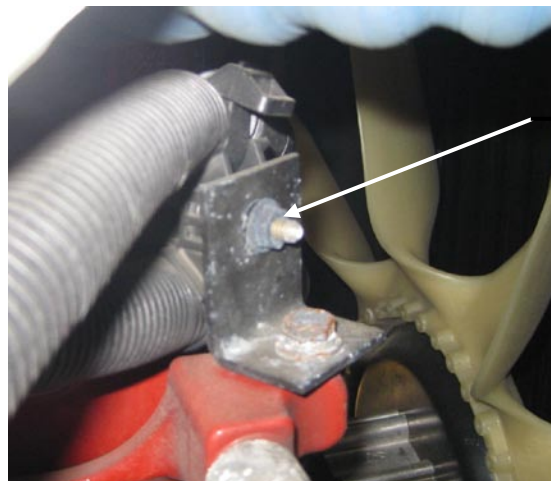
Replace serrated nut (shown) with new locknut and flat washer

- 4 One starter cable and wiring harness support is located on the right side of the engine between the alternator and engine fan.
5. Remove and discard the ¼" serrated nut (and flat washer if installed). Install the new ¼" locknut (0145847) and flat washer (01247709) provided. Torque nut to 60-85 in. lbs. Note: two complete threads must extend completely through the nut.

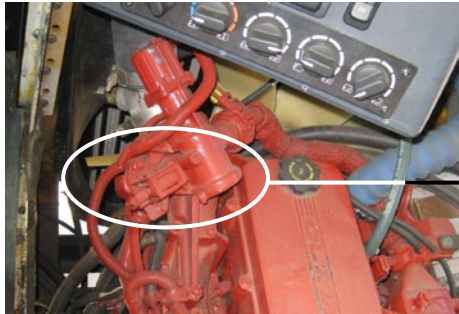
Left Side Support

6. The second starter cable and wiring harness support is located on the front left side of the engine block.

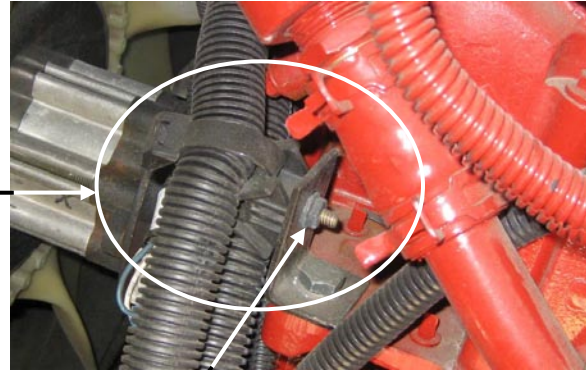
Replace serrated nut (shown) with locknut and flat washer

- 7 Remove and discard the 1/4" serrated nut (and flat washer if installed). Install the new 1/4" locknut (0145847) and flat washer (01247709) provided. Torque nut to 60-85 in. lbs. Note: two complete threads must extend completely through the nut.
  8. Reinstall the engine cover assembly by reversing the steps above. Reconnect the batteries.
- Caution:** *When reconnecting the batteries, connect the negative cable last.*
9. Place bus back in service.
