Customer Service Notice

Date: September 15, 2010

GM 4500/5500 Series Diesel Chassis Clutch Pump Hose Inspection and Update

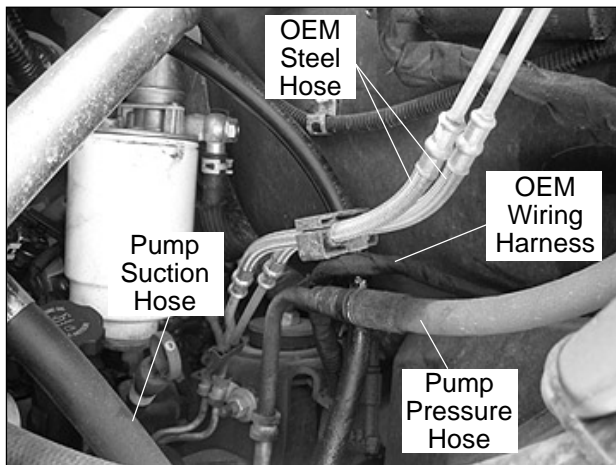
Figure 1 — Inspection Area, Example 1

1. Position the chassis on a level surface where there is adequate light to see well in the engine compartment. Shut off the engine and chock the wheels.
2. Raise the chassis hood and identify the fanbelt-driven hydraulic pump.
3. Review all hydraulic hoses connected to the hydraulic pump for evidence of wear or damage (refer to Figures 1 and 2). Installations of aerial device components can differ from chassis to chassis causing the routing of hoses or wiring to be in different places in the

engine area. Pay particular attention around any chassis hoses or components, such as the chassis power steering hoses, that might cause damage to the pump hoses over time. Inspect the wiring for the unit in the chassis engine compartment and any chassis wiring for damage where they may have been in contact with the hydraulic hoses.

4. Repair any significant wear or replace the hoses or wiring immediately. Contact Altec if you would like to have assistance with this repair.
5. Install the hose routing bracket to make sure the pump pressure and suction hoses are routed away from anything that might damage them (Refer to Figure 3).
