Recall Bulletin

PRODUCT SAFETY RECALL

SUBJECT: Accelerator Pedal Sticking

MODELS: 2009-2010 Pontiac Vibe

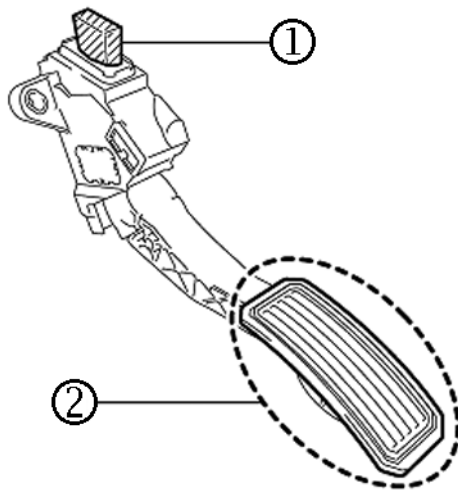
2394604

(1) Connector (2) Area of accelerator to Clean

3. Protect the accelerator pedal electrical connector (1) using UL listed electrical tape.

4. Clean the accelerator pedal assembly with water and shop towel. Refer to the illustration to view the area of the accelerator pedal to clean.

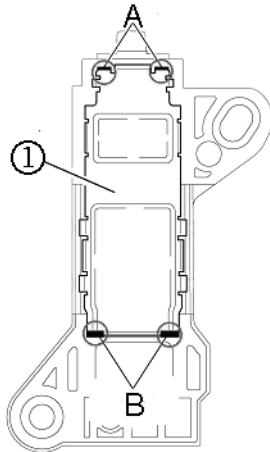
2394601

View: Back-side of Pedal Assembly (1) Accelerator Link Arm Support Cover (A) Gaps (B) Gaps

5. Remove the accelerator link arm support cover using a pocket screwdriver. Evenly and lightly pry up on gaps (A) and then gaps (B) to remove the cover. Refer to illustration.

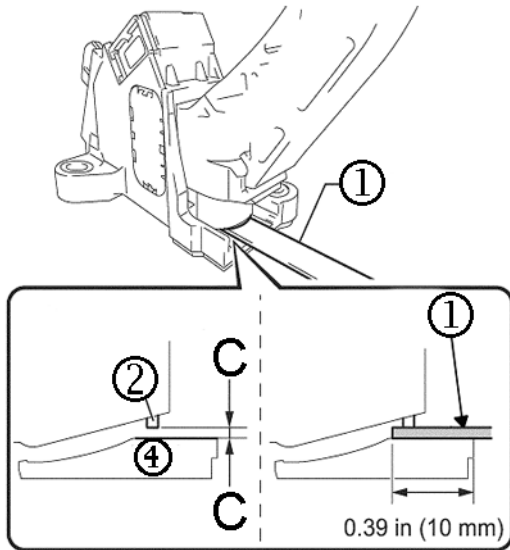
2394592

(1) Feeler Gauge (C) Clearance (2) Stopper (4) Housing

- 6.1. Using a feeler gauge (1), measure the clearance (C) between the stopper (2) and the housing (4).
- 6.2. Only insert the feeler gauge 10 mm from the end of the housing as illustrated.
- 6.3. Based on the measurement from Step 6.1, select the correct reinforcement bar using the table below.

Clearance	Reinforcement Bar	
	Thickness	Stamping
0.0 mm – 0.29 mm	1.4 mm	1.4 A
0.3 mm – 0.59 mm	1.6 mm	1.6 B
0.6 mm – 0.79 mm	1.8 mm	1.8 C
0.8 mm – 1.09 mm	2.0 mm	2.0 D
1.1 mm – 1.49 mm	2.3 mm	2.3 E
1.5 mm – 1.89 mm	2.6 mm	2.6 F
1.9 mm – 2.70 mm	2.9 mm	2.9 G
greater than 2.70 mm	Contact the Technical Assistance Center

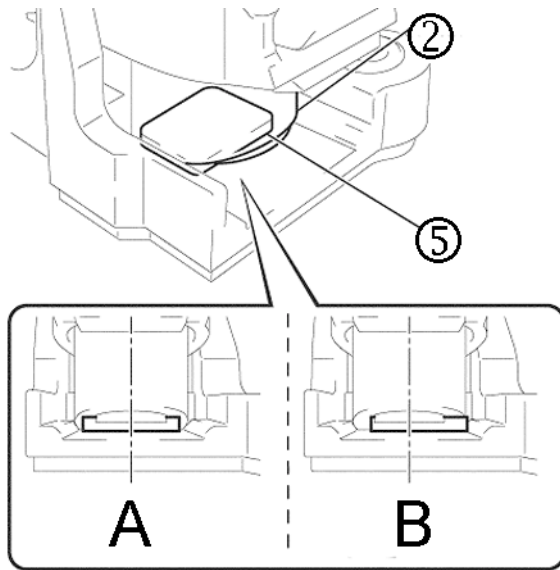
2394603

(A) OK (Centered) (B) Not OK (Not Centered)

8. Verify that the reinforcement bar (5) is properly centered (A) and flush with the stopper.
