RECALL BULLETIN:
10625FRV

PRODUCT(S) AFFECTED:
Encounter,
Storm

MODEL(S) AFFECTED:
28MS

SUBJECT:
Providing
Egress for
Driver's Side
Bedroom
Window

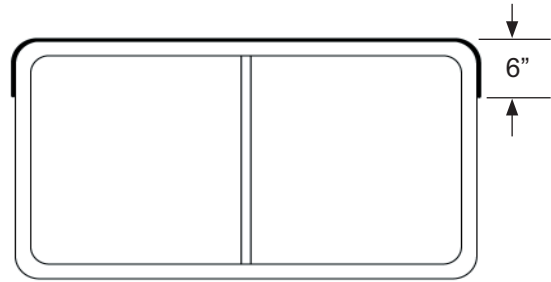
Figure 1

Certain 2010 Encounter and 2011 Storm motor homes were built with an alternate exit/emergency egress window installed on the same sidewall as the entry door. The applicable ANSI/NFPA Fire & Life Safety code requires that the secondary means of escape must be "located on an exterior wall other than the primary means of escape or in the roof."

5. Install the new emergency egress window using the compression seal and screws supplied in the Recall kit. Apply a 1/8" bead of clear silicone sealant to the exterior upper six inches of the new window frame after installation. See Figure 1.
