BY EMAIL AND
BY CERTIFIED MAILAssociate Administrator for Enforcement
National Highway Traffic Safety Administration
Attention: Recall Management Division (NVS – 215)
1200 New Jersey Avenue, SE.
Washington, DC 20590Re: **PART 573 NOTICE RE IDLER PULLEY COVER**

Safety Defect and Noncompliance Report Guide for Vehicles
PART 573 Defect and Noncompliance Report

MCI Service Bulletin 351

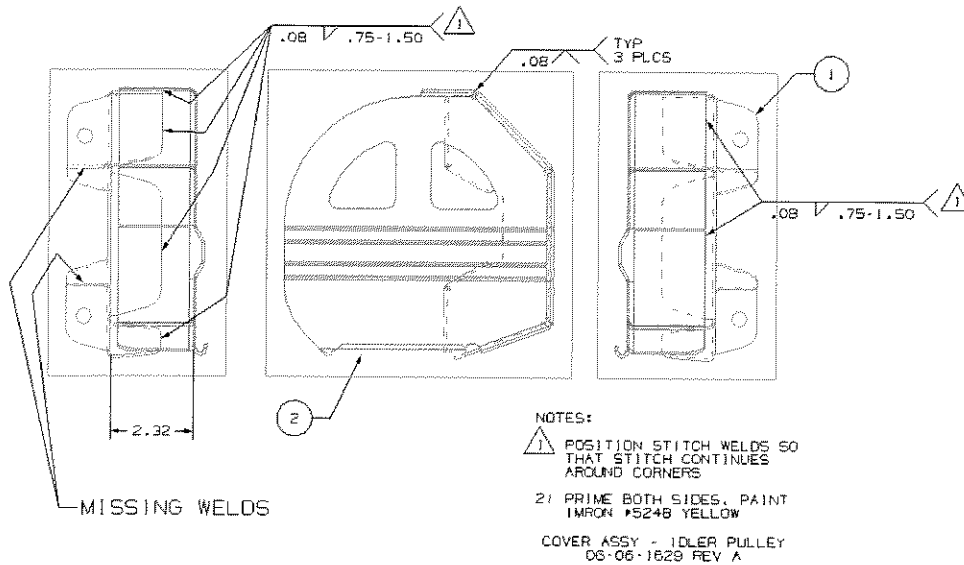
The recalled vehicles have a yellow pulley guard, MCI part number 06-06-1629 revision A. The part is defective if there are no welds present at the positions shown in the attached drawing. The pulley guard covers the idler pulley, which acts as a guide for the belt that drives the engine cooling fan. It is located in the engine compartment at the rear of the coach and is visible only when the engine compartment doors are open.

The fan belt idler pulley is designed with a guard to prevent personal injury to maintenance personnel who might otherwise come in contact with the fan drive belt at the idler pulley during maintenance operations. MCI determined that the design of the pulley guard is susceptible to fatigue failure in the area where the guard is fastened to the coach if two welds joining the attachment flange to the cover are not present (see drawing in section I above).

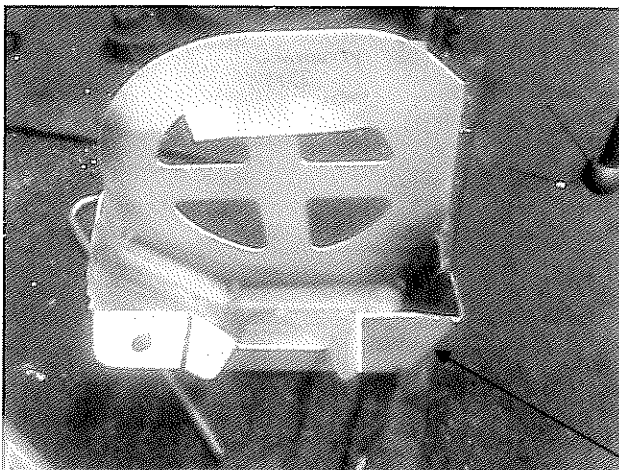
MCI has determined that the defective pulley guards lack two welds that provide stiffness and rigidity to the part. Without these welds, the guards will likely eventually fail as a result of fatigue near the area where the guard is assembled to the coach structure. The following pictures show where the part fails.

Broken Tab

MCI will provide, at no cost to customers, the parts and labor to replace the defective part 06-06-1629 revision A on all affected coaches with new part 06-06-1629 revision B. The procedure to replace defective parts is defined in MCI Service Bulletin 351.

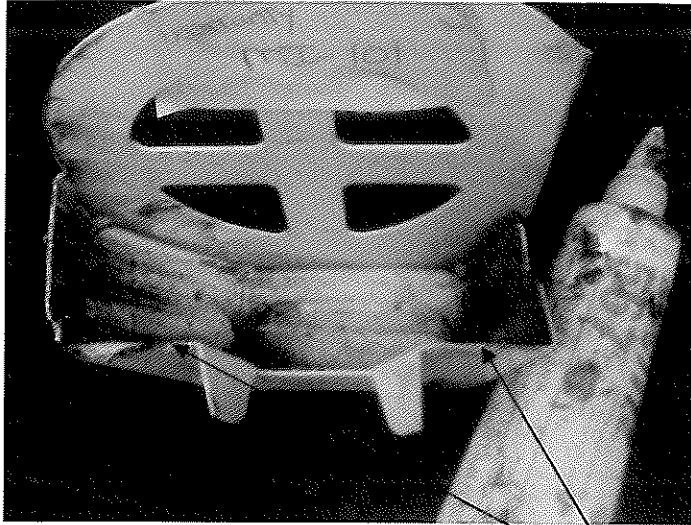
Broken Tabs
