RE: Terex Telelect Inc. Aerial Devices and Digger Derricks

## DEFECT INFORMATION REPORT

**CAMPAIGN BULLETIN**

**SUBJECT:** Miller "D" lanyard anchor p/n 472452

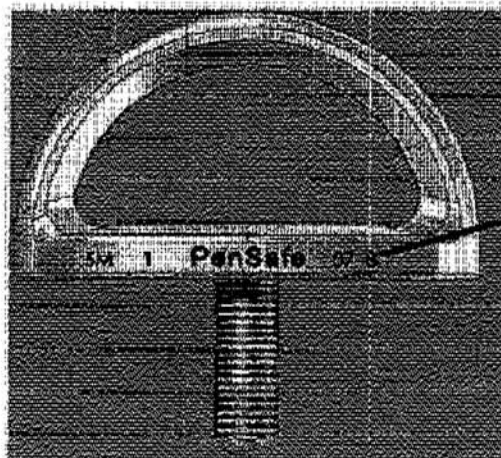
Date code

TEREX Utilities has received notice of a recall from the supplier of the D shaped lanyard anchor, p/n 472452 with the date code 07B. There is a deficiency in the material strength that may cause the threads on the stem to fracture prematurely. These parts could be on machines built from June, 2008 through November, 2010.

**During a fall arrest event the D shaped lanyard anchor can fail.**

Immediately inspect the lanyard anchors on units listed in the attached letter for lanyard anchors having the date code 07B, as shown below. Immediately take the unit out of service if the date code appears. If the date code does not appear, simply complete the enclosed form to complete this bulletin.

If your lanyard anchor is affected, call TEREX Utilities, at 605-884-3892 for a replacement kit, p/n Z-1200. Follow the installation instructions that accompany the kit. Complete the enclosed form and return it with the affected anchor to TEREX Utilities, using the shipping label and shipping box, for credit.
