June 1, 2011

American Honda Motor Co., Inc.
 1919 Torrance Boulevard
 Torrance, CA 90501-2746
 Phone (310) 783-2000

Re: Recall Notification
2010-11 Model Year VT750
Bank angle sensor

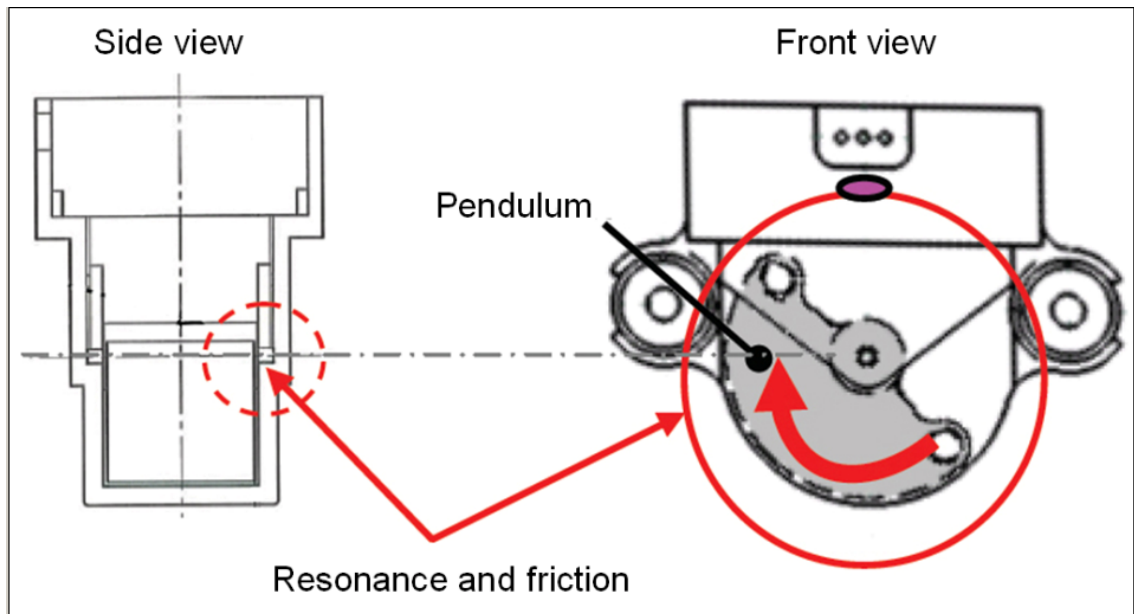
Through our investigation, Honda has determined that unexpected engine stopping results from a combination of resonance in the motorcycle's bank angle sensor and friction between the sensor's pendulum and case. Under certain operating conditions, resonance caused by engine vibration (when operated at approximately 3,000 rpm) can move the pendulum as if the motorcycle were leaning, even though it is not. Subsequently, friction characteristics unique to the inside surface of a newly manufactured sensor hinder the pendulum's return to the center (non-angled) position as would normally occur due to gravity.

Computer simulation has shown that with (a) sufficient friction in the new sensor and (b) operation in the resonance zone for a sufficient period of time, the pendulum can move to the specified shut-off angle of 42.5 degrees, which causes the engine to stop. Simulation also shows that as the contact surfaces inside the sensor wear with motorcycle use and surface friction is reduced, the likelihood of the pendulum moving to the shut-off angle without the motorcycle being leaned decreases significantly. The simulated behavior explains why no claims have been received for motorcycles with more than 500 miles of use, and the reported symptoms could not be reproduced with returned claim parts.

Note: The bank angle sensor is comprised of a weighted pendulum and a switching mechanism designed to stop the flow of electrical power to the ignition and fuel injection systems in the event the motorcycle falls onto its side.

Honda motorcycle dealers will replace the bank angle sensor in all affected motorcycles delivered to Honda dealerships or sold to consumers. The owners of affected motorcycles will be contacted by mail and asked to take their motorcycle to a Honda dealer. The dealer will replace the bank angle sensor free of charge.
