**MOTOR COACH
INDUSTRIES**

**Re: PART 573 NOTICE RE MCI 2011 J & E MODEL COACHES WITH DOGA
WINDSHIELD WIPER MOTORS**

Safety Defect and Noncompliance Report Guide for Vehicles
PART 573 Defect and Noncompliance Report

MCI Service Bulletin 362

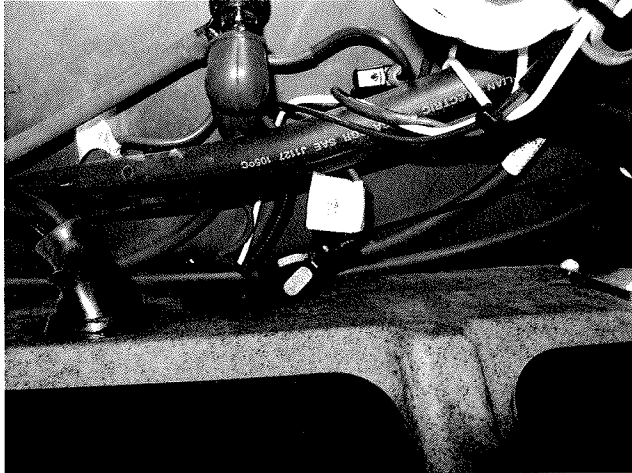
Wrong inline fuse
installed

MCI identified a potential incorrect installation of the inline fuse that may have occurred in the manufacturing facility. If the incorrect fuse (15A) is installed, the wiper motor fuse may open under a heavy load created by other coach accessories connected to the electrical stud block. Please refer to the figure in section 2 above.

If the recalled vehicle has the incorrect fuse installed, the wiper motor will be powered from a lower-rated fuse that may open under a heavy load created by other coach accessories connected to the electrical stud block.

The windshield wipers may completely stop operating if the incorrect fuse opens due to loading from other coach accessories. If this occurs, the driver's clear field of view may be reduced.

MCI will provide, at no cost to customers, the parts and labor to inspect and replace as necessary any incorrect fuses installed as part of the wiper motor system, and to ensure that a wiring label is in place to alert operators as to the correct fuse size to be used. The procedure is further described in the attached MCI Service Bulletin 362.

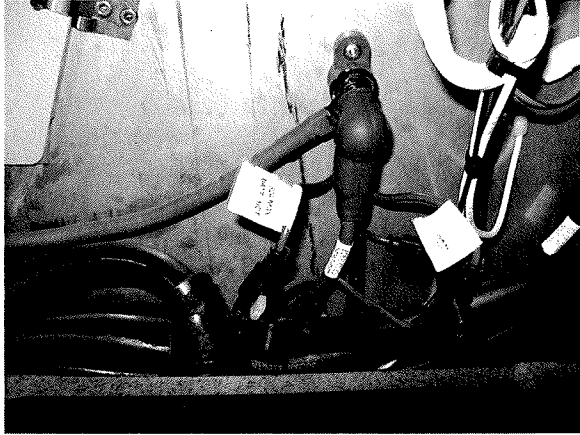
The rework will result in the proper inline fuse size being installed. The picture below depicts the correct fuse installed.
