September 9, 2011
Ref. No.: GR11-050

11V-467
(4 Pages)

RE: Part 573 Defect Information Report – Moonroof Glass Coming-off on 2011 Subaru Legacy & Outback Vehicles

Defect Information Report (49 CFR Part 573.6)

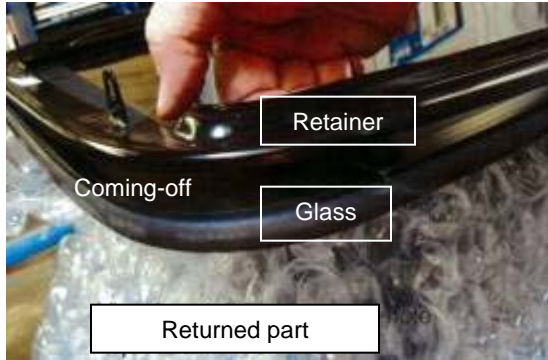
(1) Evaluation result of returned parts

Moonroof glass comes loose or off. Adhesion area between glass and retainer is small.

- a) Width of primer application was found less than the amount specified in the design drawing in certain areas.
- b) Amount and positions of seal (adhesive) application was inappropriate at both of outer and inner circumferences of certain areas.

(i) The remedy plan calls for dealers to inspect glass adhesion condition and dealers will either apply additional seal or replace the moonroof glass with a new one according to the inspection result.

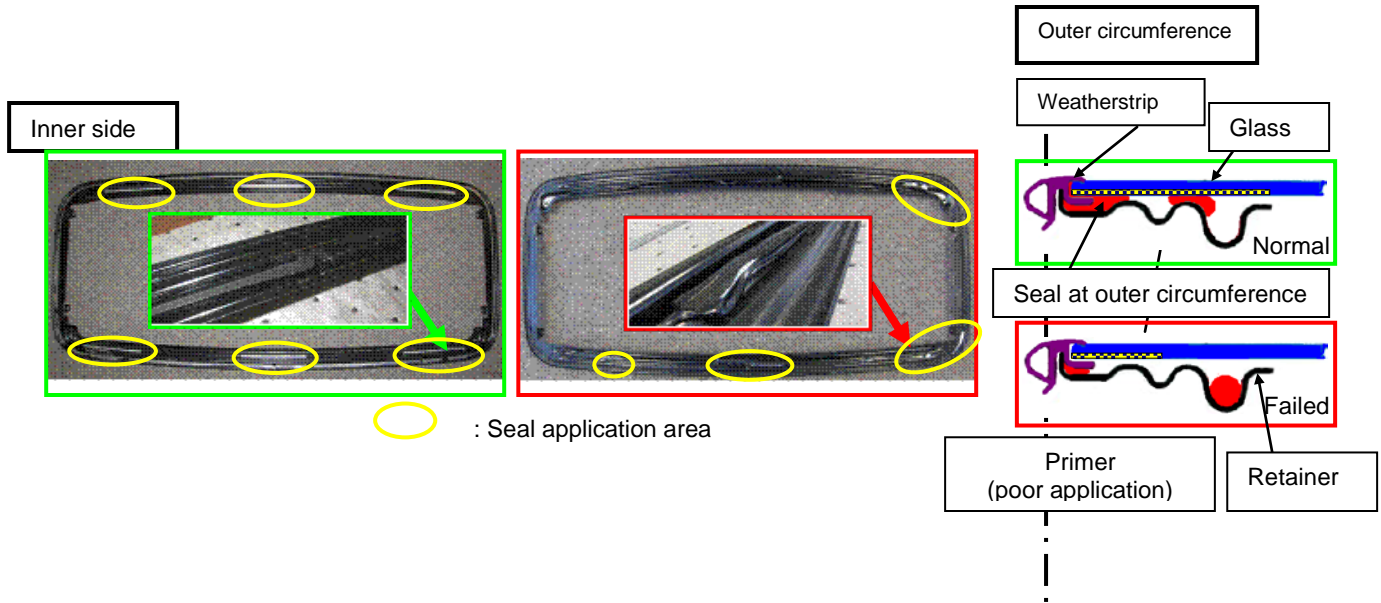
(2) Cause of the Defect

Assembly process of glass and retainer was changed at supplier from another vendor during summer shut-down in 2010. Application management of primer and seal was inappropriate.

- a) Specification (40 +/- 10mm) of primer application width was not specified in work procedure.
- b) Poor management of seal application amount.

The moonroof glass can loosen and detach from the vehicle during driving, resulting in a potential road hazard for other vehicles that may lead to a collision.
