Defect Information Report
(Section 573.6)
EQ11-004

11V-479
(3 Pages)

September 16, 2011

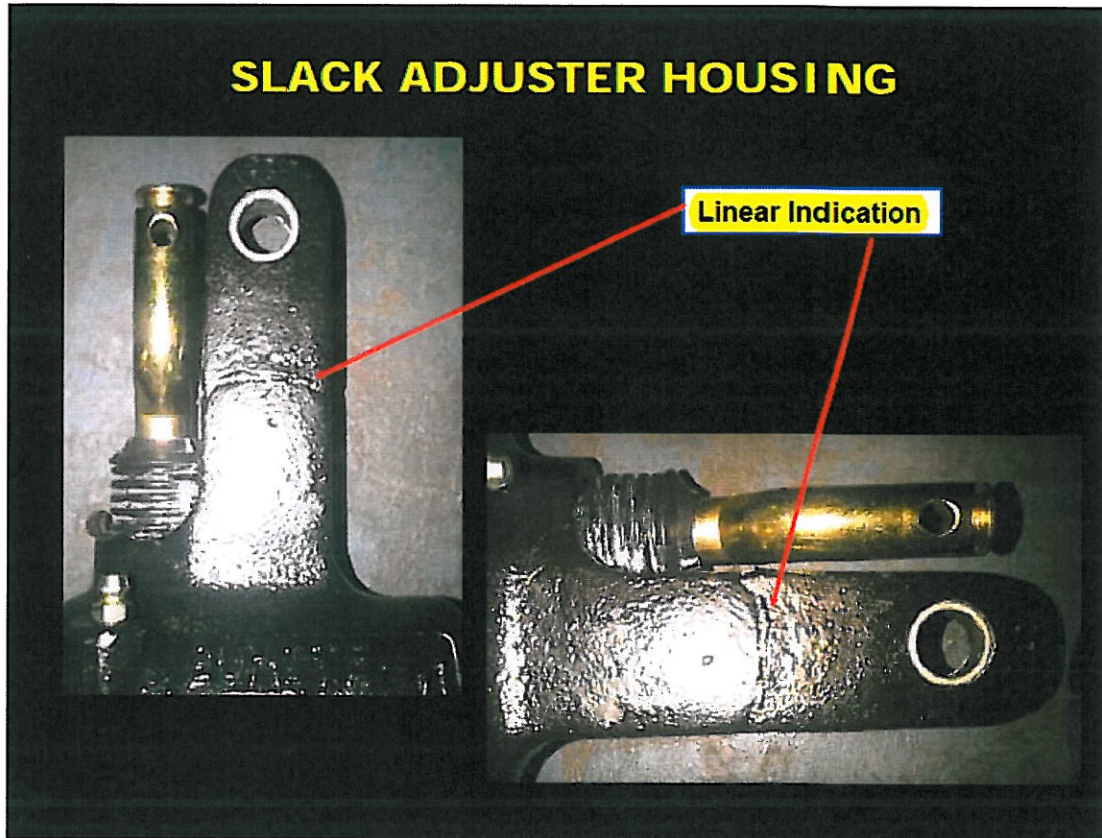
Pictorial of nonconformance:

The nonconformance is caused due to incomplete "knitting" of the iron at the time of casting, which is commonly referred to as a "misrun" by the foundry industry. While the dimensional characteristics of the area in question are within specification, in certain cases the casting process resulted in a "flow notch" in the "handle" portion. Causes of the nonconformance could be an interruption in the pour of the mold, low iron temperature, slow pouring practice or temporary blockage in the gating system.

Silver Eagle initiates notification of sixteen (16) users. If any defective slack adjustors are located, the full remedy process is in the letter to the end user (sample of Silver Eagle letter appended to this document – appendix #3). This remedy process was written, owned, and managed by Accuride-Gunite Corporation who will replace any defective automatic slack adjustors free of charge, including time for removal and replacement of defective unit.
