**Re: PART 573 NOTICE RE MCI COACHES WITH A PENNTEX ALTERNATOR**

Safety Defect and Noncompliance Report Guide for Vehicles  
**PART 573 Defect and Noncompliance Report**

**MCI Service Bulletin 373**

**Certain Motor Coach Industries, Inc. ("MCI") D4505 model coaches equipped with a PennTex Brushless Alternator.**

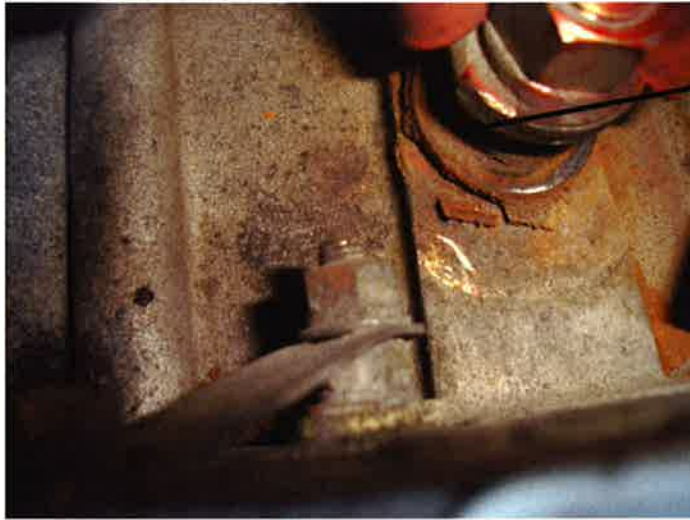
**Only the coaches in the recall population were equipped with a PennTex alternator due to a customer special request. The PennTex alternator has a unique stud orientation which, when combined with the end bracket, makes it difficult for moisture to drain away. Moisture collecting on the end bracket may result in corrosion buildup at and around the power stud base (see picture below). This corrosion may create a short circuit between the power stud and the alternator body, which in turn could result in burning of the power stud or the power cable end. MCI coaches manufactured with other brand alternators do not have the same corrosion buildup conditions.**

Corrosion buildup at the power stud base

**As installed in MCI's D4505 model coach, the Penntex alternator has a unique stud orientation which, when combined with the end bracket, makes it difficult for moisture to drain away. Moisture collecting on the end bracket may result in corrosion buildup at and around the power stud base (see picture above). This corrosion may create a short circuit between the power stud and the alternator body, which in turn could result in burning of the power stud or the power cable end.**

**Moisture collecting on the end bracket may result in corrosion buildup at and around the power stud base. The corrosion may create a short circuit between the power stud and the alternator body, which in turn could result in burning of the power stud or the power cable end.**

**A short circuit between the power stud and the alternator body could result in burning of the power stud or the power cable end, in addition to a loss of alternator power in the coach.**

**The rework will consist of adding two drain holes to the end bracket and applying Hi-Tack moisture resistant coating to reduce corrosion buildup (see picture below).**
