11V-562
(4 Pages)

Ref. No.: GR11-080

RE: Part 573 Defect Information Report – Increased Brake Pedal Travel Distance on 2012MY Subaru Impreza (except WRX/STI), Legacy and Outback Vehicles

Defect Information Report (49 CFR Part 573.6)

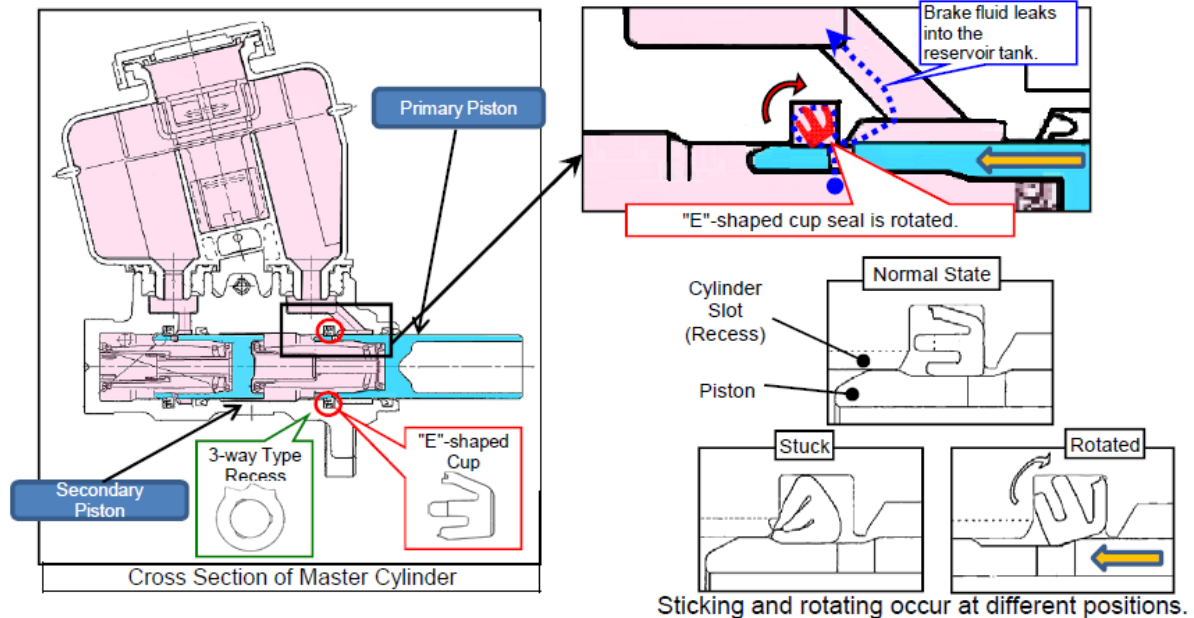
Investigation result of returned parts

As the "E"-shaped cup seal of the primary piston in the master cylinder rotates, brake fluid leaks into the reservoir tank.

i) During production, the brake system is filled with hydraulic fluid using high pressure. This pressure collapses the "E"-shaped cup seal causing it to deform and get "stuck" in the cylinder slot recess (refer to the "stuck" picture in 573.6(c)(5)(1) above).

This event only occurs on the primary circuit. There is no impact on the secondary circuit.

ii) The "stuck" condition results in a force that pushes a portion of the E-shaped cup seal against the primary piston

iii) When the piston is actuated during braking, the piston moves left and the chamfer portion of it engages and rotates the "E"-shaped cup seal. This new orientation of the "E"-shaped cup seal compromises the hydraulic sealing of the system.

Design of the "E"-shaped cup seal cannot tolerate the process, during production, under which the brake system is filled with hydraulic fluid using high pressure.

In the failure mode described above, brake pedal travel distance will increase. The driver might misjudge the amount of brake pedal travel required to achieve the desired stopping distance, possibly resulting in a crash.

- (i) The remedy plan calls for dealers to inspect, and if necessary, replace the master cylinder assembly with a new one that incorporates a proven cup seal design in place of the "E"-shaped cup seal design.
- (ii) Subaru of America, Inc. notified U.S. dealers on November 25, 2011. Subaru will start preparing modified parts. It is expected that owner notification will begin within 30 days. Subaru will update NHTSA if the situation changes significantly.
