Fuji Heavy Industries U.S.A., Inc.

RE: Part 573 Defect Information Report – Increased Brake Pedal Travel Distance on 2012MY Subaru Impreza (except WRX/STI), Legacy and Outback Vehicles (Second Submission)

Defect Information Report (49 CFR Part 573.6)

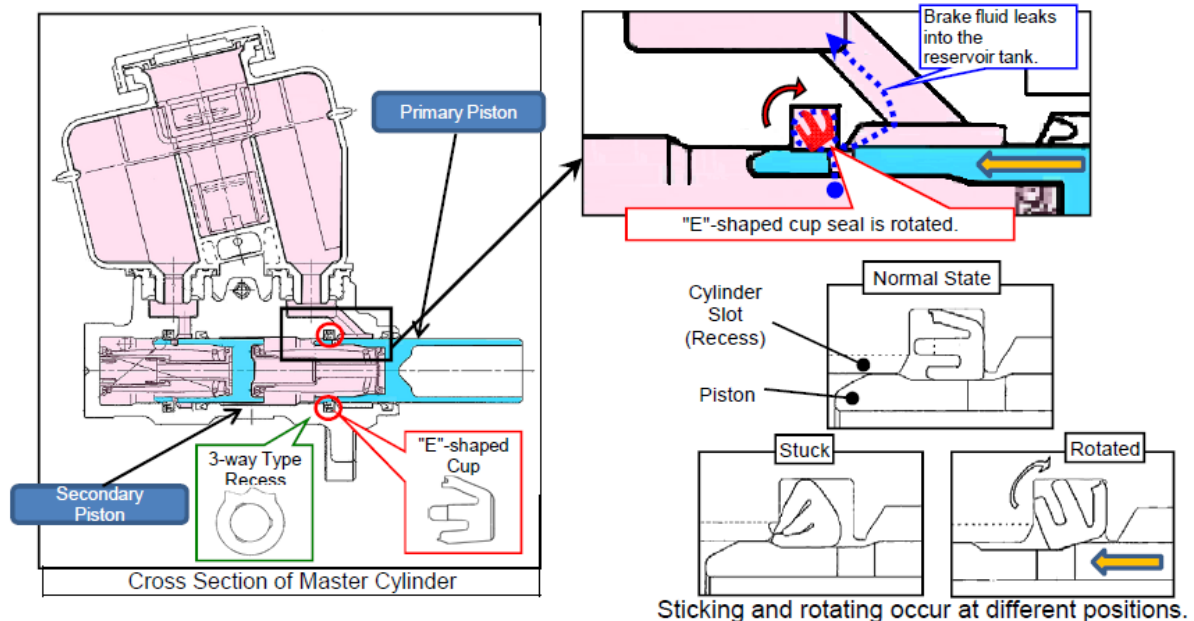
Investigation result of returned parts

As the "E"-shaped cup seal of the primary piston in the master cylinder rotates, brake fluid leaks into the reservoir tank.

i) During production, the brake system is filled with hydraulic fluid using high pressure. This pressure collapses the "E"-shaped cup seal causing it to deform and get "stuck" in the cylinder slot recess (refer to the "stuck" picture in 573.6(c)(5)(1) above).

ii) The "stuck" condition results in a force that pushes a portion of the E-shaped cup seal against the primary piston

iii) When the piston is actuated during braking, the piston moves left and the chamfer portion of it engages and rotates the "E"-shaped cup seal. This new orientation of the "E"-shaped cup seal compromises the hydraulic sealing of the system.

Design of the "E"-shaped cup seal cannot tolerate the process, during production, under which the brake system is filled with hydraulic fluid using high pressure.

- (i) The remedy plan calls for dealers to inspect, and if necessary, replace the master cylinder assembly with a new one that incorporates a proven cup seal design in place of the "E"-shaped cup seal design.
- (ii) Subaru of America, Inc. notified U.S. dealers on November 25, 2011. Mailing of owner notification letters began and was completed on December 5, 2011.
