# Recall Bulletin

## PRODUCT SAFETY RECALL

**SUBJECT:** Rear Axle Cross Pin Fracture

**MODELS:** 2011 Cadillac Escalade, Escalade ESV, Escalade EXT  
2011 Chevrolet Avalanche, Colorado, Silverado, Suburban, Tahoe  
2011 GMC Canyon, Sierra, Yukon, Yukon XL

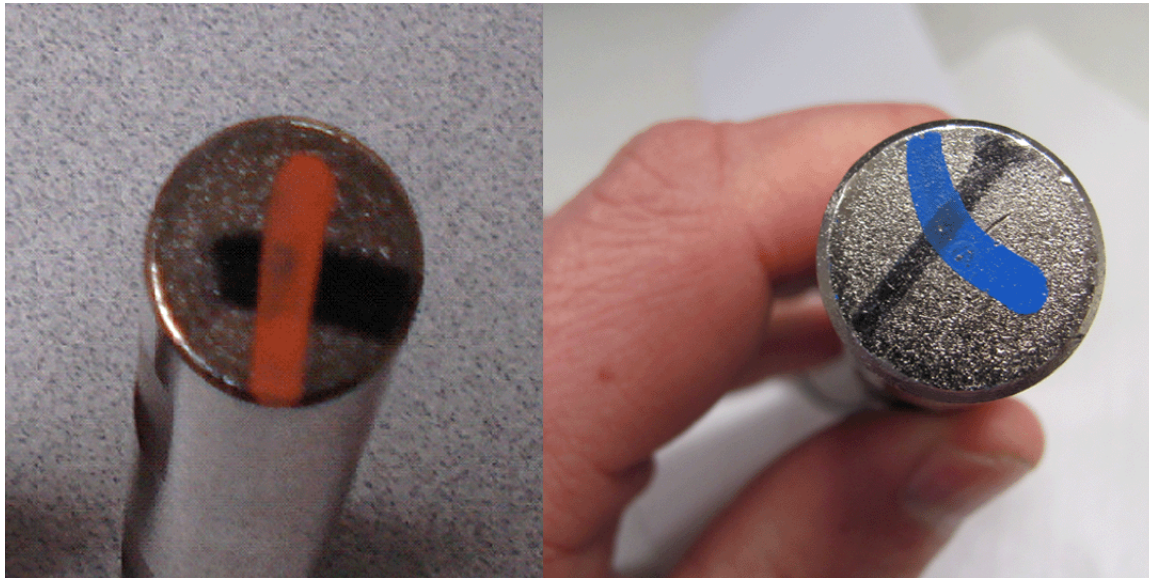
2554944

- If the head of the rear axle cross pin has orange and black paint marks or blue and black paint marks, do NOT replace the cross pin. Refer to illustration. Proceed to Step 14.

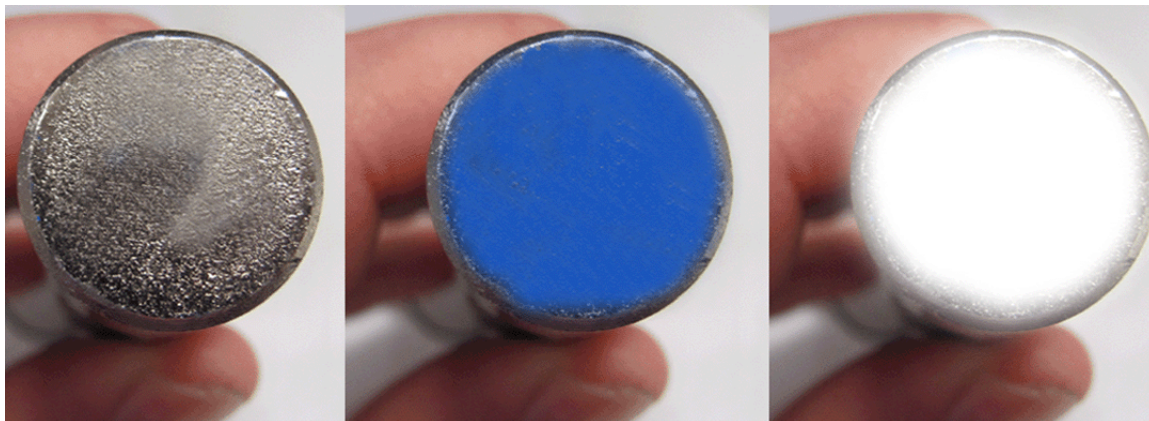
2554945

- If the head of the rear axle cross pin has no color or has solid blue or white paint marks, REPLACE the rear axle cross pin. Refer to illustration. Proceed to Step 10.
