**Re: Defect Information Report – Supplemental Report No. 1  
11V-008, FL-587, M2 Seat Belt Anchor Backing Plate**

## Subject: Freightliner Business Class M2 Seat Belt Anchor Backing Plates

March 2011  
FL587A  
NHTSA #11V-008  
Transport Canada #11-010

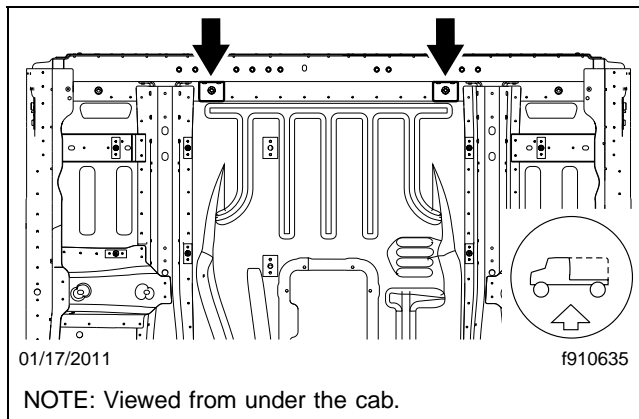
**Fig. 1, Locations of Inboard Tether Anchor Backing Plates**

1. Check the base label (Form WAR259) for a completion sticker for FL587 (WAR260) indicating this work has been completed. The base label is usually located on the passenger-side door about 12 inches (30 cm) below the door latch. If a completion sticker is present, no further work is needed. If a completion sticker is not present, proceed to the next step.
2. Shut down the engine, set the parking brake, and chock the tires.
3. Under the cab, inspect the backing plates for the *inboard* tether belt anchors. They are located on the underside of the cab floor, just inboard of the longitudinal reinforcements, as shown in **Fig. 1** and **Fig. 2**.

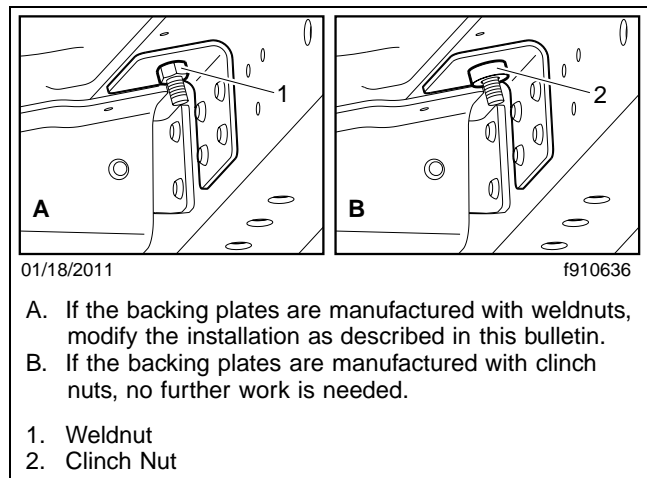
**Fig. 2, Tether Belt Backing Plate**

If the backing plates are manufactured with *clinch nuts*, no further work is needed. Clean a spot on the base label and attach a completion sticker for FL587 to the base label.

If the backing plates are manufactured with *weldnuts*, continue to the next step and modify the installation as follows.
