DEALER NOTIFICATION – SAFETY RECALL

Subject: Demonstration / Delivery Hold / Stop Sale
Field Action No.: 11-101

Field Action 11-101 --- Customer and Dealer Notification **SAFETY RECALL** – Incorrect Seat Belt Installation

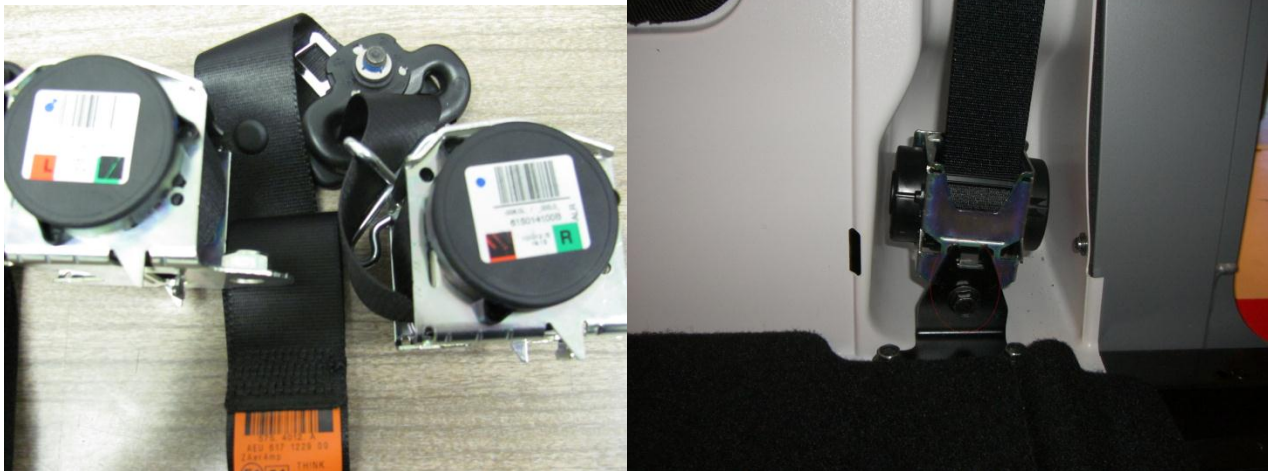
THINK North America has determined that front seat belt subassemblies may have been incorrectly installed in some 2011 THINK City model vehicles. The driver seat belt retractor assembly marked LHS may have been installed on the passenger-side of the vehicle and the passenger seat belt retractor assembly marked RHS may have been installed on the driver-side of the vehicle.

1. Remove driver and passenger side seat belt trim to verify which seat belt retractor assembly was installed in which location. The vehicle should have one LHS and one RHS belt assembly installed on the proper side of the vehicle.

2. If the LHS retractor is on the driver side of the vehicle and the RHS retractor is on the passenger side of the vehicle then the installation is correct -- reinstall the trim and the inspection is complete.
3. If the retractors are in the wrong position continue with repair procedure below.
