DEALER NOTIFICATION – SAFETY RECALL

Subject: Demonstration / Delivery Hold / Stop Sale
Field Action No.: 11-102

SAFETY RECALL – Poor Performance of Fluid Heater Systems

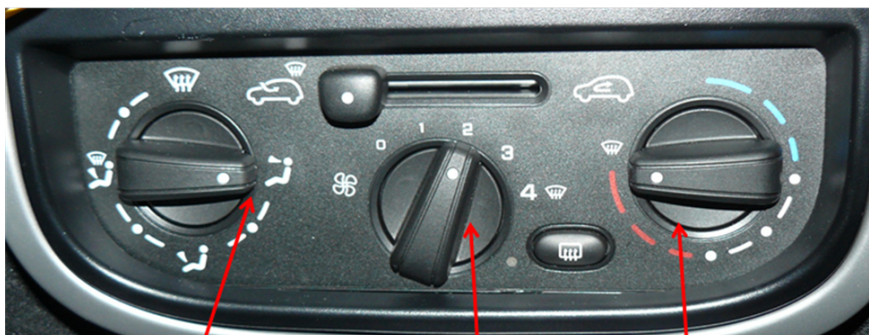
Vent mode

Fan speed 2

Max warm air

1. Set the climate control panel according to picture

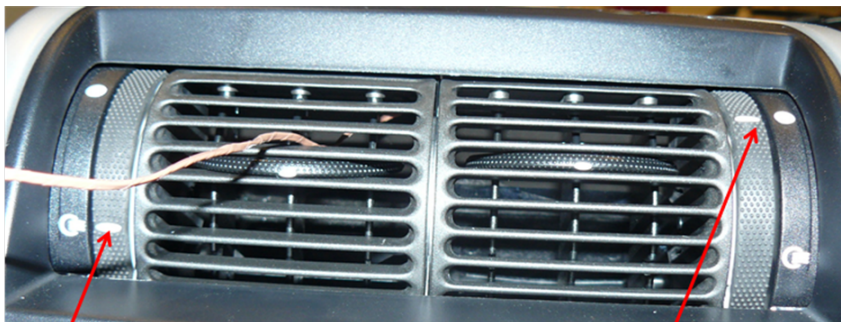
Fully open

Fully closed

2. Set the air outlets according to picture
3. Place thermo couple or thermometer As pictured.
