Subject: Safety Recall B0A (interim B1A) – **Interim Notification**
Certain 2004 – 2006 model year Highlander/Highlander HV
Driver's Side Floor Carpet Cover and Retention Clips

Safety Recall B0A (INTERIM B1A) – INTERIM Carpet Floor Cover and Retention Clip Inspection 2004 through Certain Early 2006 MODEL YEAR Highlander/Highlander HV

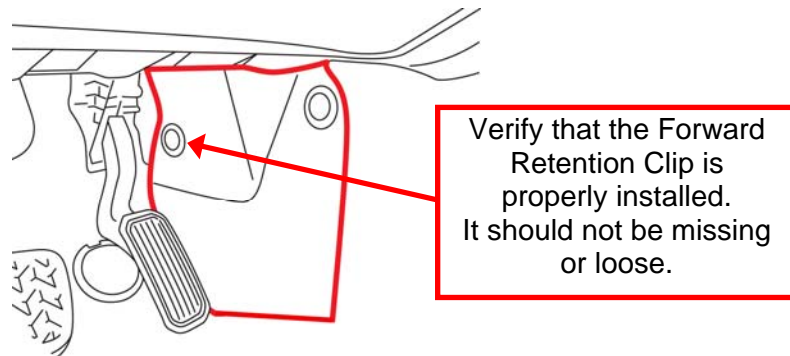
In certain 2004 through 2006 model year Highlander and Highlander HV vehicles, if the forward retention clip used to secure the driver's side Floor Carpet Cover, which is located in front of the center console, is not installed properly, the cover may lean toward the accelerator pedal and interfere with the accelerator pedal arm. If this occurs, the accelerator pedal may temporarily become stuck in a partially depressed position rather than return to the idle position. An accelerator pedal temporarily stuck in a partially depressed position may increase the risk of a crash.

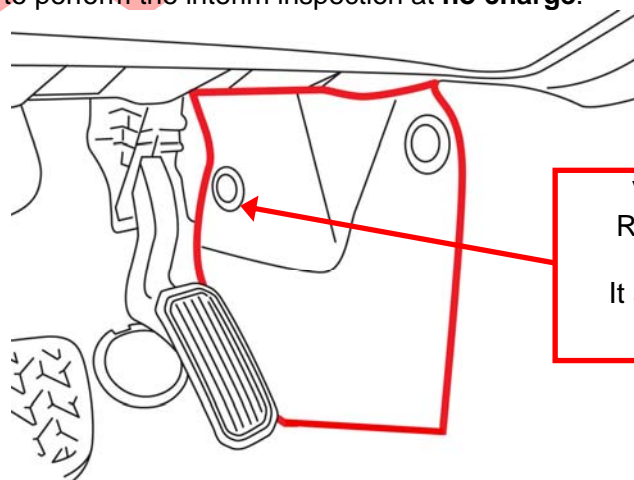
Verify that the Forward Retention Clip is properly installed. It should not be missing or loose.

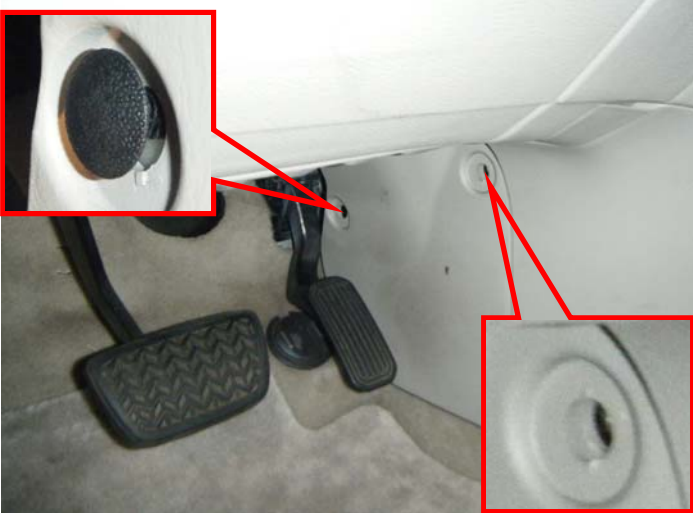
NG

Clip Loose:

Clip(s) Missing:

Replace if clip is loose

*Replacement Clip: 90467-06020-C0

Install new clip in missing location

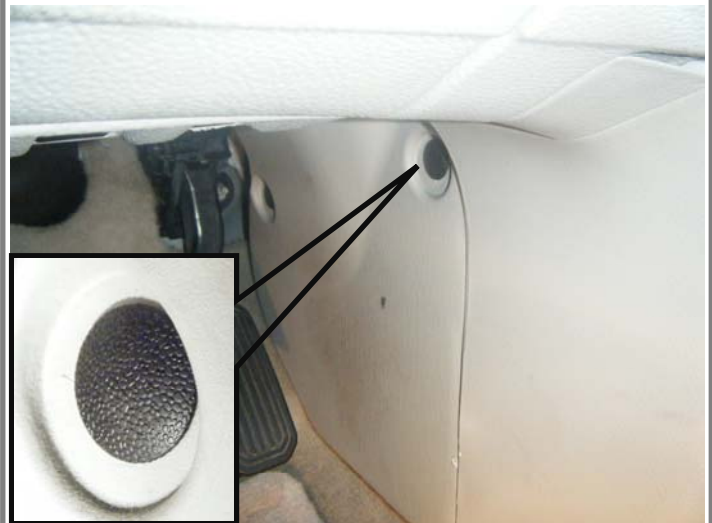
OK

Clips are secure

Proceed to Step 3.
