Subject: Safety Recall BLC (Interim B2C) - **Interim Notice**
Certain 2004 - Early 2007 Model Year RX 330, RX 350 and RX 400h Vehicles
Driver's Side Floor Carpet Cover and Retention Clip

**Certain 2004 – 2007 Model Year RX330/350/400h
Floor Carpet Cover and Retention Clip
Safety Recall Notice (*Interim Notice*)**

Safety Recall BLC - Q&A
Certain 2004 - Early 2007 Model Year RX 330/350/400h
Driver's Side Floor Carpet Cover and Retention Clips

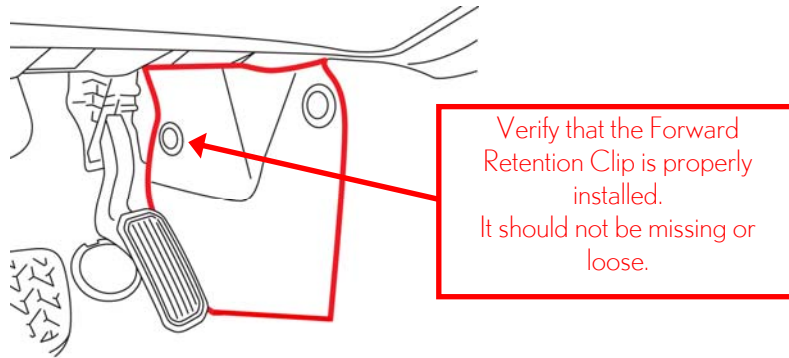
In certain 2004 through early 2007 model year RX 330, RX 350 and RX 400h vehicles, if the forward retention clip used to secure the driver's side floor carpet cover, which is located in front of the center console, is not installed properly, the cover may lean toward the accelerator pedal and interfere with the accelerator pedal arm. If this occurs, the accelerator pedal may temporarily become stuck in a partially depressed position rather than return to the idle position. An accelerator pedal temporarily stuck in a partially depressed position may increase the risk of a crash.
