Subject: Safety Recall BLC (Interim B2C) - **Interim Notice**
Certain 2004 - Early 2007 Model Year RX 330, RX 350 and RX 400h Vehicles
Driver's Side Floor Carpet Cover and Retention Clip

Safety Recall BLC (INTERM B2C) – INTERIM Carpet Floor Cover and Retention Clip Inspection 2004 through Certain Early 2007 Model Year RX330/RX350/RX400h

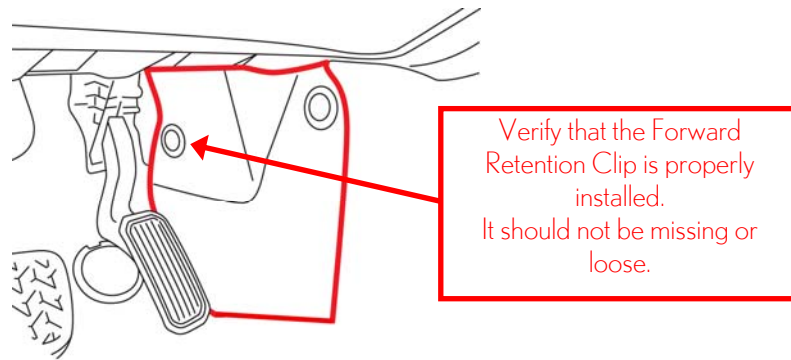
In certain 2004 through early 2007 model year RX 330, RX 350 and RX 400h vehicles, if the forward retention clip used to secure the driver's side floor carpet cover, which is located in front of the center console, is not installed properly, the cover may lean toward the accelerator pedal and interfere with the accelerator pedal arm. If this occurs, the accelerator pedal may temporarily become stuck in a partially depressed position rather than return to the idle position. An accelerator pedal temporarily stuck in a partially depressed position may increase the risk of a crash.

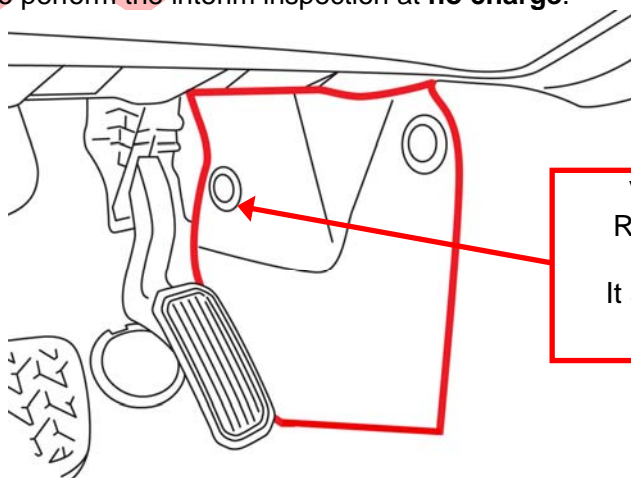
Verify that the Forward Retention Clip is properly installed. It should not be missing or loose.

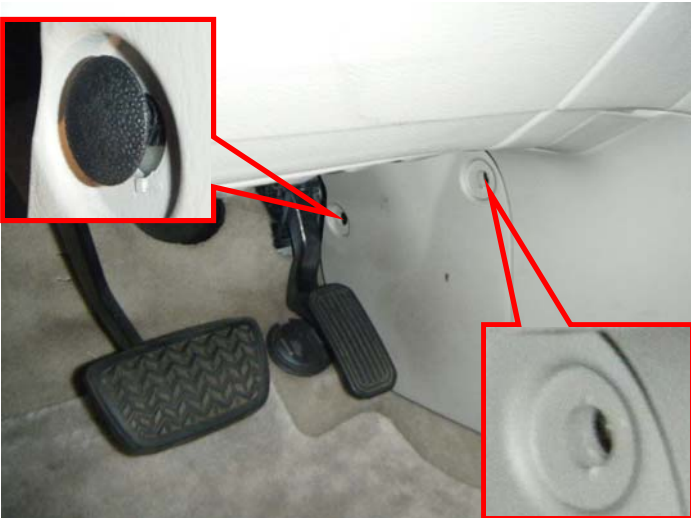
NG

Clip Loose:

Clip(s) Missing:

Replace if clip is loose

*Replacement Clip: 90467-06020-C0

Install new clip in missing location

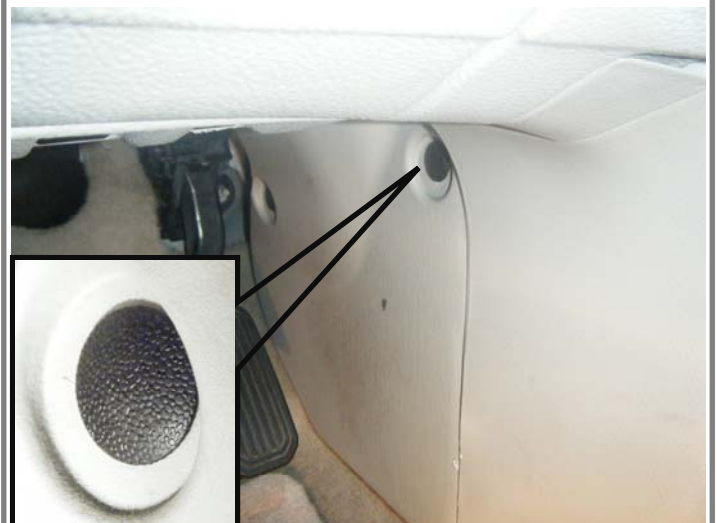
OK

Clips are secure.

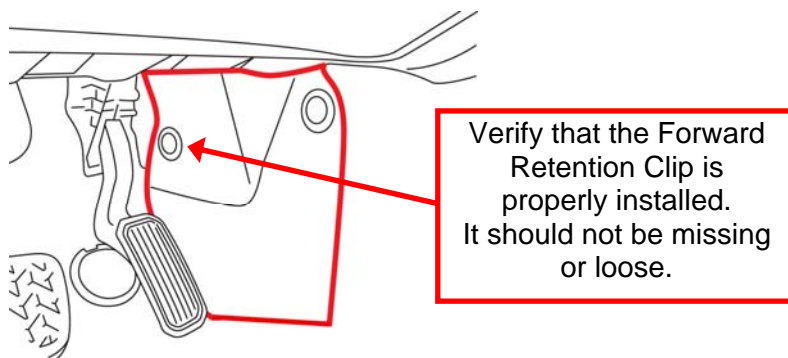
In certain 2004 through early 2007 model year RX 330, RX 350 and RX 450h vehicles, if the forward retention clip used to secure the driver's side floor carpet cover, which is located in front of the center console, is not installed properly, the cover may lean toward the accelerator pedal and interfere with the accelerator pedal arm. If this occurs, the accelerator pedal may temporarily become stuck in a partially depressed position rather than return to the idle position. An accelerator pedal temporarily stuck in a partially depressed position may increase the risk of a crash.
