TOYOTA CUSTOMER SERVICES

Volume: XVIII
Number: TC11-016
Date: 4/27/2011
 Action
 Retain
 Information

Subject: Safety Recall B0A – *Remedy Parts Available*
Certain 2004 – 2006 model year Highlander/Highlander HV
Driver's Side Floor Carpet Cover and Retention Clips

TECHNICAL INSTRUCTIONS

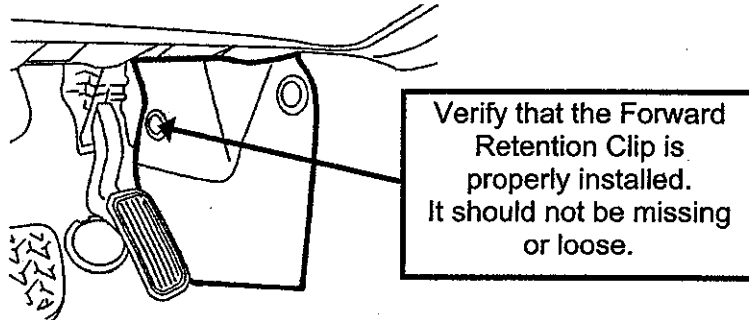
In certain 2004 through 2006 model year Highlander and Highlander HV vehicles, if the forward retention clip used to secure the driver's side Floor Carpet Cover, which is located in front of the center console, is not installed properly, the cover may lean toward the accelerator pedal and interfere with the accelerator pedal arm. If this occurs, the accelerator pedal may temporarily become stuck in a partially depressed position rather than return to the idle position. An accelerator pedal temporarily stuck in a partially depressed position may increase the risk of a crash.

Toyota will replace the Driver's side Floor Carpet Cover and Retention clips with newly designed parts. The new Floor Carpet Cover has an additional tab which extends beyond the travel of the accelerator pedal arm, so as not to interrupt the movement of accelerator pedal arm even if the cover is leaning.

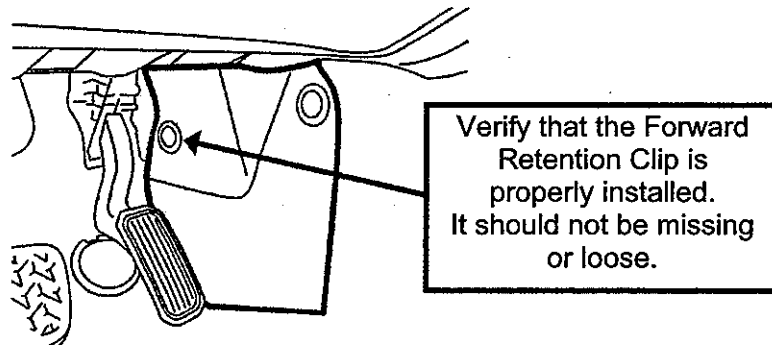
In certain 2004 through 2006 model year Highlander and Highlander HV vehicles, if the forward retention clip used to secure the driver's side Floor Carpet Cover, which is located in front of the center console, is not installed properly, the cover may lean toward the accelerator pedal and interfere with the accelerator pedal arm. If this occurs, the accelerator pedal may temporarily become stuck in a partially depressed position rather than return to the idle position. An accelerator pedal temporarily stuck in a partially depressed position may increase the risk of a crash.

Toyota will replace the Driver's side Floor Carpet Cover and Retention clips with newly designed parts. The new Floor Carpet Cover has an additional tab which extends beyond the travel of the accelerator pedal arm, so as not to interrupt the movement of accelerator pedal arm even if the cover is leaning.

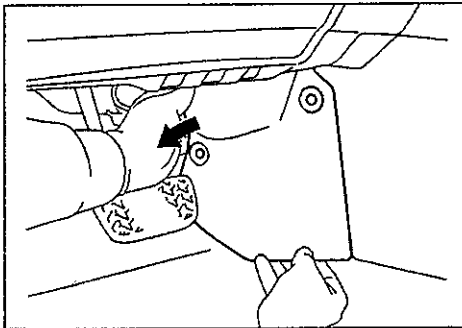
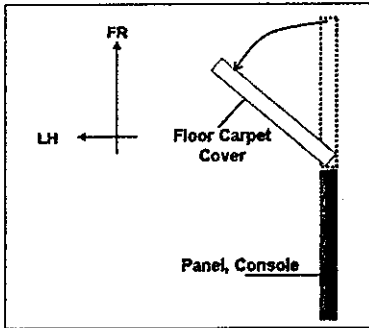
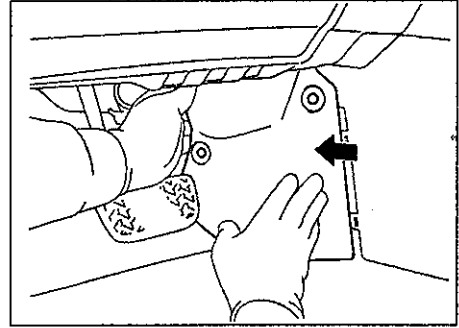
3. REMOVE THE CARPET COVER

The accelerator pedal **MUST** be removed. The center console panel will be damaged if the pedal is not removed.

- a) Tilt the front of the carpet cover toward the brake pedal.
- b) Move the carpet cover toward the front of the vehicle to remove it.
