# TOYOTA

Subject: Safety Recall B0A – **Remedy Parts Available**  
Certain 2004 – 2006 model year Highlander/Highlander HV  
Driver's Side Floor Carpet Cover and Retention Clips

**TECHNICAL INSTRUCTIONS**

**SAFETY RECALL B0A**

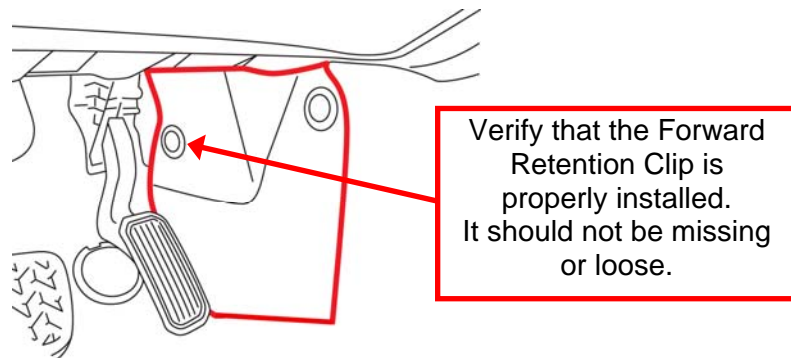
In certain 2004 through 2006 model year Highlander and Highlander HV vehicles, if the forward retention clip used to secure the driver's side Floor Carpet Cover, which is located in front of the center console, is not installed properly, the cover may lean toward the accelerator pedal and interfere with the accelerator pedal arm. If this occurs, the accelerator pedal may temporarily become stuck in a partially depressed position rather than return to the idle position. An accelerator pedal temporarily stuck in a partially depressed position may increase the risk of a crash.

Toyota will replace the Driver's side Floor Carpet Cover and Retention clips with newly designed parts. The new Floor Carpet Cover has an additional tab which extends beyond the travel of the accelerator pedal arm, so as not to interrupt the movement of accelerator pedal arm even if the cover is leaning.

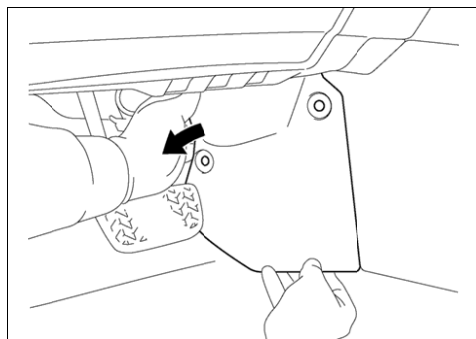
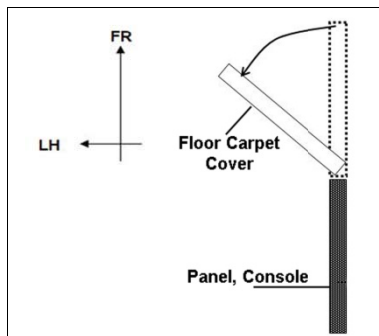
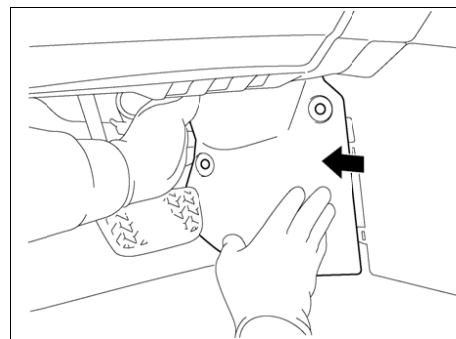
The accelerator pedal **MUST** be removed. The center console panel will be damaged if the pedal is not removed.

- Tilt the front of the carpet cover toward the brake pedal.
- Move the carpet cover toward the front of the vehicle to remove it.
