TO: All Mazda Dealership General Managers, Service Managers, and Parts Managers
DATE: March 2011
SUBJECT: 2009-2010 Mazda6 2.5L Engine Fuel Tank Safety and Emission Recall 6211B

ATTACHMENT I - DEALER INFORMATION
Safety & Emission Recall 6211B

2009-2010 MAZDA6 2.5L ENGINE FUEL TANK SAFETY AND EMISSION RECALL 6211B

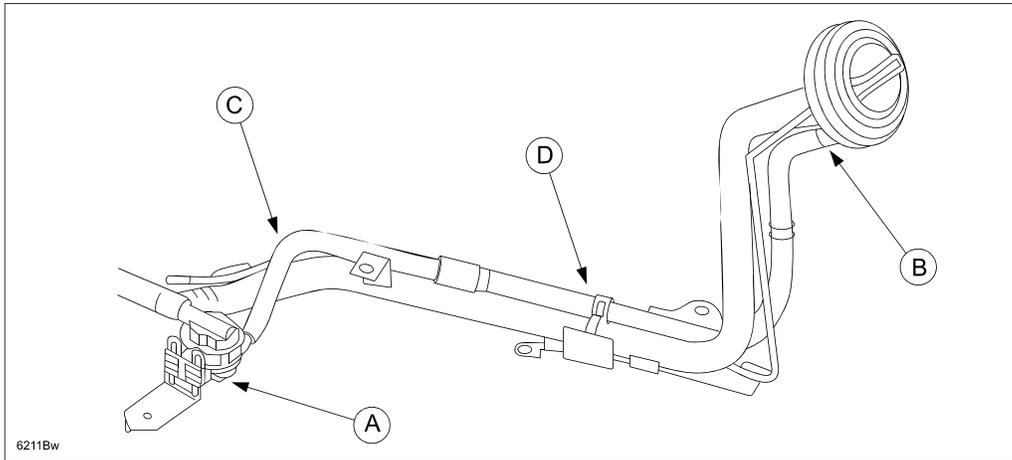
1. Visually inspect inside of the evaporative chamber (A) and vent port (B) to verify if spider webs are present or not. Insert the SST (Spider Brush: Part Number "MAZ6BRUSH") into the vent port and short ventilation hose (C) and long ventilation hose (D) and verify if spider webs are present or not.

- If spider webs are not found during the inspection, perform Step 2 (install spring) and Step 3 (reprogram PCM) only.
- If spider webs are found during the inspection, perform Step 2 (install spring), Step 3 (reprogram PCM) and Step 4 (replace fuel tank/evaporative chamber).

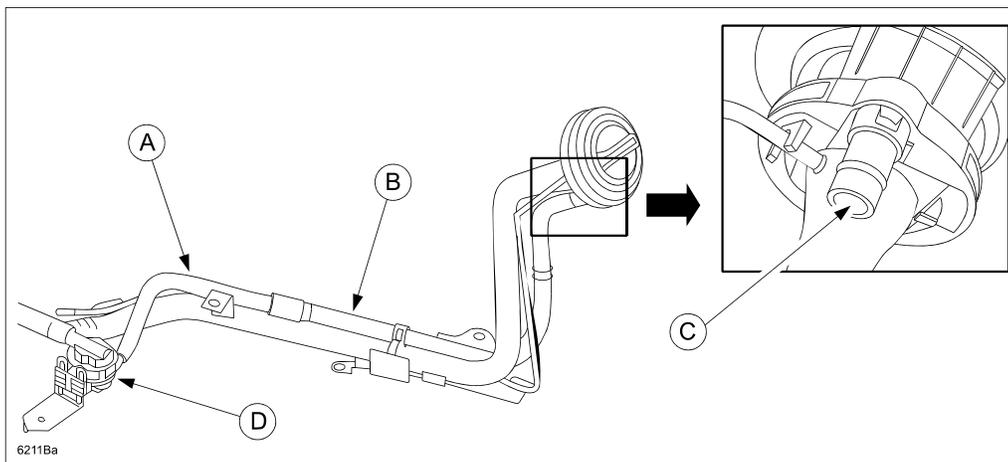
Using the Spider Brush SST, inspect the short ventilation hose (A), long ventilation hose (B), vent port nipple (C) and evaporative chamber (D) for spider webs.

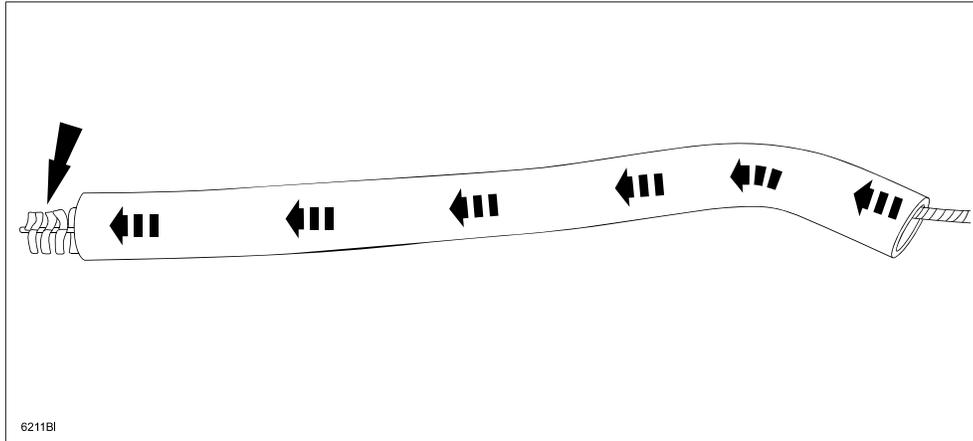
- a. Run the brush through the short ventilation hose, then check the tip of the brush to see if spider webs are present or not.

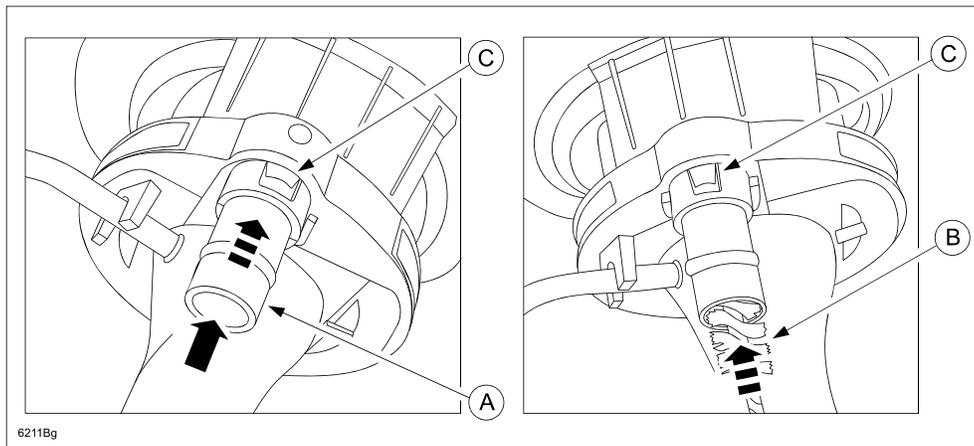
- a. Visually check inside of the vent port nipple (A) to see if spider webs are present or not.
- b. Insert the brush (B) into the vent port (C) and pull it out. Check the brush to see if spider webs are present or not.

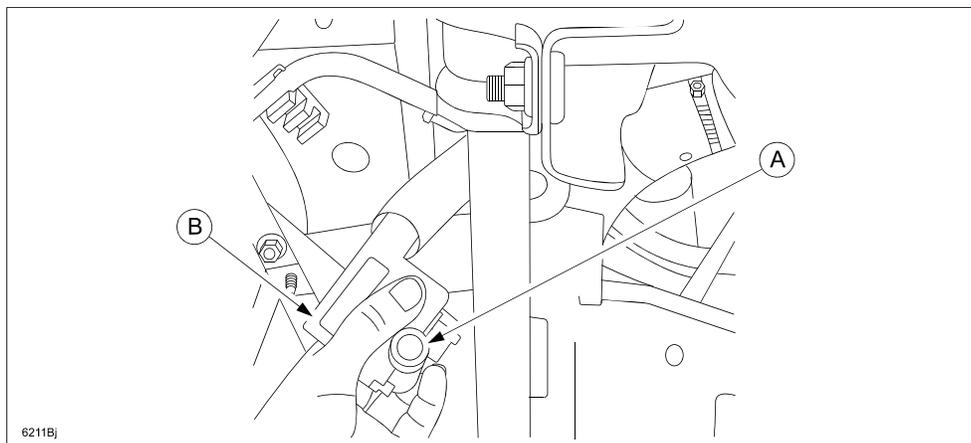
- a. Visually check location (A) inside of the evaporative chamber (B) and verify if spider webs are present or not.

- If spider webs ARE NOT FOUND in any one of the above inspections, proceed to and complete "Spring Installation" and "D. PCM REPROGRAMMING" only.
- If spider webs ARE FOUND in any one of the above inspections, proceed to and complete "Spring Installation", "D. PCM REPROGRAMMING" and "E. FUEL TANK AND EVAPORATIVE CHAMBER REPLACEMENT".
