TO: Winnebago Industries, Inc. Dealers

SUBJECT: Campaign #122 – LP Line Interference

INSTRUCTIONS TO PERFORM CAMPAIGN 122

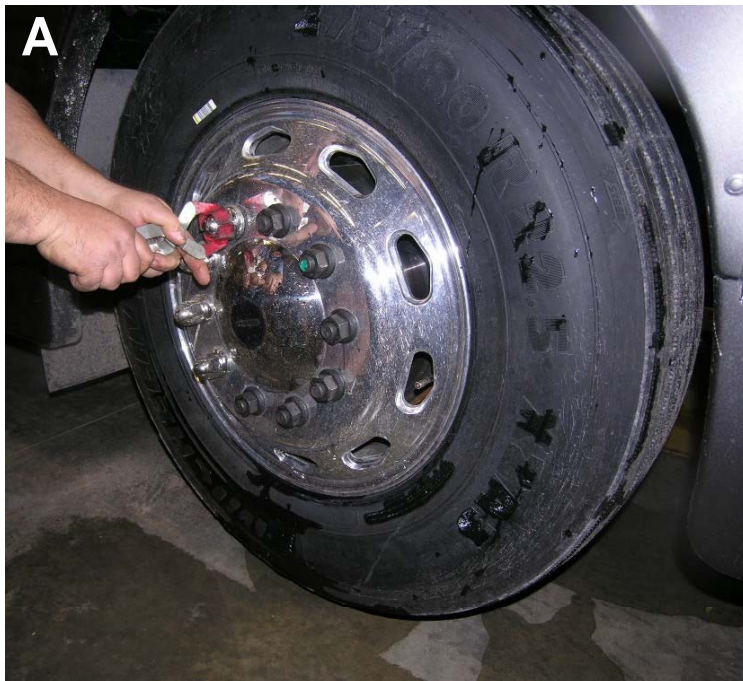
1. Shut off the LP gas on outside of coach.
2. Raise front of vehicle for front passenger side tire removal.
3. Using a lug nut cover tool, remove lug nut covers from front passenger side wheel and set aside. See Photo A.

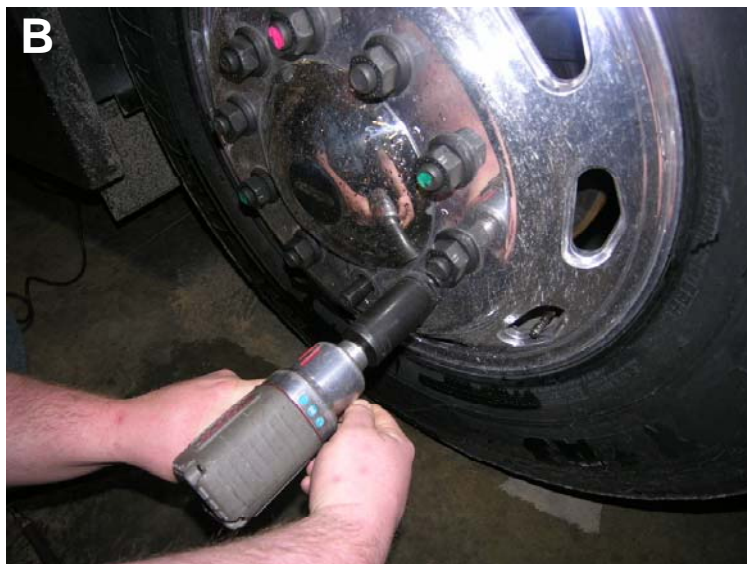
4. Using an impact wrench and 33 mm socket, remove lug nuts and set aside. See Photo B.

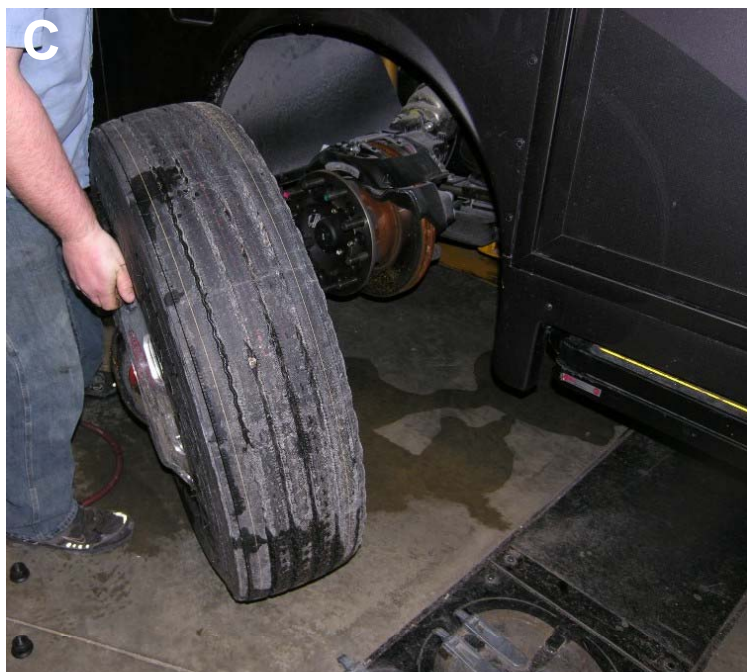
5. Remove tire and set aside. See Photo C.

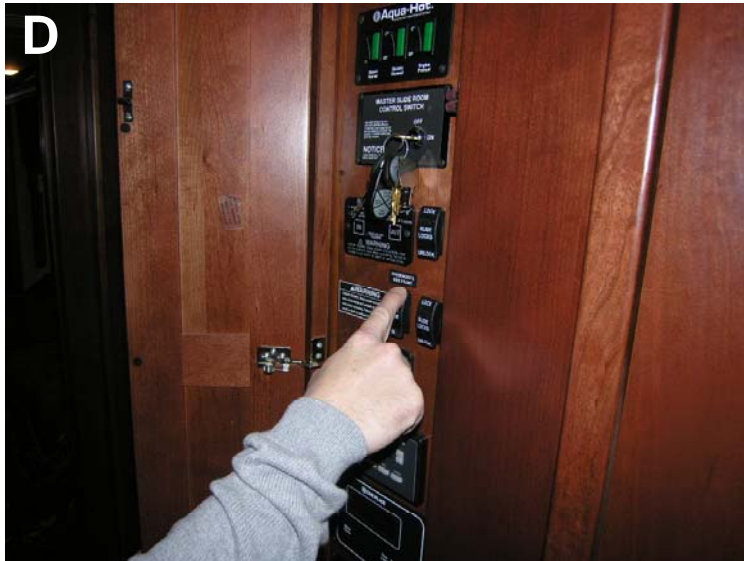
6. Unlock front passenger side slideout room travel lock and extend room. See Photo D.
NOTE: Switches are located near OnePlace® monitor panel in the middle of coach.

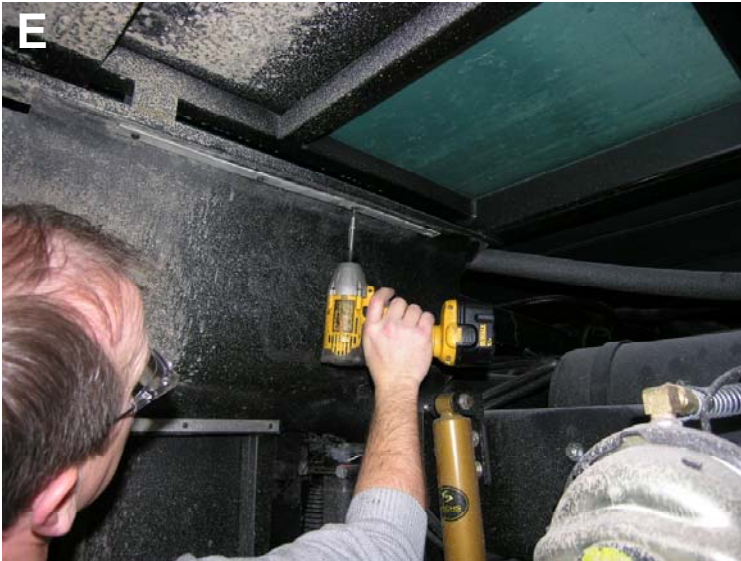
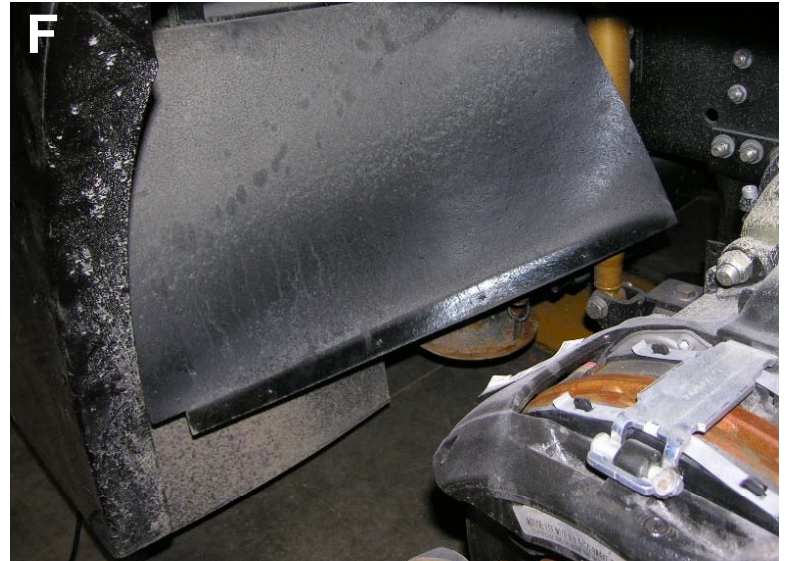
7. Using a screw gun, remove the top portion of the rubber splash guard (located to the rear of wheel well) and allow to hang loose. See Photos E and F.

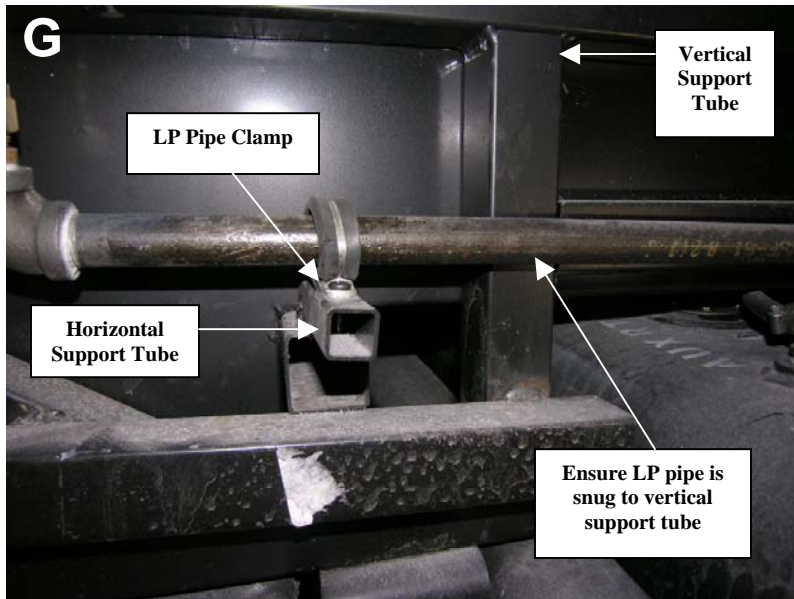
These vehicles have the potential for a LP hose connection to be damaged when the slideout room is operated. If the LP hose makes contact with the slideout ram, it could be disconnected. If this were to happen, a leak would occur when the LP tank is opened. The leaking LP then has the potential to ignite, which could result in personal injury or death.

9. Ensure LP pipe is snug to vertical support tube. If not, remove LP pipe clamp and reinstall clamp (as shown), ensuring that LP pipe is snug to the vertical support tube. See Photo G.

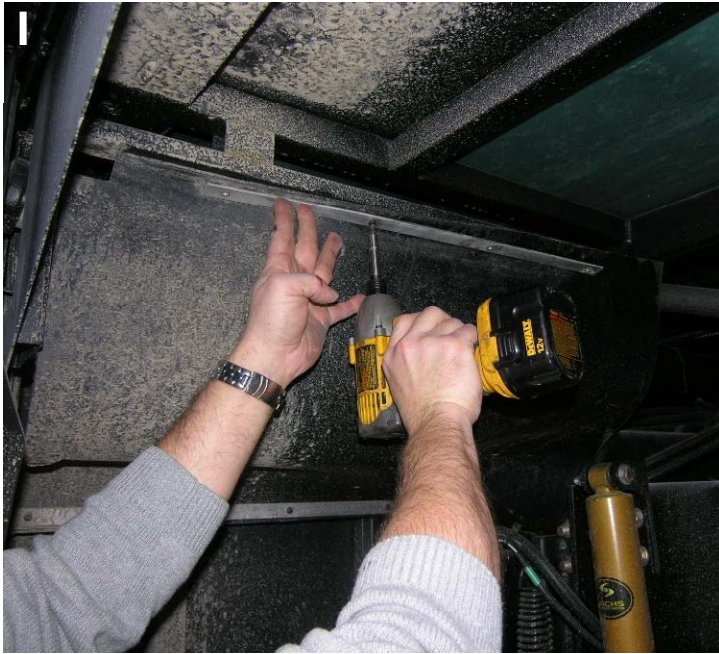
12. Reinstall rubber splash guard. See Photo I.

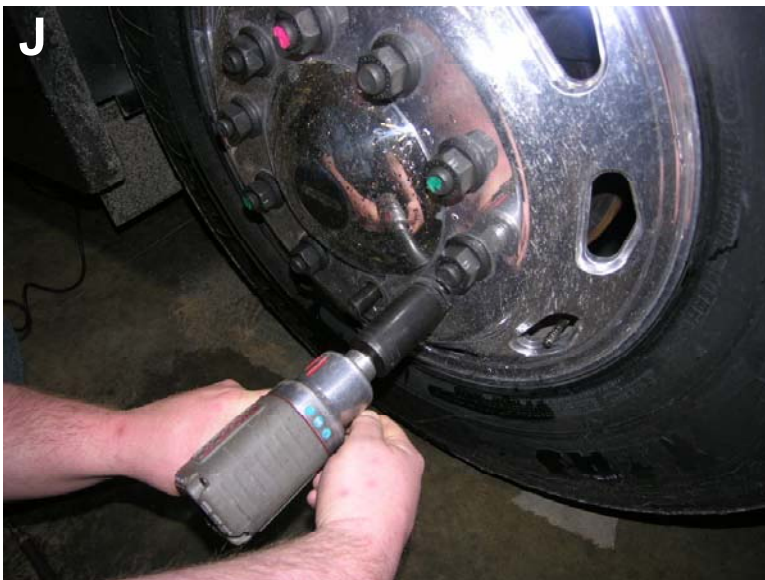
13. Reinstall tire and lug nuts. See Photo J.
