**Re: Defect Information Report – Supplemental Report No. 3  
11V-193, FL-588, Sterling Bullet Left Tie Rod Ends**

## Subject: Sterling Bullet Left Tie Rod Ends

April 2011  
FL588A  
NHTSA #11V-193  
Transport Canada #11-011

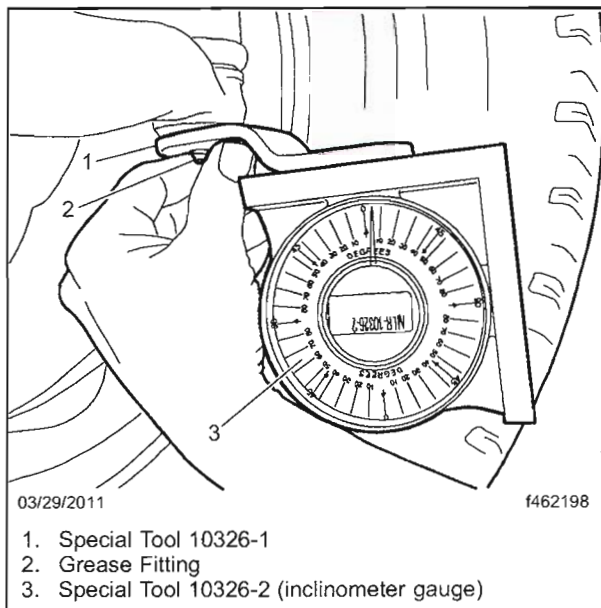
Fig. 3, Measuring Tie-Rod End Angle

Failure to set the same angles on both the left and right tie-rod ends will cause the condition this recall is addressing to still be present.

21. Set the toe and center the steering wheel following the alignment rack manufacturer's instructions.
22. Install special tools 10326-1 and 10326-2 (inclinometer gauge) on the bottom surface of the right tie-rod end. The grease fitting should be centered in the hole on special tool 10326-1. See **Fig. 3**.
23. Measure the angle of the right tie-rod end. Record the number displayed on the inclinometer gauge.
24. Install special tools 10326-1 and 10326-2 onto the bottom surface of the left tie-rod end.

25. Adjust the left tie-rod end so that the same angle appears on the inclinometer gauge as was measured on the right tie-rod end.
26. Tighten the tie rod adjuster clamp 40 lbf-ft (54 N·m).

27. Recheck both angles. If the tie-rod end angles are different, loosen the left tie-rod adjuster clamp and readjust the left tie-rod end, as necessary.
28. Clean a spot on the base label (Form WAR259), and attach a completion sticker (Form WAR 261) for campaign FL588 to the base label.
