**Re: Defect Information Report – Supplemental Report No. 6  
11V-193, FL-588, Sterling Bullet Left Tie Rod Ends  
Revised Dealer Notice**

## Subject: Sterling Bullet Left Tie Rod Ends

April 2011  
FL588A  
NHTSA #11V-193  
Transport Canada #11-011  
REVISED NOTICE

### Left Outer Tie-Rod End Replacement

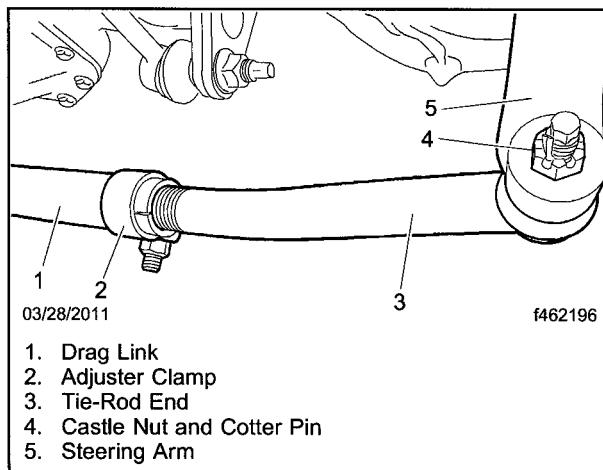
**Fig. 1, Tie-Rod End Assembly**

The left outer tie rod end may fracture due to a misalignment condition. Under certain driving conditions, the misalignment may lead to a weakening and eventual fracture of the left outer tie rod ball stud. A fractured tie rod end could cause a loss of directional stability and a vehicle crash.

4. Remove the left front wheel.
5. Loosen the adjuster clamp nut and bolt on the left tie rod. See **Fig. 1**.
6. Apply Mopar Rust Penetrant (P/N 04318039AC), or equivalent, to the threads on the tie-rod end.

9. While counting the number of turns, unscrew the tie-rod end from the drag link. Discard the tie-rod end. See **Fig. 1**.

10. Apply a light coat of Mopar Anti-Seize Lubricant (P/N 05012249AB), or equivalent, to the threads of the new tie-rod end.
11. Making the same number of turns used to remove the tie-rod end in step 9, thread the new tie-rod end onto the drag link.

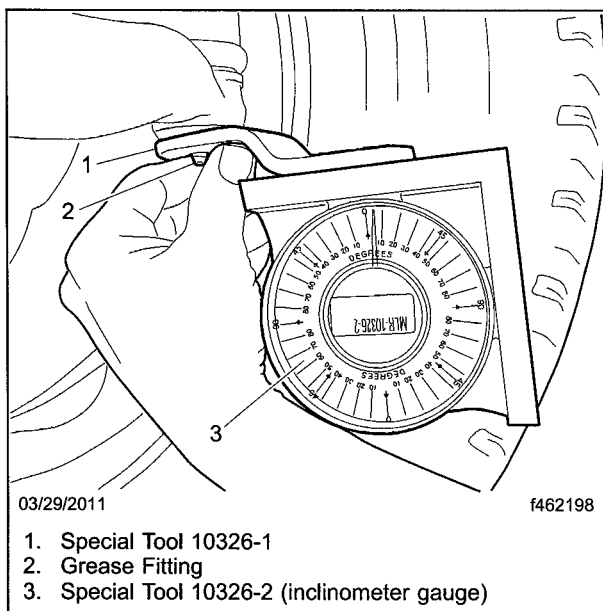
Fig. 3, Measuring Tie-Rod End Angle

**Failure to set the same angles on both the left and right tie-rod ends will cause the condition this recall is addressing to still be present.**

21. Set the toe and center the steering wheel following the alignment rack manufacturer's instructions.
22. Install special tools 10326-1 and 10326-2 (inclinometer gauge) on the bottom surface of the right tie-rod end. The grease fitting should be centered in the hole on special tool 10326-1. See **Fig. 3**.
23. Measure the angle of the right tie-rod end. Record the number displayed on the inclinometer gauge.
24. Install special tools 10326-1 and 10326-2 onto the bottom surface of the left tie-rod end.

25. Adjust the left tie-rod end so that the same angle appears on the inclinometer gauge as was measured on the right tie-rod end.
26. Tighten the tie rod adjuster clamp 40 lbf-ft (54 N·m).

27. Recheck both angles. If the tie-rod end angles are different, loosen the left tie-rod adjuster clamp and readjust the left tie-rod end, as necessary.
28. Clean a spot on the base label (Form WAR259), and attach a completion sticker (Form WAR 261) for campaign FL588 to the base label.
